DEKRA's commission No. : PKOL(W)/LODZ/54788/25/07/25  
commission/ damage No. : 01497/EO/23  
Date of commission: 25-07-2025

**Vehicle data**

| Manufacturer | BMW |
| Type / version | 530i xDrive M Sport sport-aut |

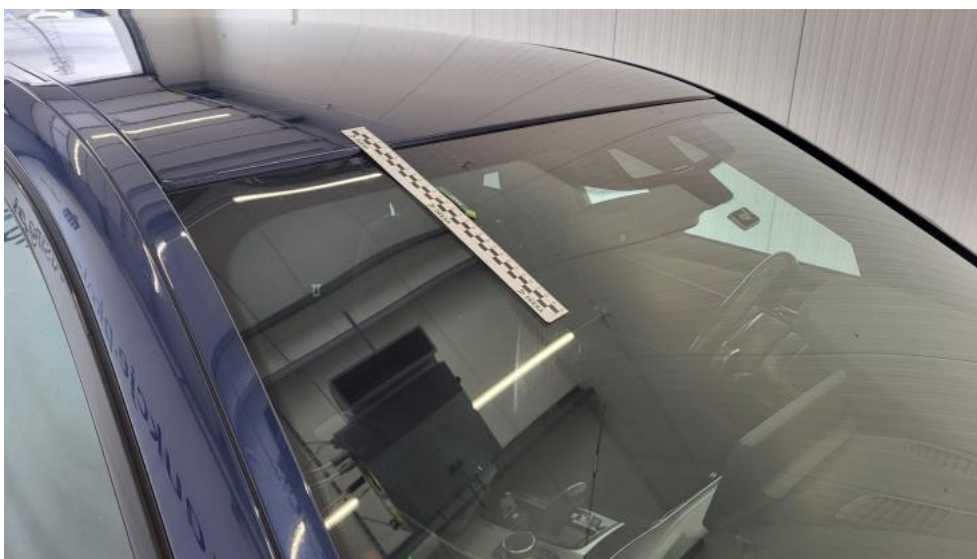
**Photo 45.**

Szyba czołowa - zdjęcie poglądowe 1

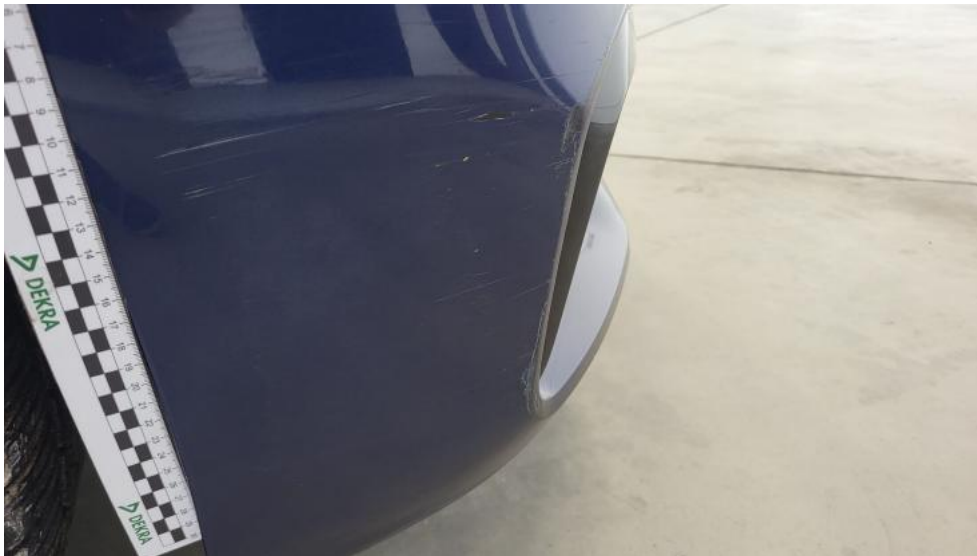
**Photo 49.**

Zderzak() - Rysa/odprysk 3

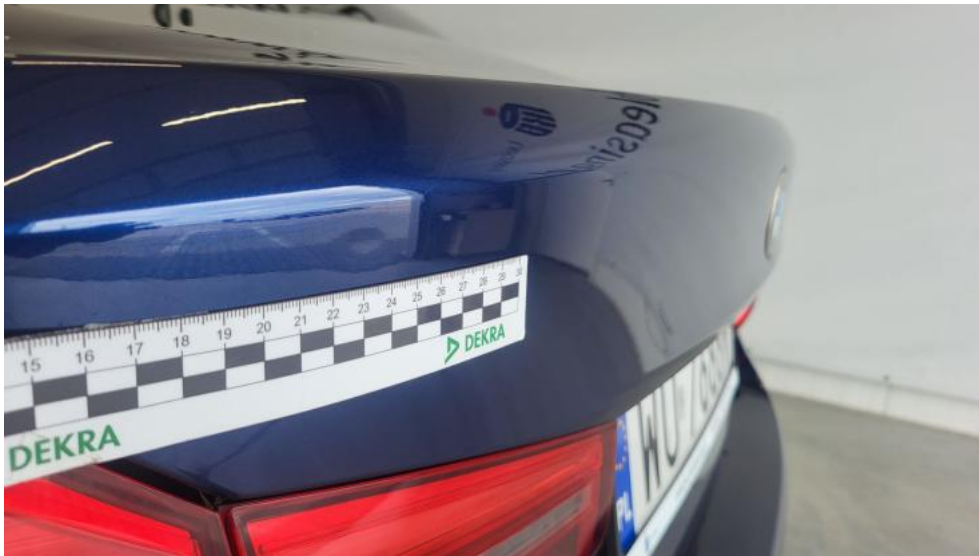
**Photo 61.**

Pokrywy bagażnika - Wgniecenie/odkształcenie 1

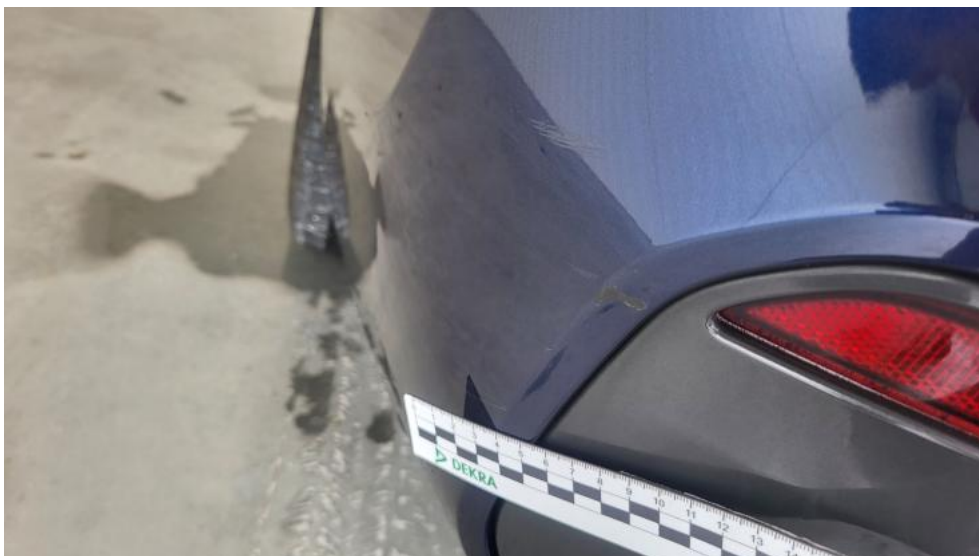
**Photo 62.**

Zderzak tylny - Rysa/odprysk 1

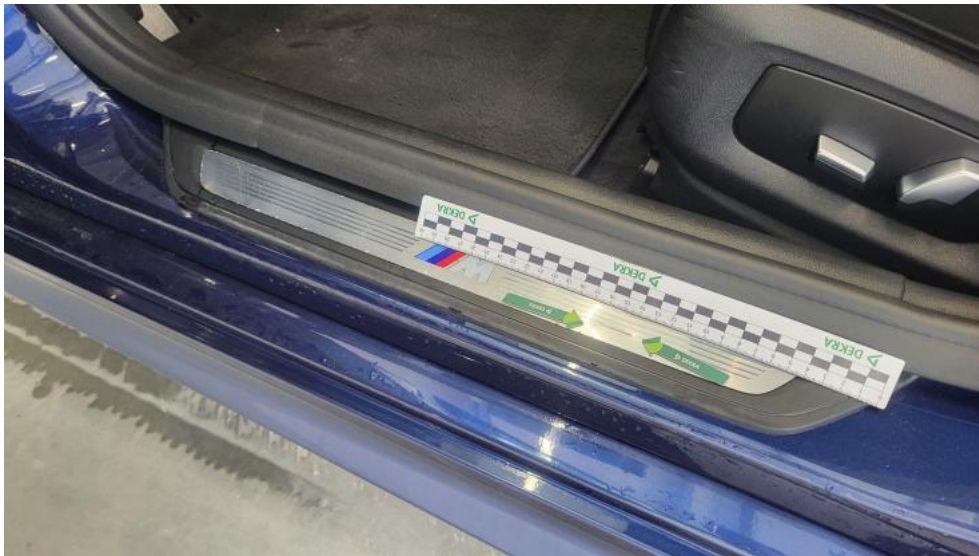
**Photo 75.**

Próg L - Wgniecenie/odkształcenie 1

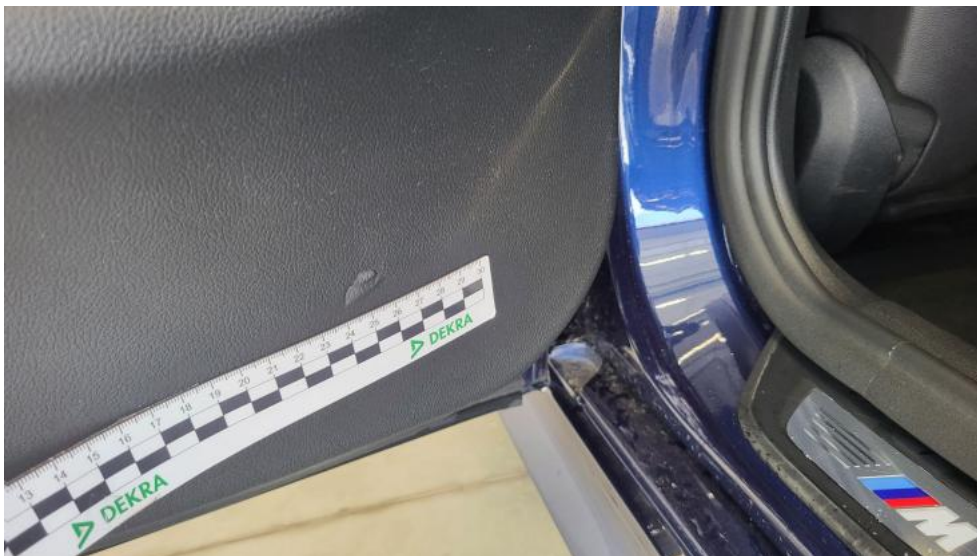
**Photo 77.**

Tapicerka drzwi tylnych L - zdjęcie poglądowe 1
