DEKRA's commission No. : PKOL(W)/LODZ/92962/25/11/28  
commission/ damage No. : 20/052733  
Date of commission: 28-11-2025

**DEKRA Poland - Headquarters**  
02-673 Warszawa, ul. Konstruktorska 12A

| Manufacturer | FORD |
| Model | Focus Kombi 18-21 |

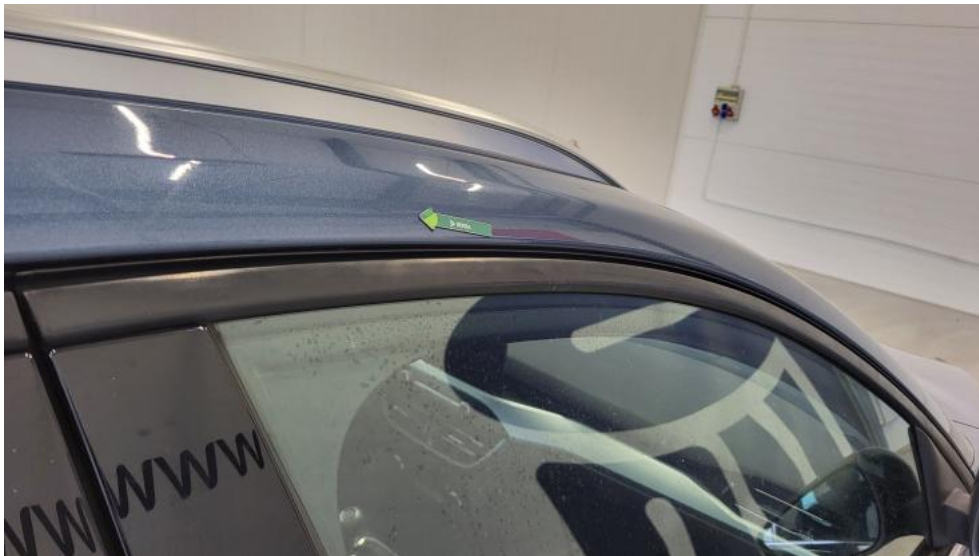
**Photo 49.**

Słupek przedni P - Wgniecenie/odkształcenie 1

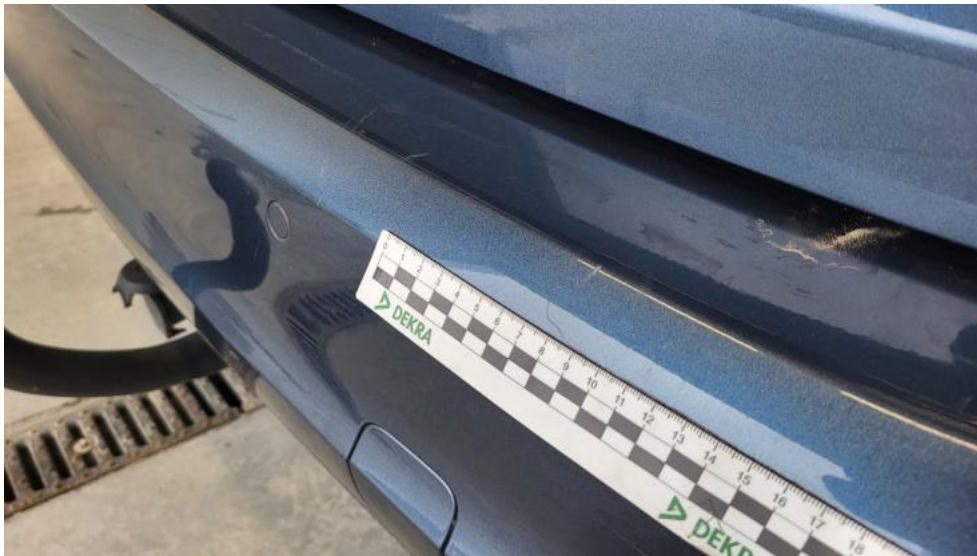
**Photo 53.**

Zderzak tylny - Rysa/odprysk 1

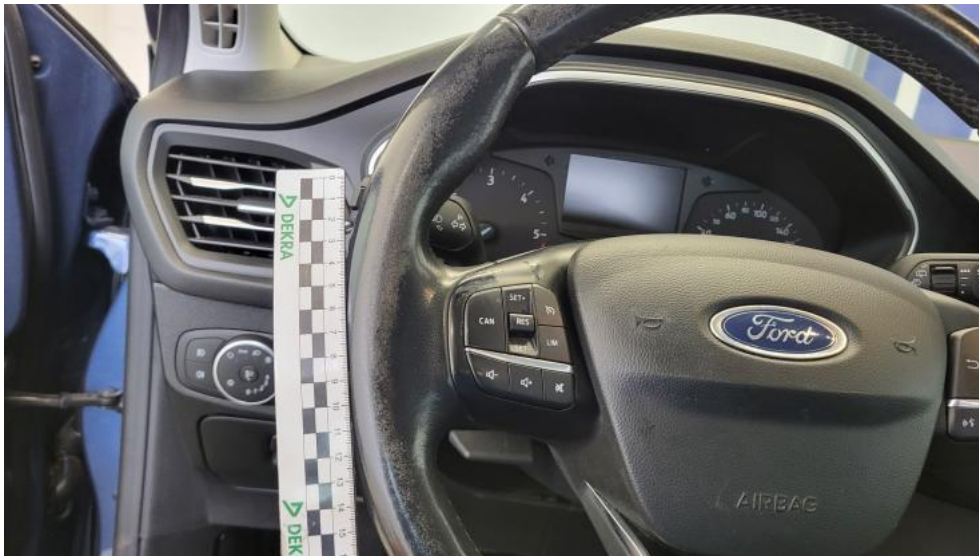
**Photo 63.**  
Koło kierownicy - Inne 1

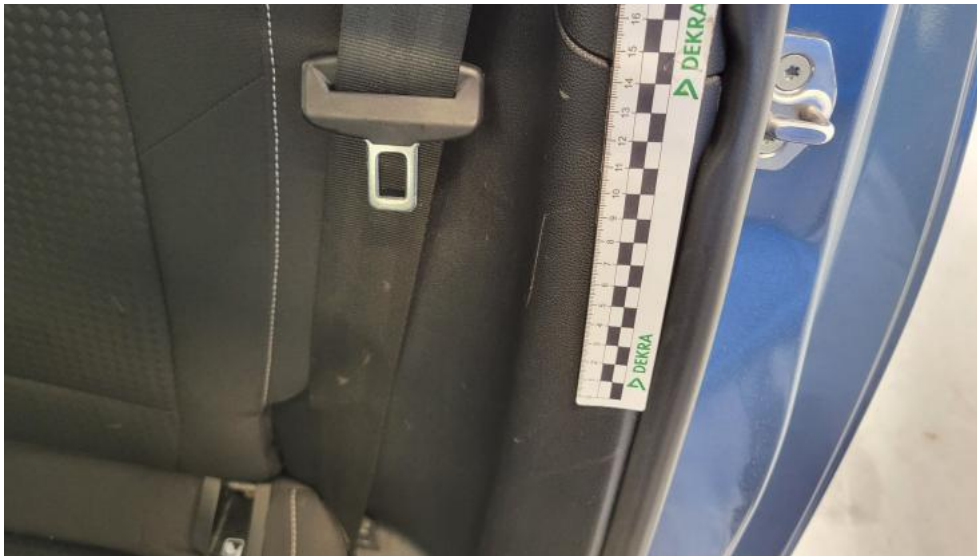
**Photo 78.**

Wykładzina(y) słupka przedniego P - Inne 1
