DEKRA's commission No. : PKOL(W)/LODZ/94506/26/10/08  
commission/ damage No. : 23/044732  
Date of commission: 08-10-2026

**DEKRA Poland - Headquarters**  
02-673 Warszawa, ul. Konstruktorska 12A

| Manufacturer | BMW |
| Type / version | X7 M50i sport-aut |

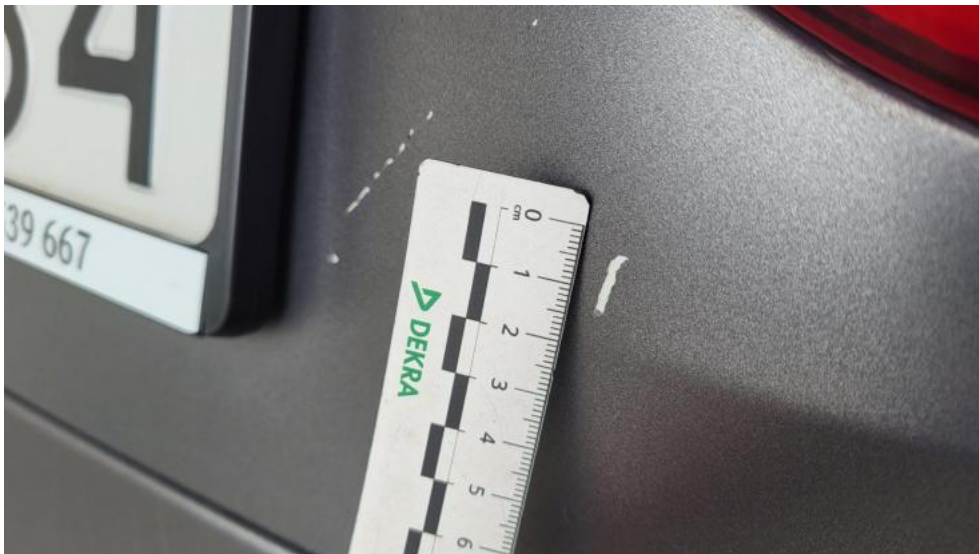
**Photo 61.**

Pokrywy bagażnika - Rysa/odprysk 1

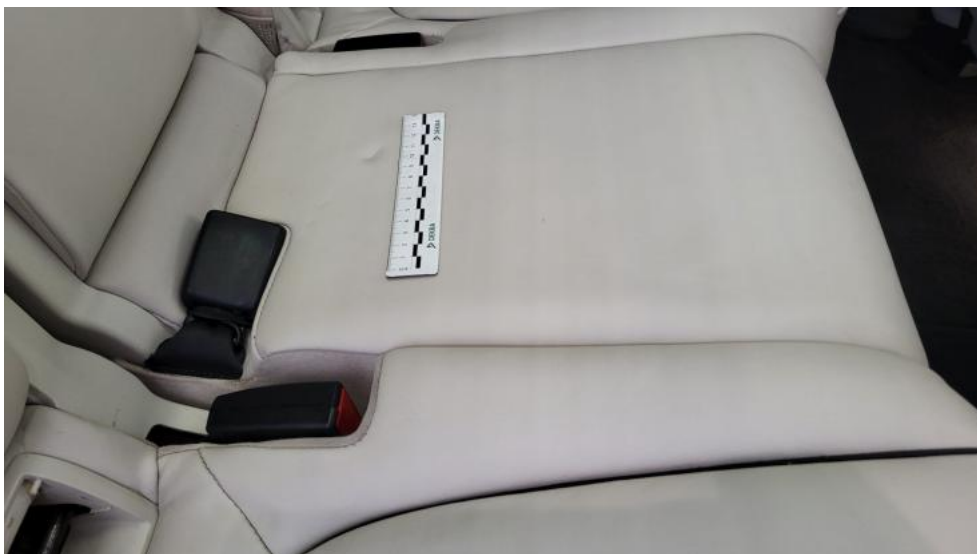
**Photo 69.**

Kanapa tyl. - Wgniecenie/odkształcenie 1
