DEKRA's commission No. : PKOL(W)/LODZ/96020/26/10/14  
commission/ damage No. : 23/032240  
Date of commission: 14-10-2026

**DEKRA Poland - Headquarters**  
02-673 Warszawa, ul. Konstruktorska 12A

| Manufacturer | AUDI |
| Type / version | R8 V10 RWD Performance |

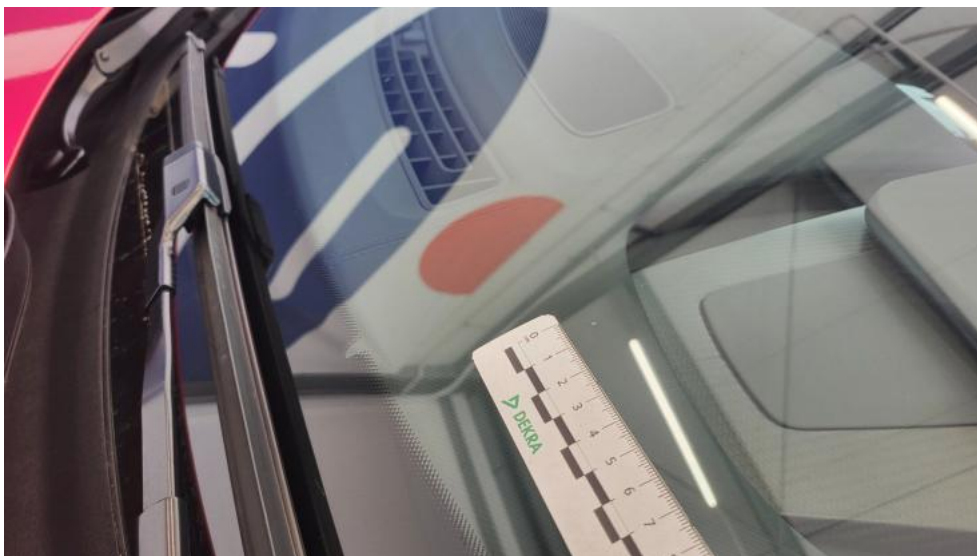
**Photo 59.**

Szyba czołowa - zdjęcie poglądowe 1

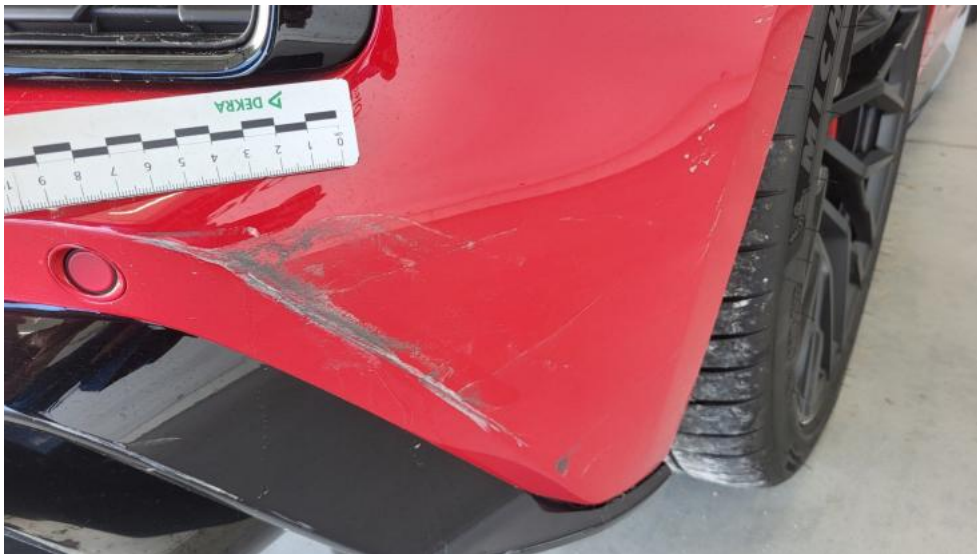
**Photo 67.**

Zderzak tylny - Rysa/odprysk 1

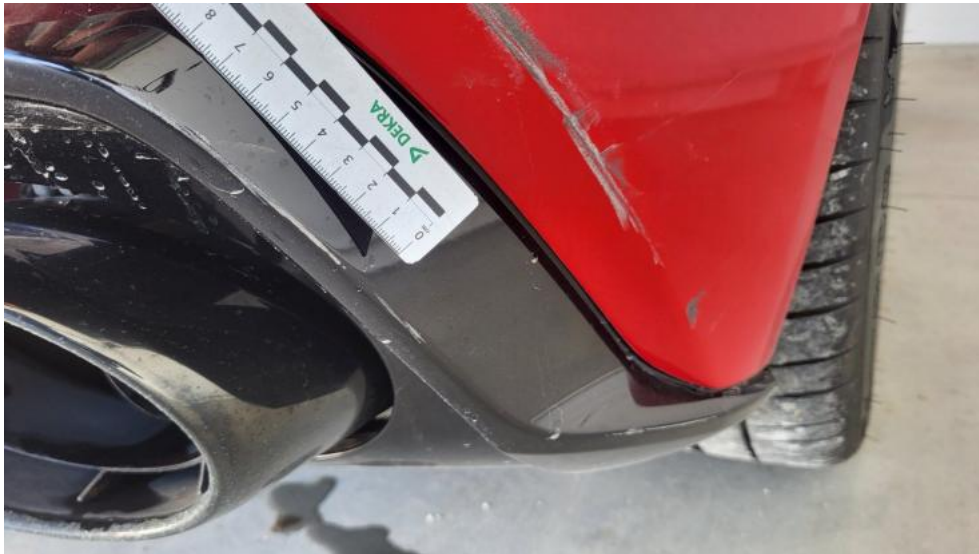
**Photo 69.**

Zderzak tylny cz P - Rysa/odprysk 1

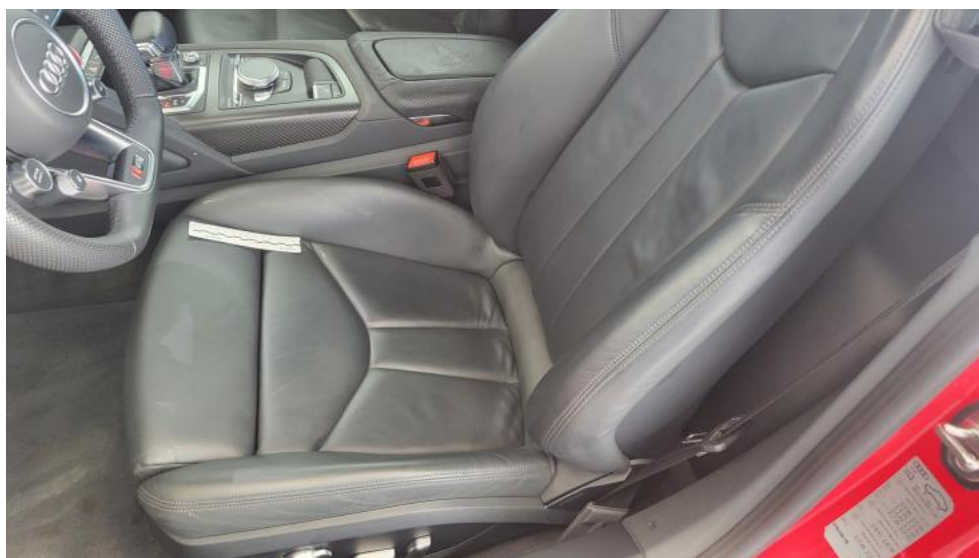
**Photo 76.**

Fotel prz. lew. - zdjęcie poglądowe 1

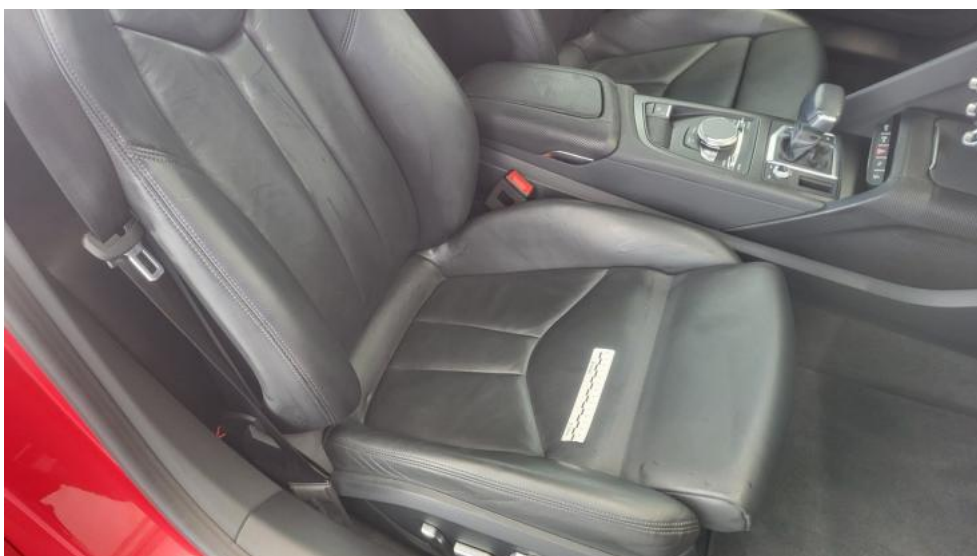
**Photo 78.**

Fotel prz. praw. - zdjęcie poglądowe 1

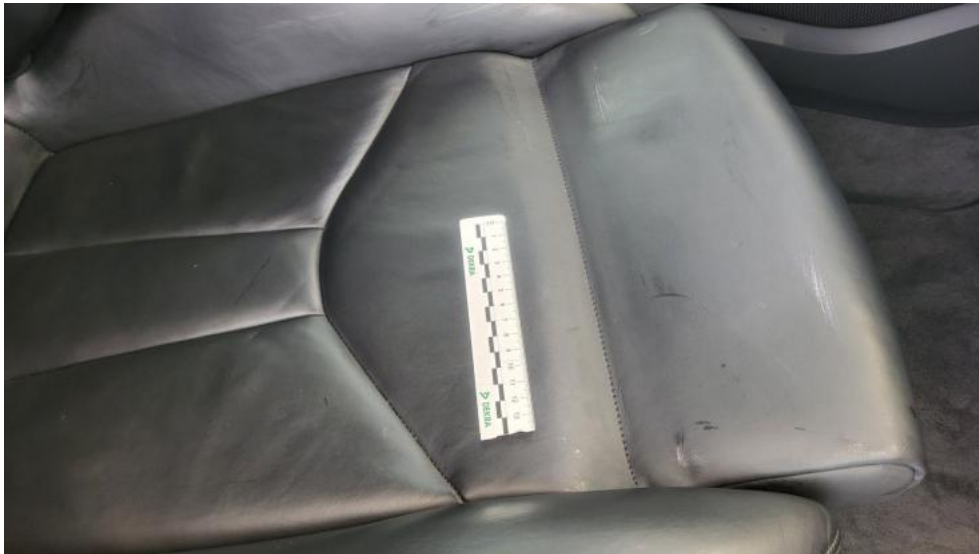
**Photo 79.**

Fotel prz. praw. - Inne 1

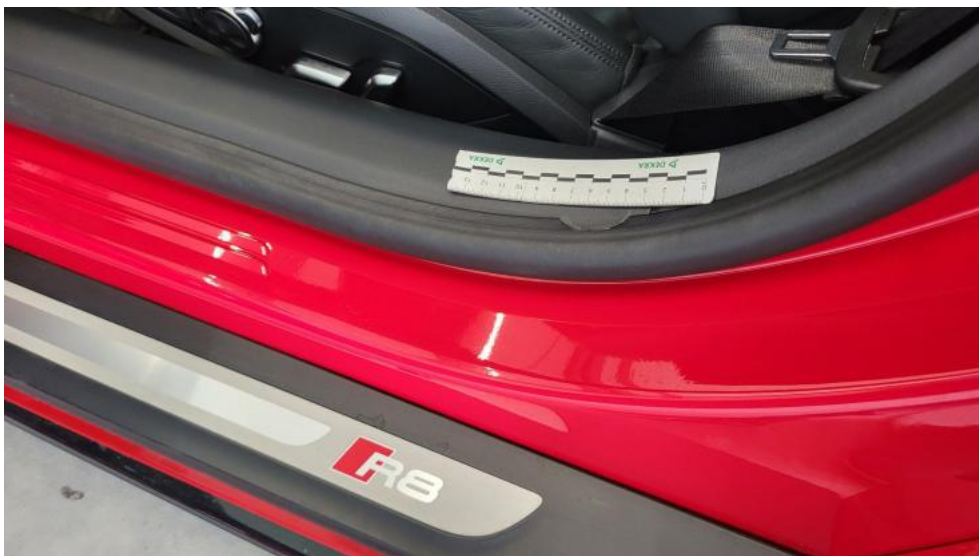
**Photo 80.**

Uszczelka drzwi przednich L - zdjęcie poglądowe 1
