DEKRA's commission No. : PKOL(W)/LODZ/03993/26/01/16  
commission/ damage No. : 22/028047  
Date of commission: 16-01-2026

| Manufacturer | TOYOTA |
| Type / version | Corolla 2.0 Hybrid Selection |
| Registration /record No. | CB897NW |

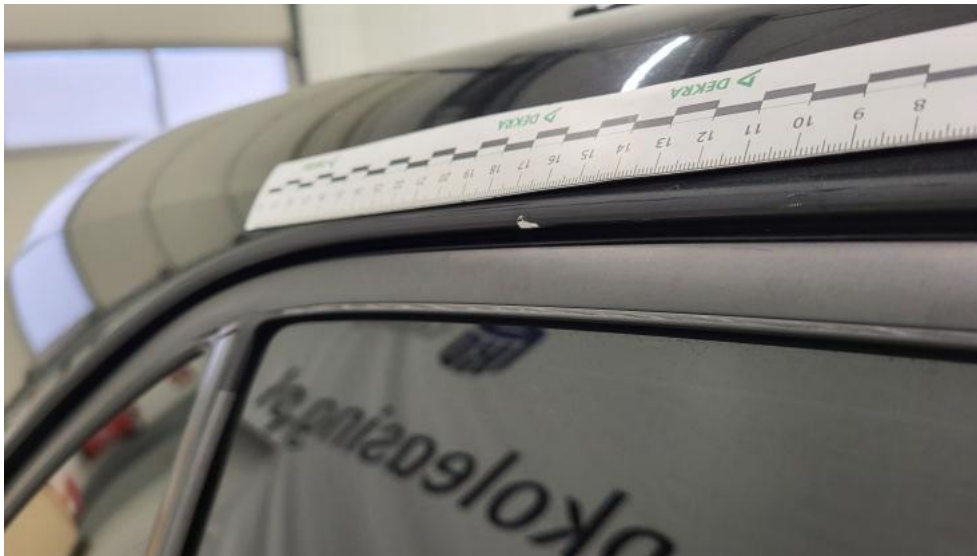
**Photo 55.**

Błotnik tylny P / Ściana boczna P - Rysa/odprysk 1

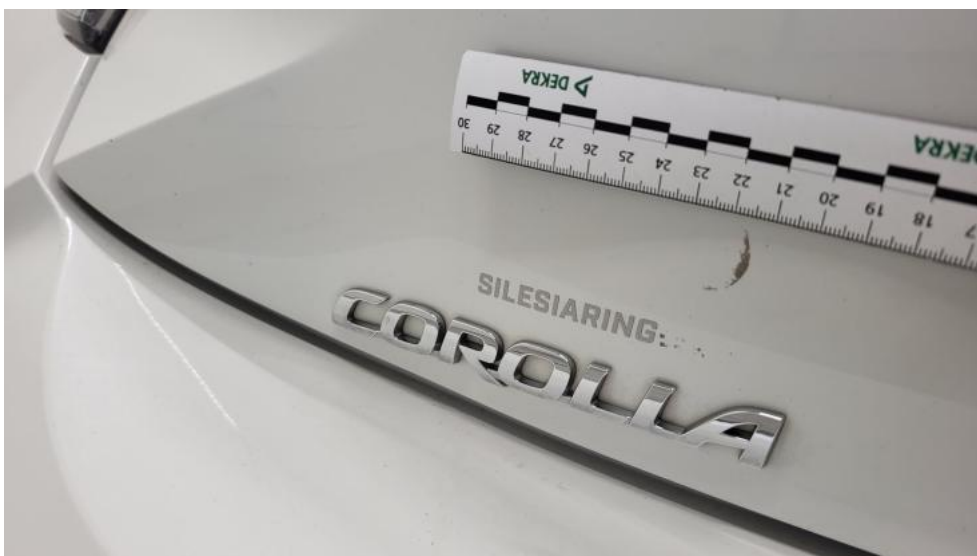
**Photo 60.**

Pokrywy bagażnika - Inne 1

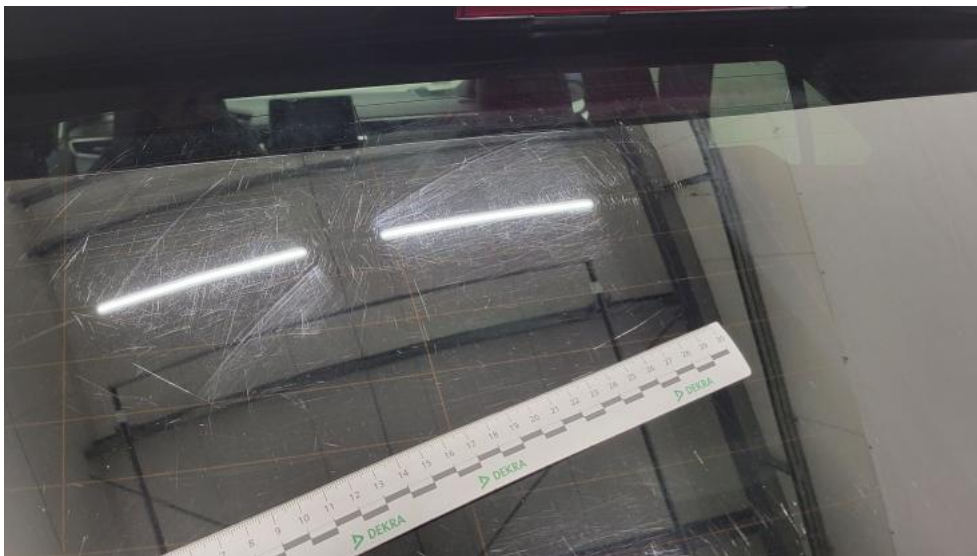
**Photo 61.**

Szyba tylna - Rysa/odprysk 1

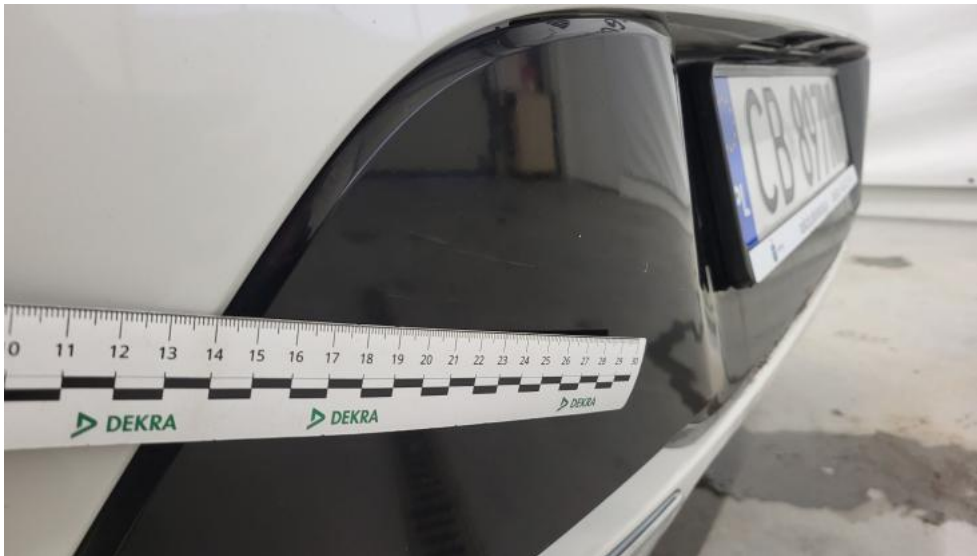
**Photo 63.**

Zderzak tylny cz dolna - Rysa/odprysk 1

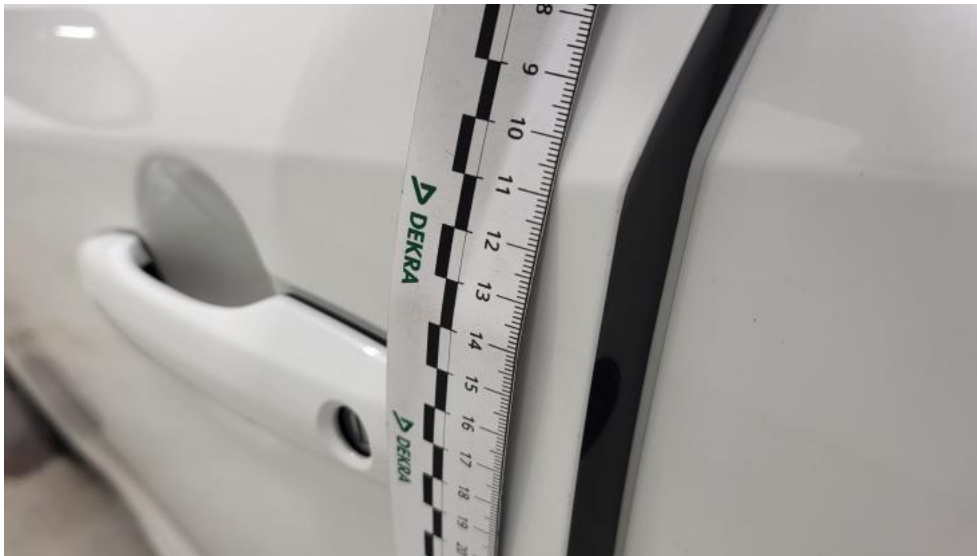
**Photo 69.**

Drzwi przed L - Rysa/odprysk 1

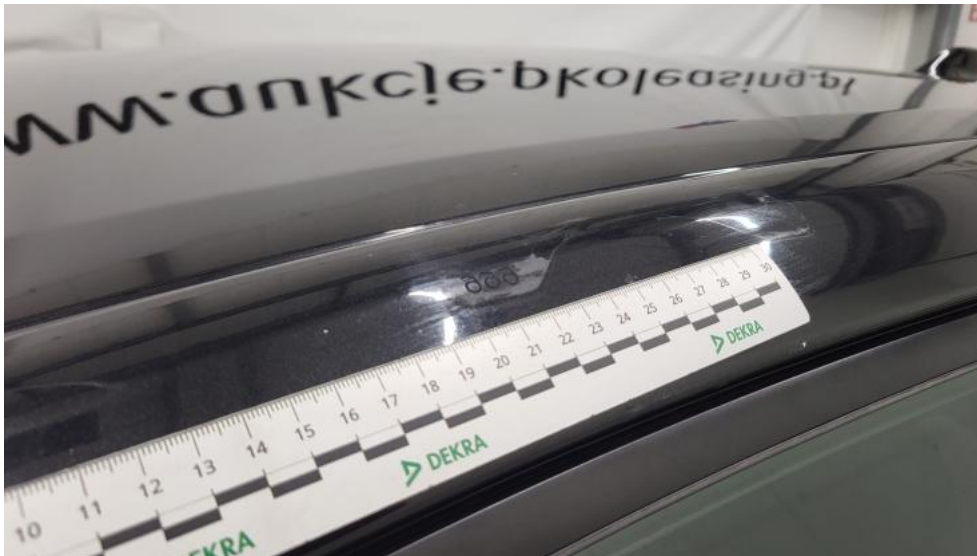
**Photo 73.**

Słupek przedni L - Inne 1
