DEKRA's commission No. : PKOL(W)/LODZ/63830/24/08/21  
commission/ damage No. : 49501  
Date of commission: 21-08-2024

**Vehicle data**

| Model | Jumper 35 BlueHDi Euro 6 1997ccm - 130KM 3,5t<br>16-19 |
| Registration /record No. | DW2EG12 |

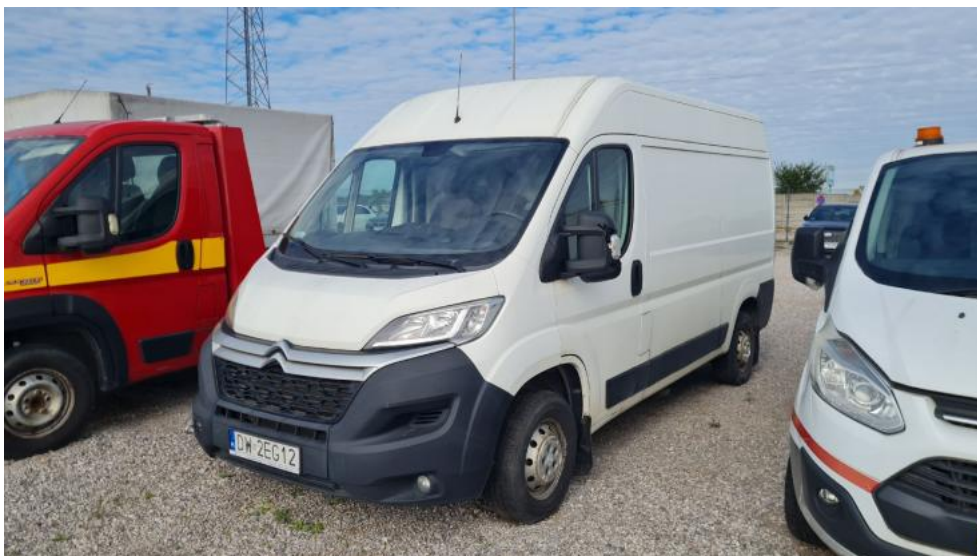
**Photo 1.**  
Przekątna przednia lewa

Niesprawny akumulator, podłączono zewnętrzne źródło zasilania. Pojazd nie odpala. Brak dowodu rejestracyjnego. Dostarczono ksero pozwolenia czasowego, rok produkcji do weryfikacji. Brak możliwości zweryfikowania wyposażenia. Rysy, odpryski i wgniecenia na samochodzie. Ślady korozji na samochodzie.

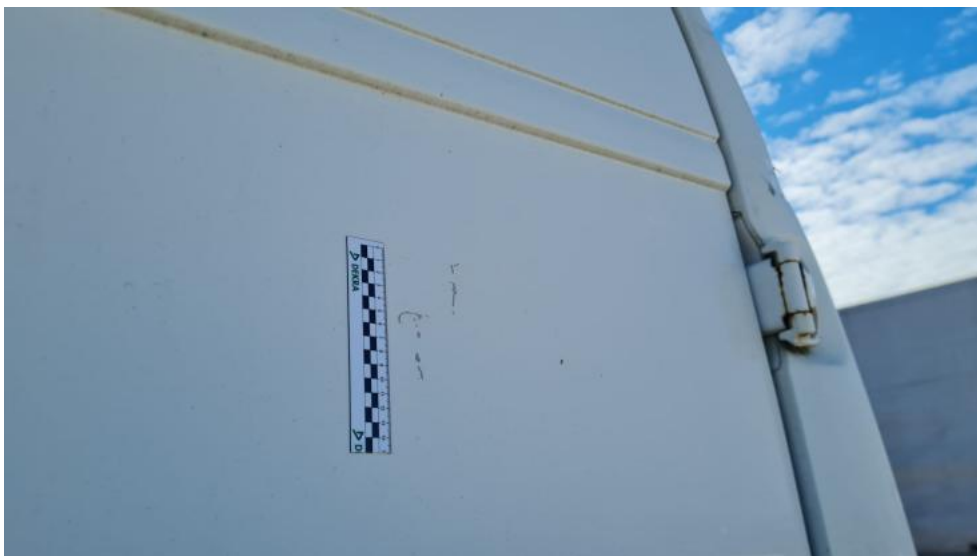
**Photo 71.**

Drzwi tyłu prawe - Rysa/odprysk 1
