DEKRA's commission No. : PKOL(W)/LODZ/17211/25/03/07
 commission/ damage No. : 23/033957
 Date of commission: 07-03-2025

Vehicle data

Group of objects (Eurotax)	jeeps
EC code (Eurotax)	0109187
Manufacturer	VOLVO
Model	XC90 14-19
Type / version	XC90 T8 AWD Plug-In Hybrid Inscription 7os
Body type	KOM
Number of doors / seats	5/7
Curb weight [kg]	2244
Gross vehicle weight [kg]	3010
Wheelbase 1/2	2984
Engine type	spark ignition
Pollution reduction system	three-way catalytic converter
Engine capacity [ccm]	1969
Engine Power [hp/kW]	320/236
Gearbox	automatic
Registration /record No.	RZ288EY
VIN / serial number	YV1LFBABDH1131575
Date of first registration	05-10-2016
Date of next. tech. test	28-03-2024
Year of manufacture	2016 (year has been verified with the manufacturer's base)
Readout [km]	255 828 (read)
Body color / type of coating	white/double-layered, metallized

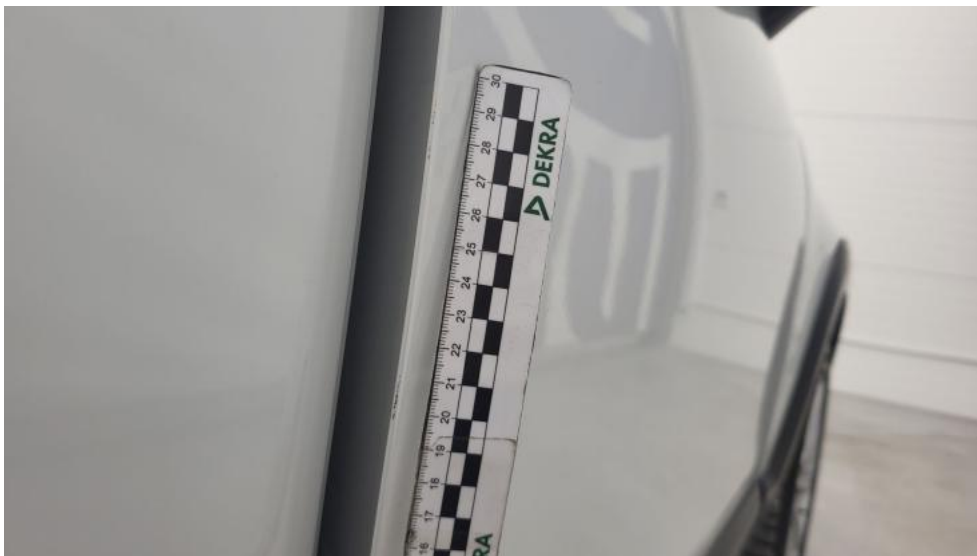
Photo 57.

Drzwi przednie P - Rysa/odprysk 2

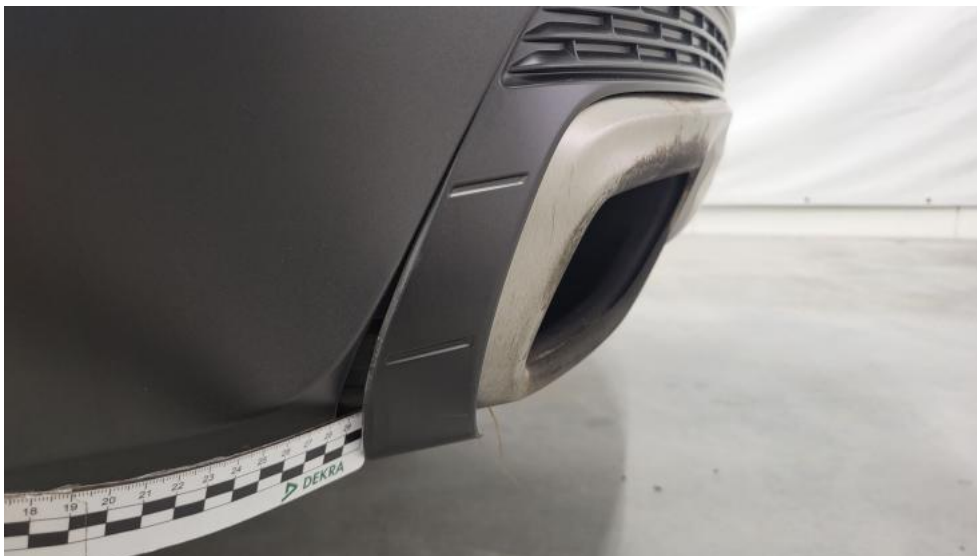
Photo 61.

Listwa śr zderzaka tylnego - Inne 1

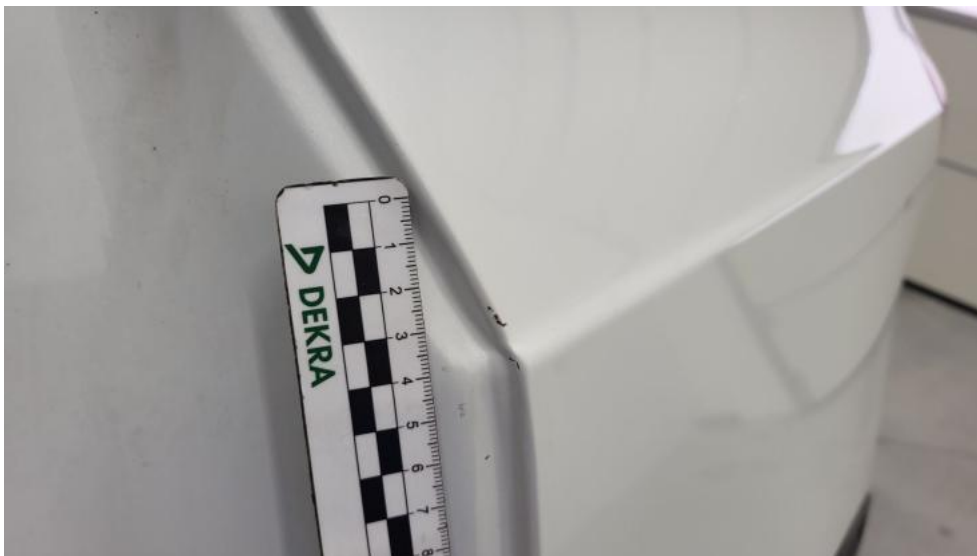
Photo 69.

Błotnik tylny L / Ściana boczna L - Rysa/odprysk 1

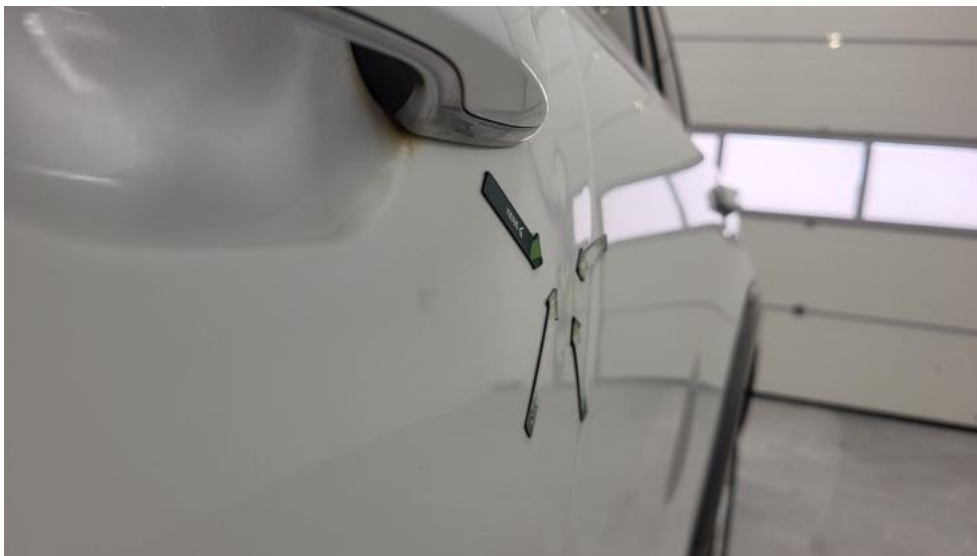
Photo 75.

Drzwi przed L() - Wgniecenie/odkształcenie 3

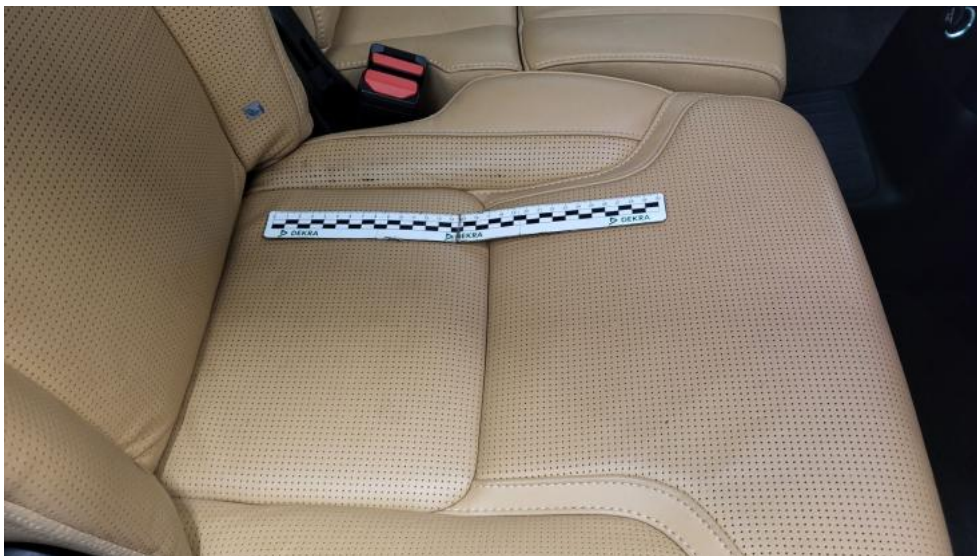
Photo 83.
Kanapa tyl. - Inne 2
