DEKRA's commission No. : PKOL(W)/LODZ/82841/24/10/25  
 commission/ damage No. : 21/048549  
 Date of commission: 25-10-2024

Group of objects (Eurotax)	cars
EC code (Eurotax)	0149193
Manufacturer	FORD
Model	Mondeo Kombi 19-21
Type / version	Mondeo 2.0 EcoBlue Executive Plus aut
Body type	KOM
Number of doors / seats	5/5
Curb weight [kg]	1677
Gross vehicle weight [kg]	2330
Wheelbase 1/2	2850
Engine type	Automatic ignition
Supercompression	turbocompressor with intercooler
Pollution reduction system	KSC
Emission standard	EURO 6
Engine capacity [ccm]	1995
Engine Power [hp/kW]	190/140
Gearbox	automatic 8- gear
Registration /record No.	GA558HL
VIN / serial number	WF0FXXWPCFMJ44676
Date of first registration	28-05-2021
Date of next. tech. test	22-05-2026
Year of manufacture	2021 (year has been verified with the manufacturer's base)
Readout [km]	124 603 (read)
Body color / type of coating	blue/METALIK

Date: 04-11-2024

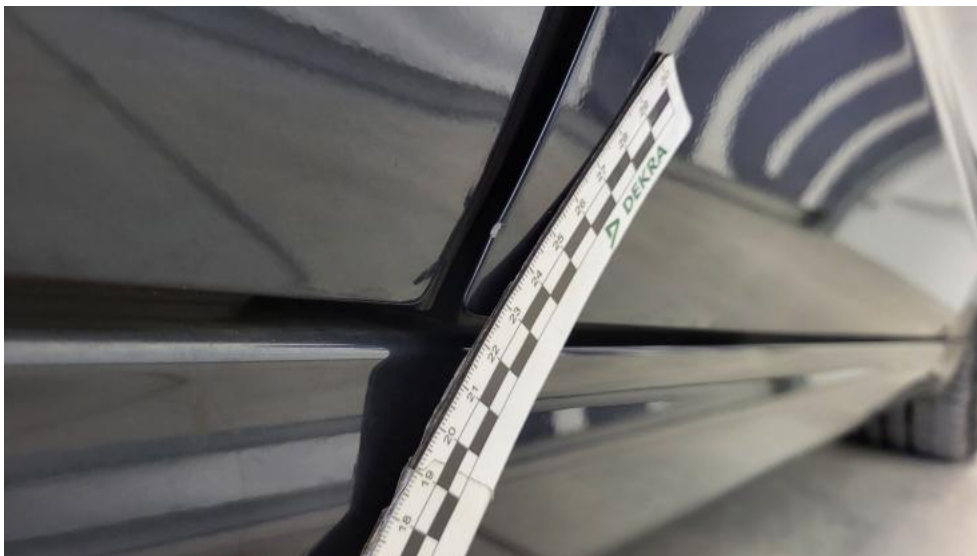
**Photo 55.**  
Drzwi przednie P - Rysa/odprysk 2

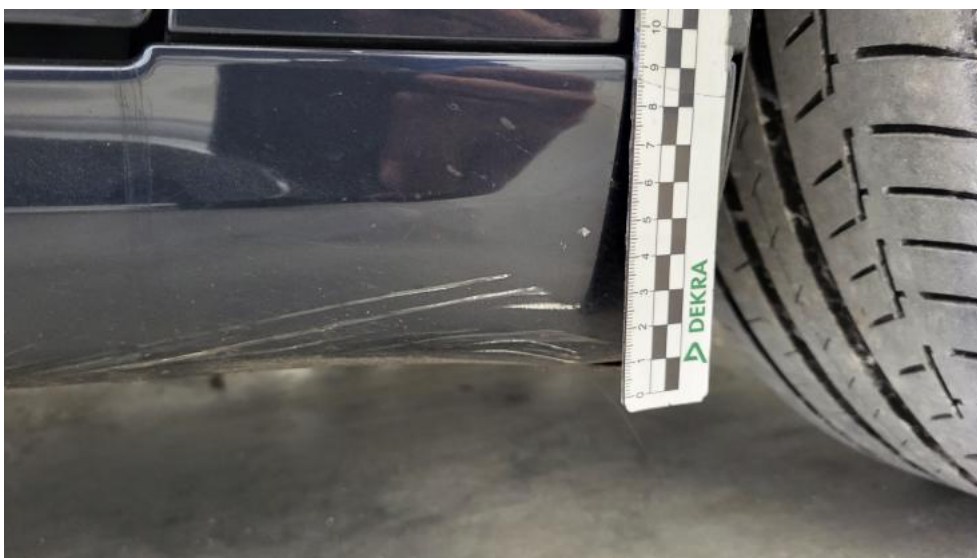
**Photo 56.**  
Próg P - zdjęcie pogładowe 1

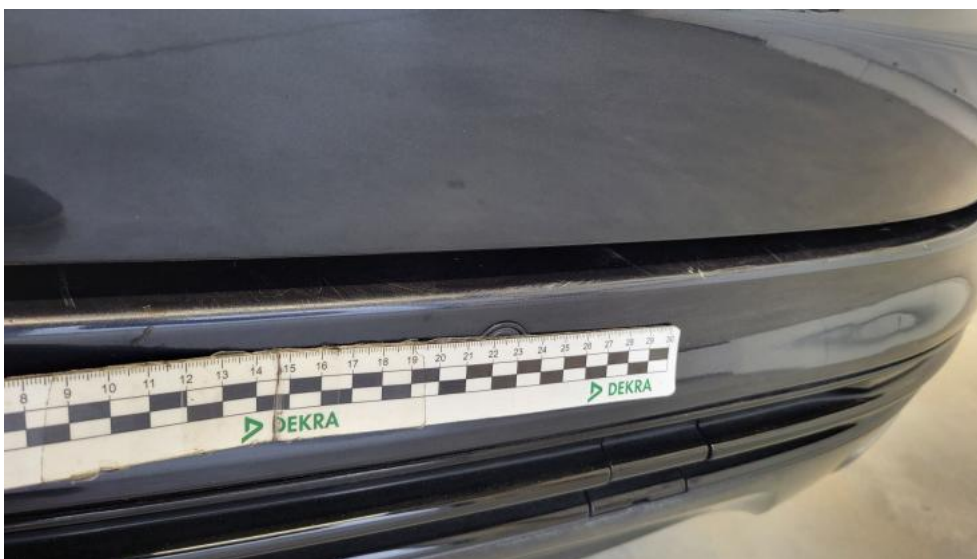
**Photo 63.**  
Zderzak tylny - zdjęcie poglądowe 1

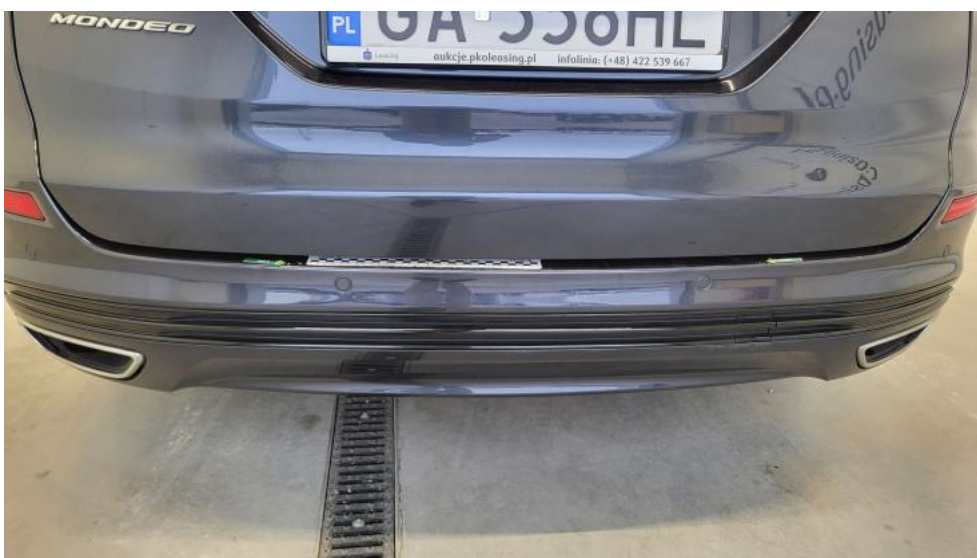
**Photo 64.**  
Zderzak tylny - zdjęcie poglądowe 2

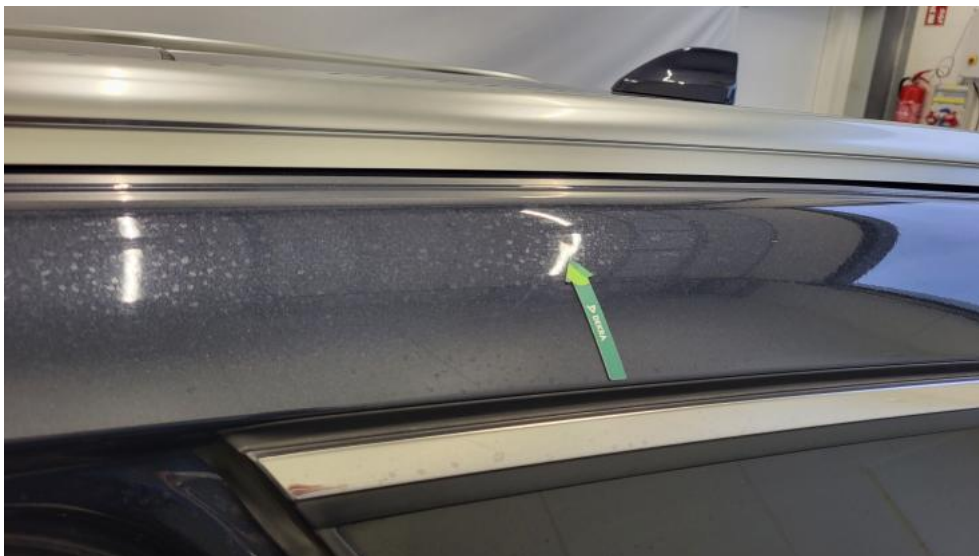
**Photo 69.**  
Błotnik tylny L / Ściana boczna L - Wgniecenie/odkształcenie 1

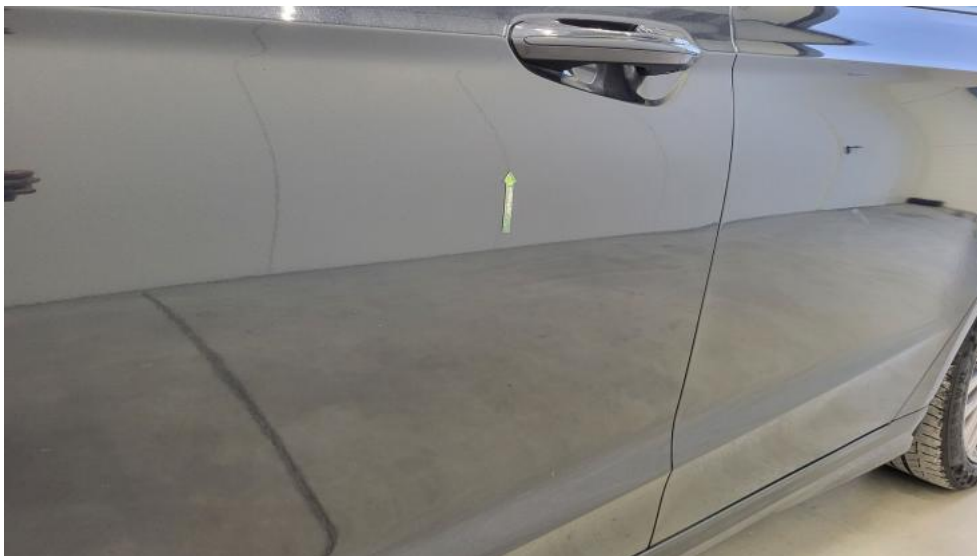
**Photo 75.**

Drzwi przed L - zdjęcie poglądowe 1

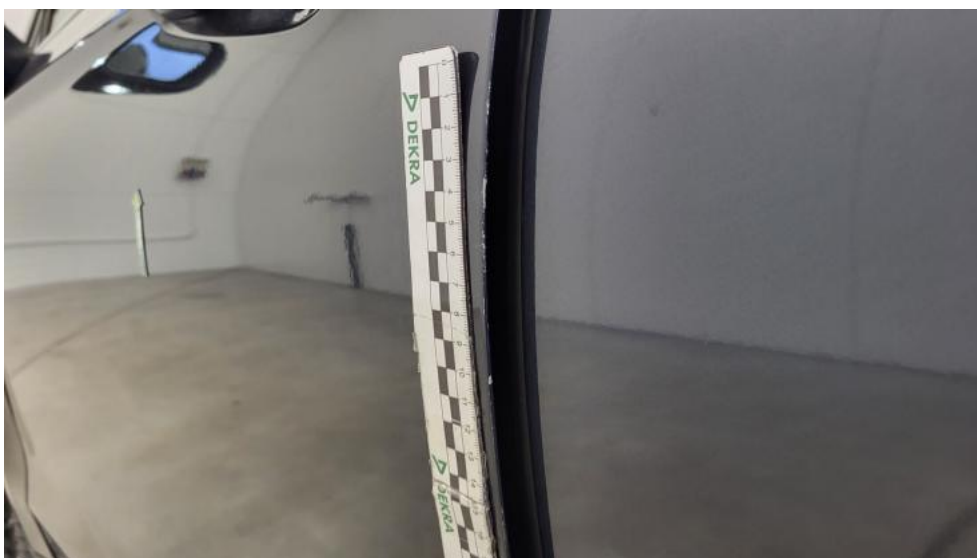
**Photo 76.**

Drzwi przed L - Rysa/odprysk 1

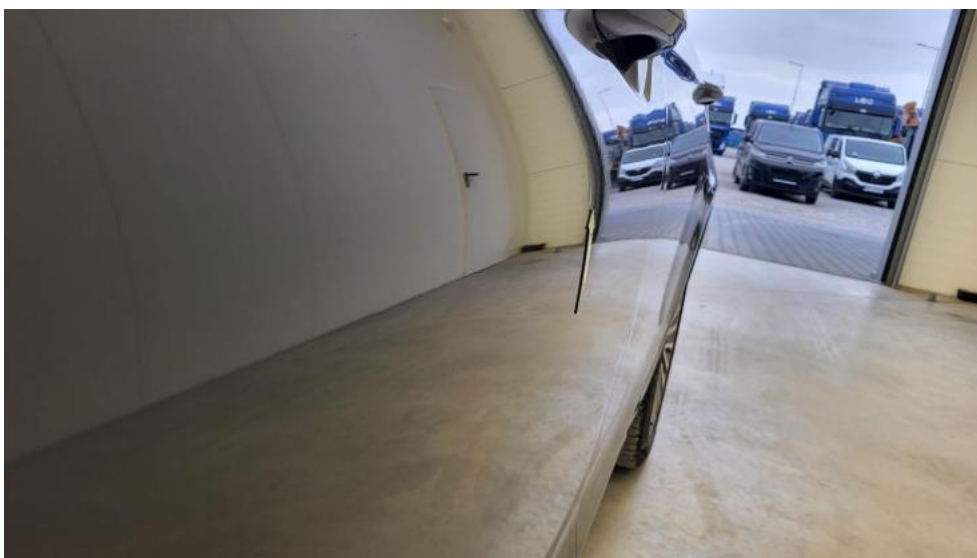
**Photo 78.**

Drzwi przed L - Wgniecenie/odkształcenie 1

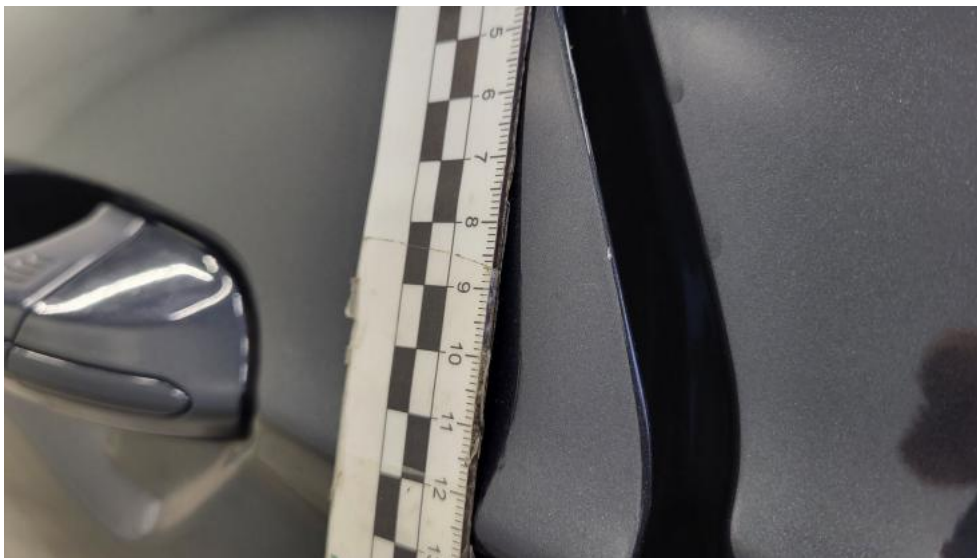
**Photo 79.**

Drzwi tylne L - Rysa/odprysk 1

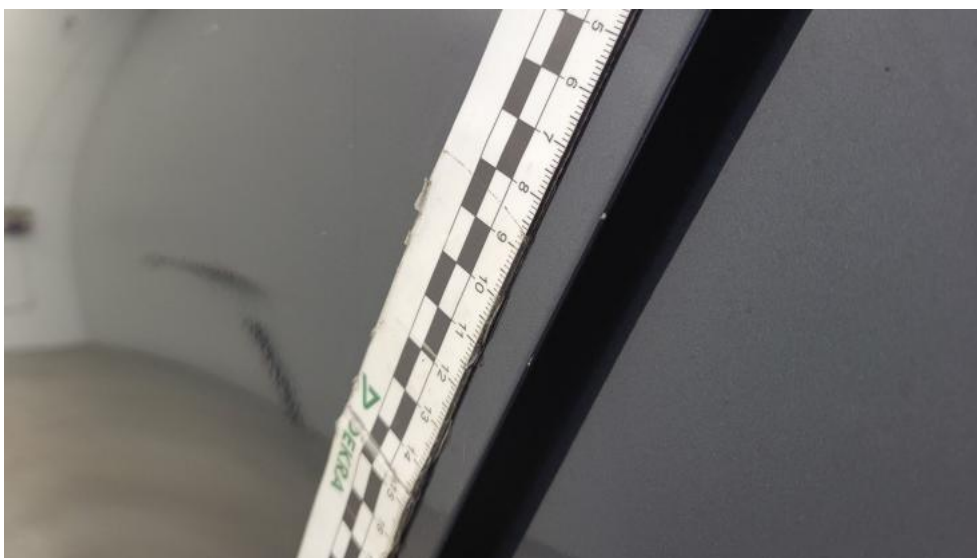
**Photo 80.**

Drzwi tylne L - Rysa/odprysk 2

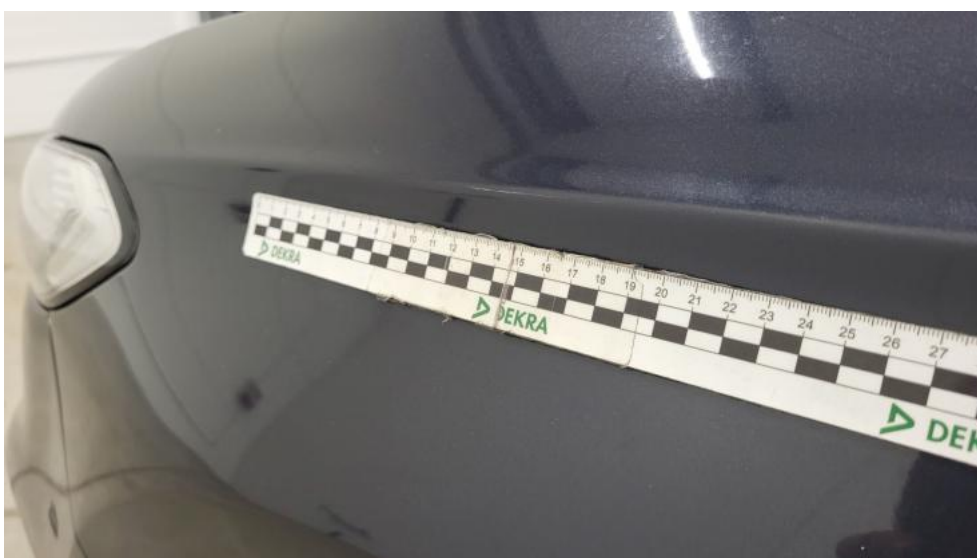
**Photo 82.**

Błotnik przedni L - Rysa/odprysk 1
