DEKRA's commission No. : PKOL(W)/LODZ/82472/24/10/24
commission/ damage No. : 22/008145
Date of commission: 24-10-2024

| Manufacturer | AUDI |
| Model | A6 Allroad 14-19 |
| VIN / serial number | WAUZZZ4G0JN089806 |

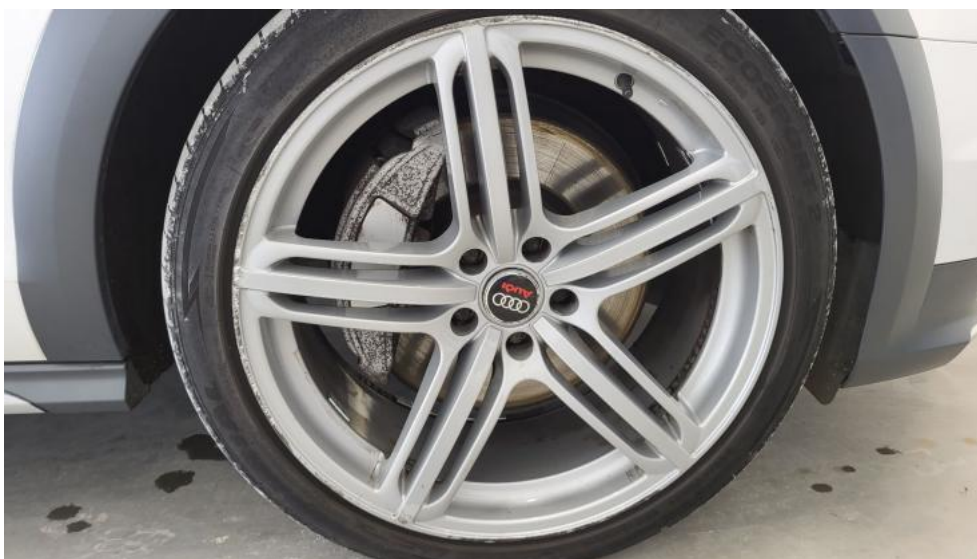
Photo 55.

Felga aluminiowa przednia P - zdjęcie poglądowe 1

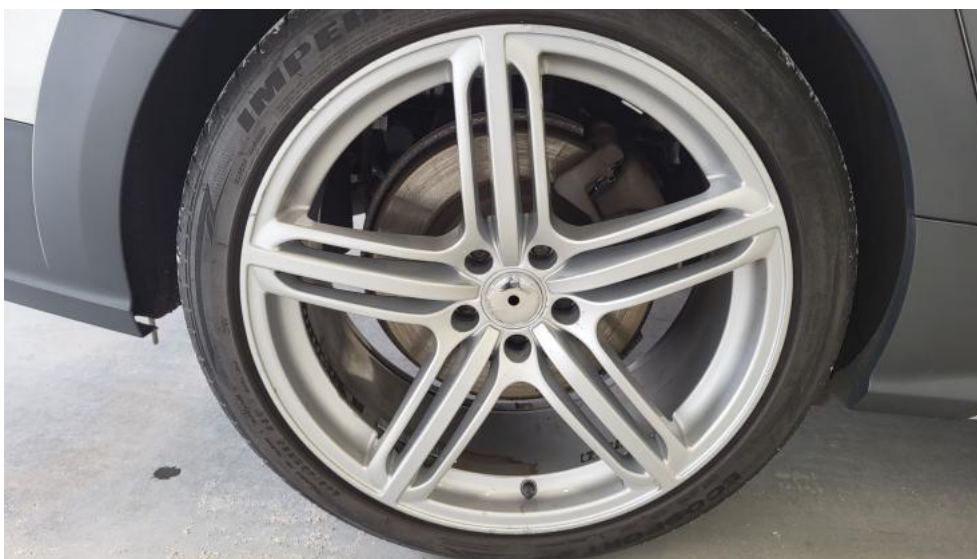
Photo 59.
Felga aluminiowa tylna P - zdjęcie pogładowe 1

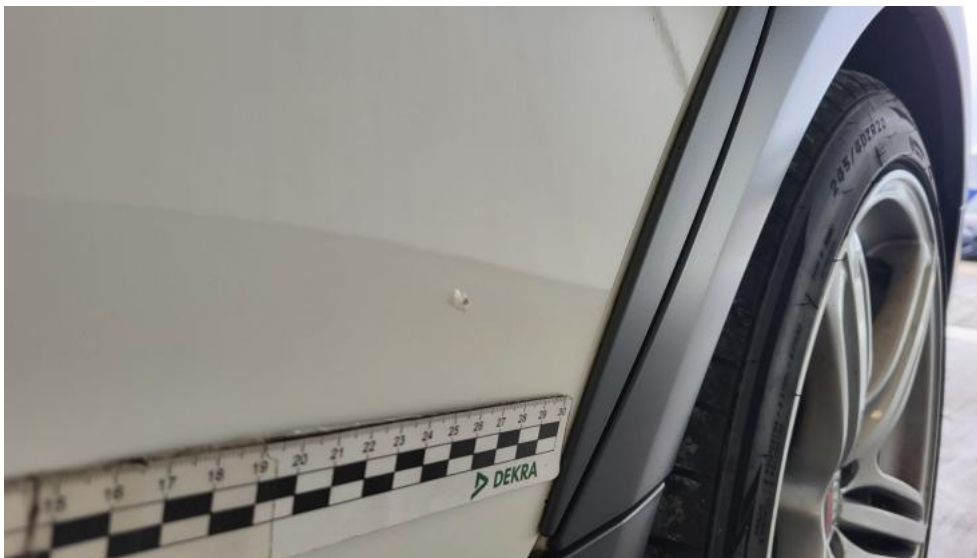
Photo 67.

Drzwi tylne L - zdjęcie poglądowe 1

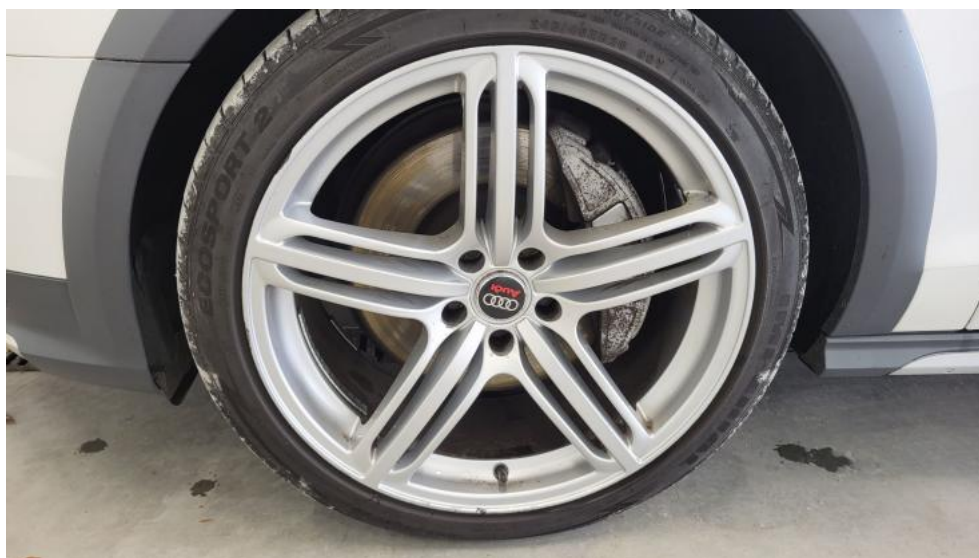
Photo 74.
Felga Aluminiowa przednia L - zdjęcie poglądowe 1
