DEKRA's commission No. : PKOL(W)/LODZ/99348/26/10/23  
commission/ damage No. : 22/026066  
Date of commission: 23-10-2026

**DEKRA Poland - Headquarters**  
02-673 Warszawa, ul. Konstruktorska 12A

**Vehicle data**

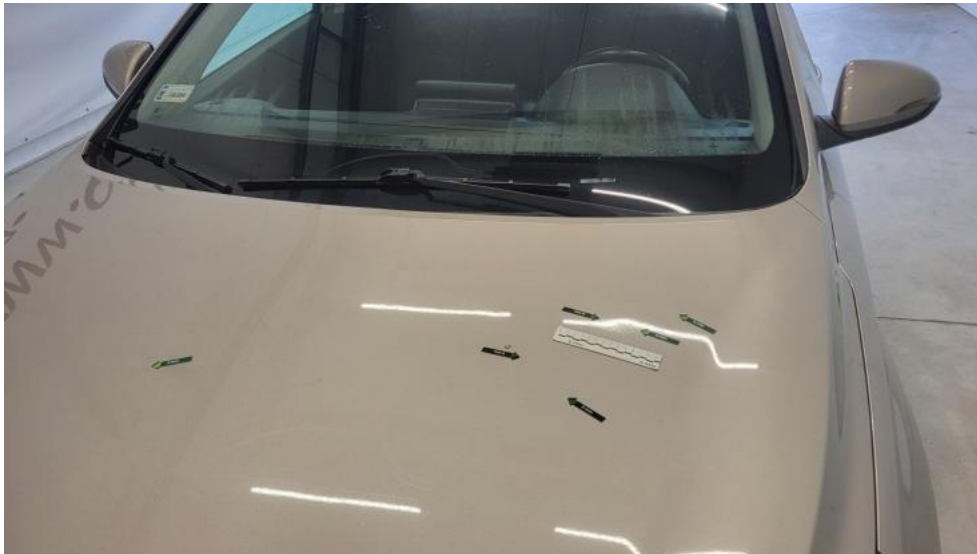
**Photo 41.**

Pokrywa komory silnika - Wgniecenie/odkształcenie 1

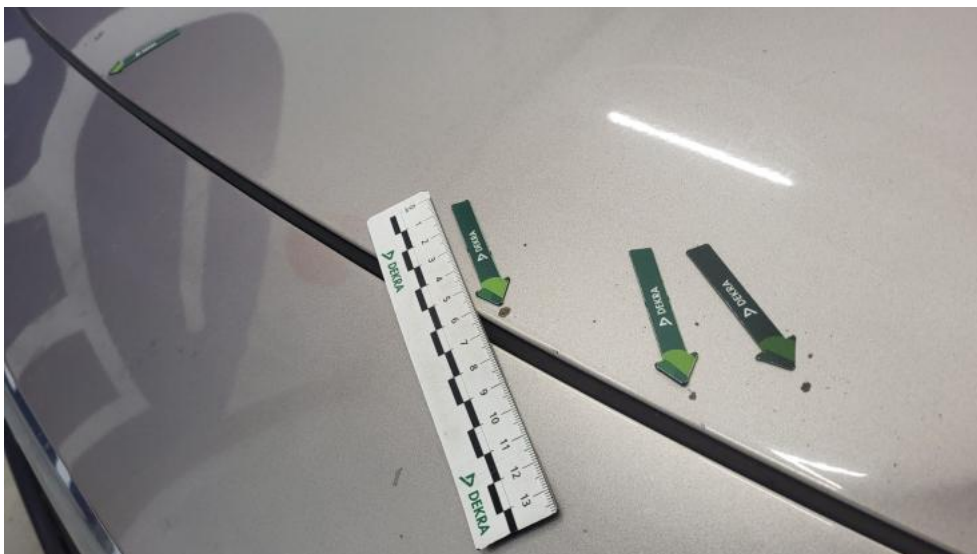
**Photo 42.**

Pokrywa komory silnika - Inne 1

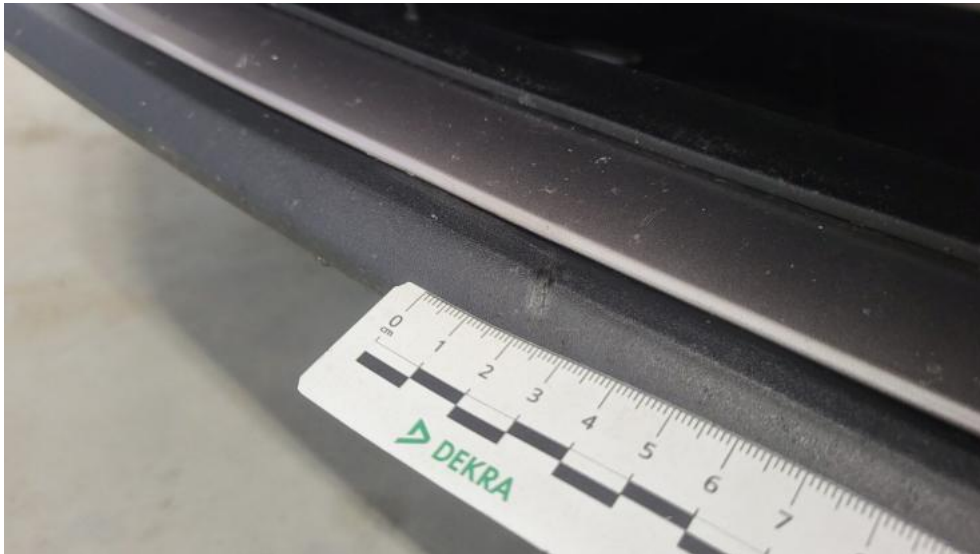
**Photo 43.**

Spoiler zderzaka przedniego - Rysa/odprysk 1

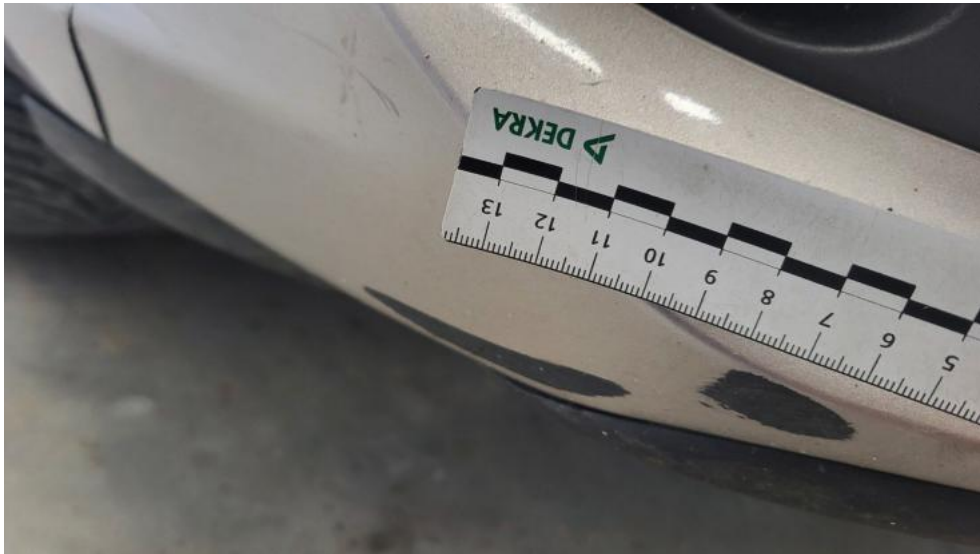
**Photo 47.**

Zderzak - Rysa/odprysk 2

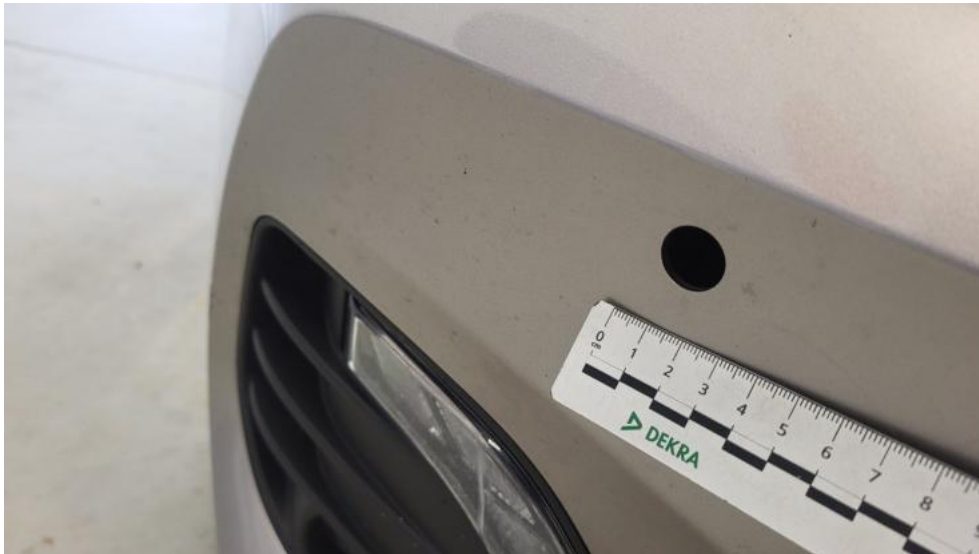
**Photo 51.**  
Zderzak - Inne 2

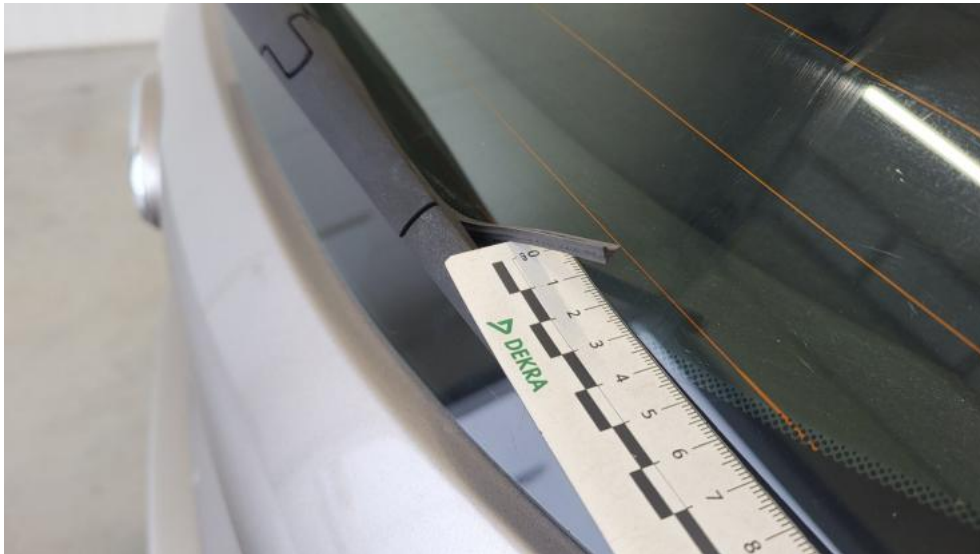
**Photo 61.**

Pióro wycieraczki szyby tyl - Inne 1

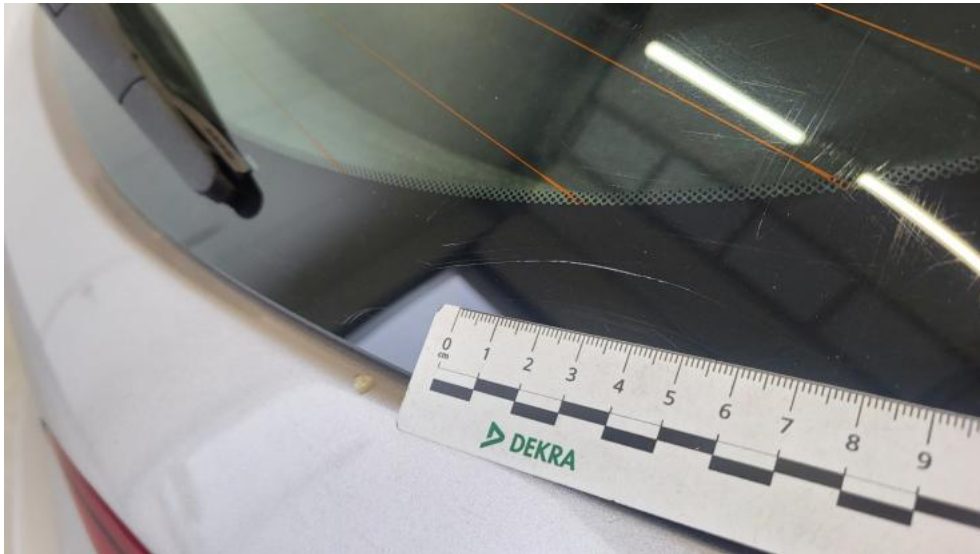
**Photo 63.**

Szyba tylna - Rysa/odprysk 1

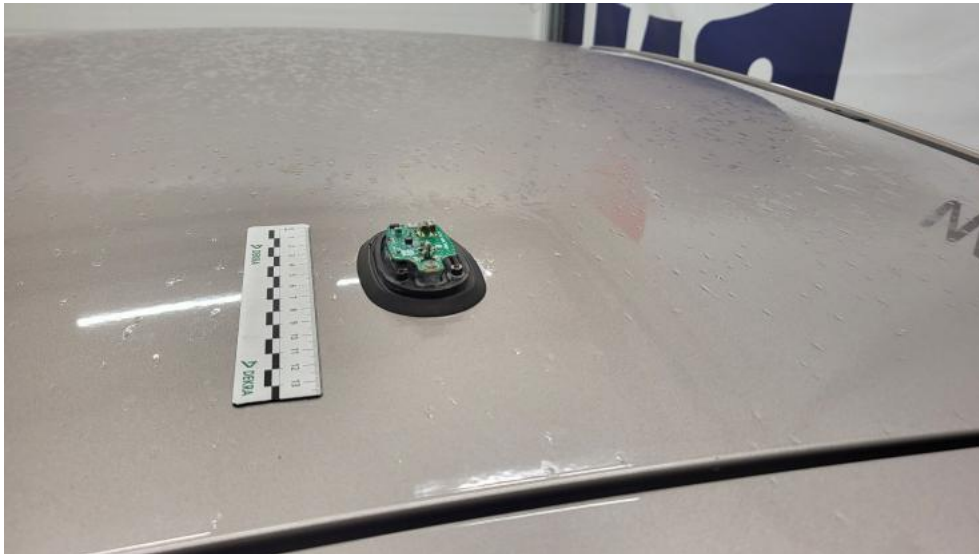
**Photo 65.**  
Dach - Inne 1

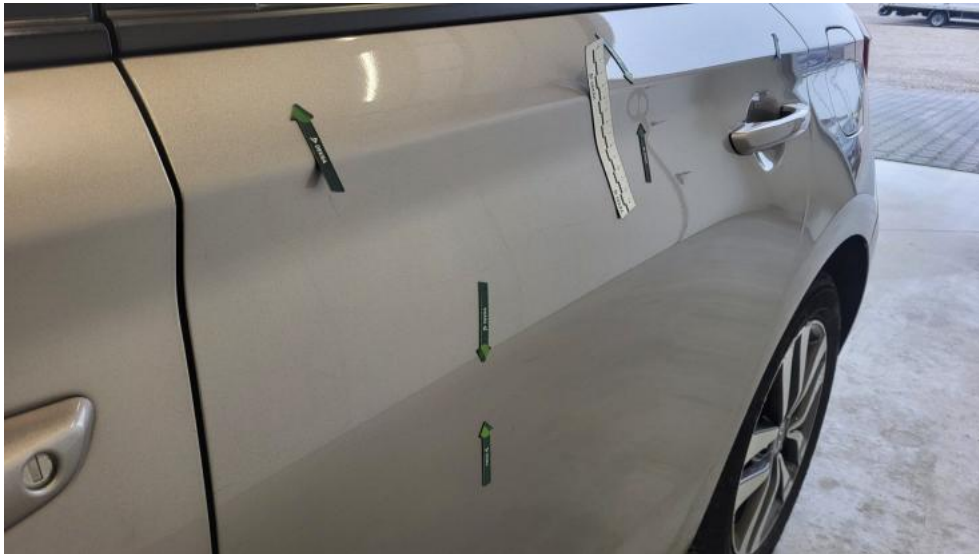
**Photo 73.**

Drzwi tylne L - Wgniecenie/odkształcenie 1

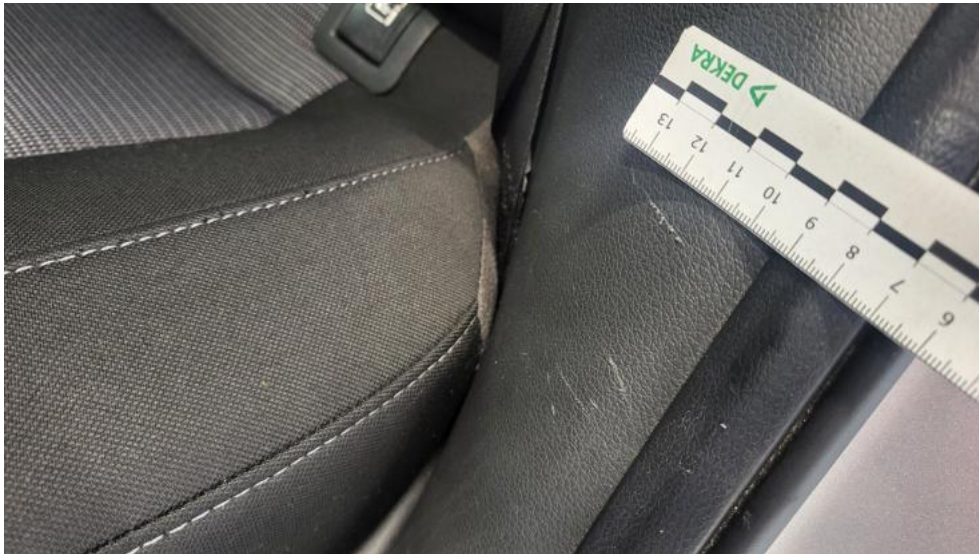
**Photo 87.**

Wykładzina(y) słupka tylnego L - Rysa/odprysk 1
