DEKRA's commission No. : PKOL(W)/LODZ/73095/25/09/26  
commission/ damage No. : 22/013693  
Date of commission: 26-09-2025

| Manufacturer | NISSAN |
| Type / version | Leaf 40kWh Acenta |
| Registration /record No. | GD188YR |

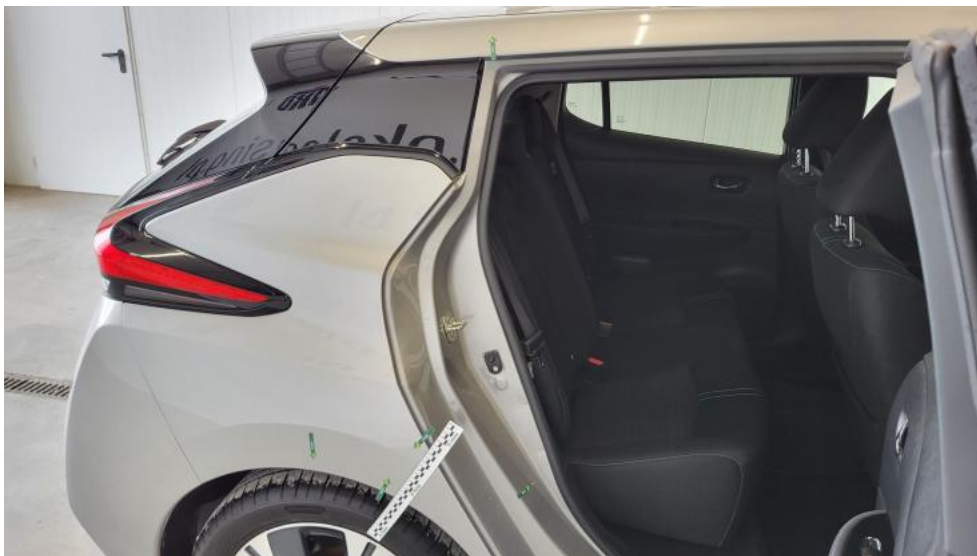
**Photo 53.**

Błotnik tylny P / Ściana boczna P - zdjęcie poglądowe 1
