DEKRA's commission No. : PKOL(W)/LODZ/17567/26/02/26  
commission/ damage No. : 23/044125  
Date of commission: 26-02-2026

| Manufacturer | BMW |
| Model | Seria 5 Touring [G31] 17-20 |
| Registration /record No. | WZ947HC |

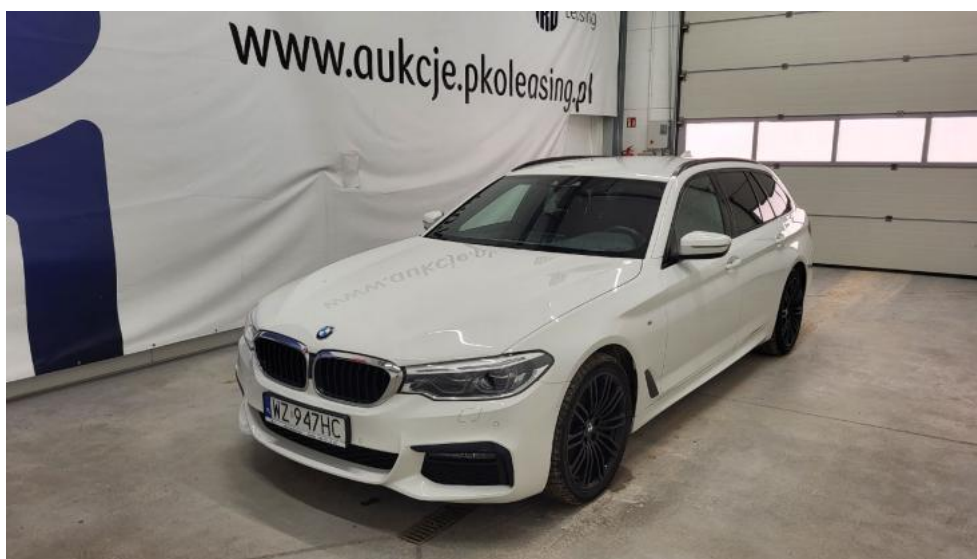
**Photo 1.**

Przekątna przednia lewa

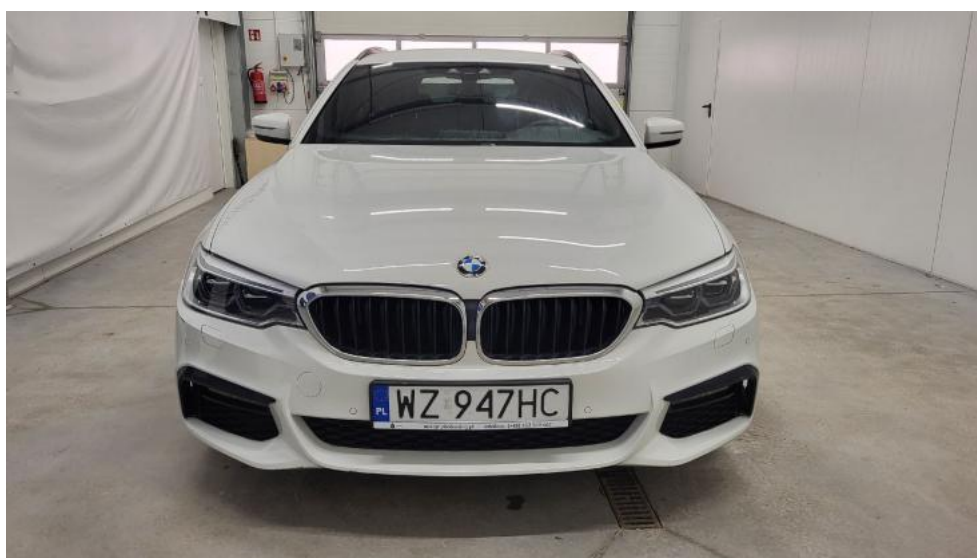
**Photo 2.**

Przód

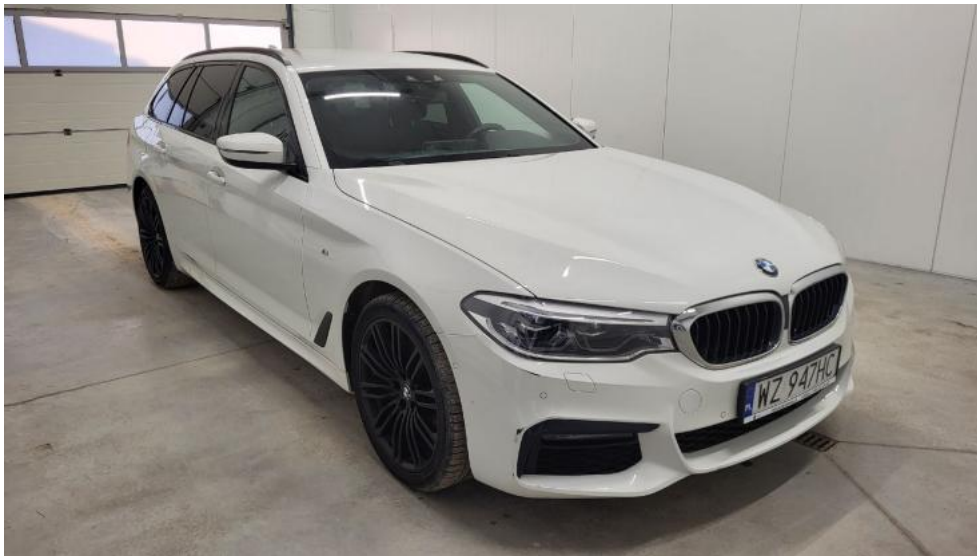
**Photo 3.**

Przekątna przednia prawa

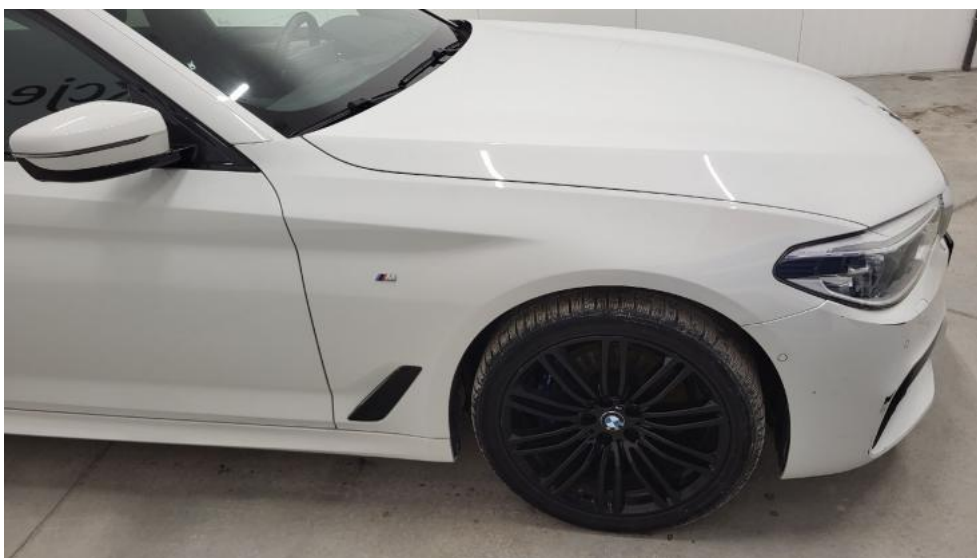
**Photo 4.**

Bok prawy z przodu

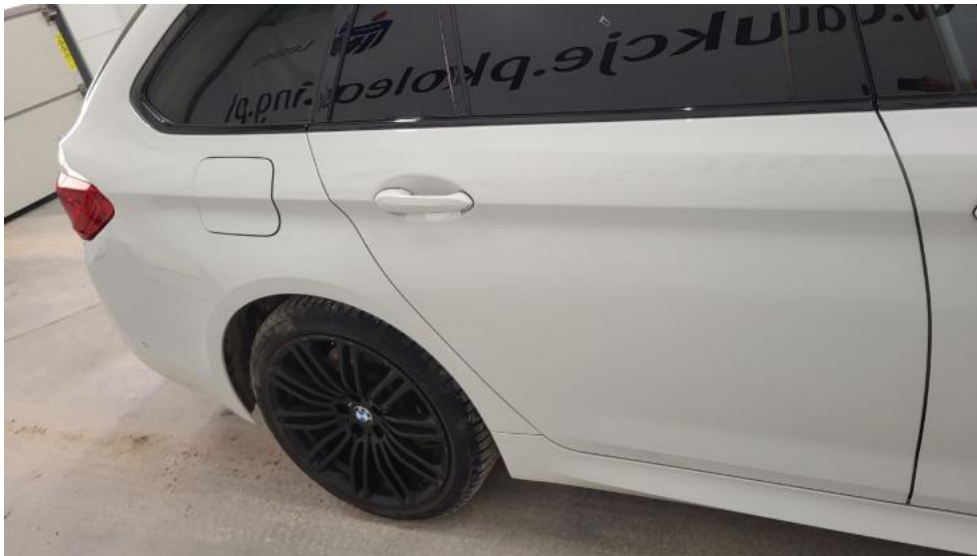
**Photo 5.**

Bok prawy z tyłu

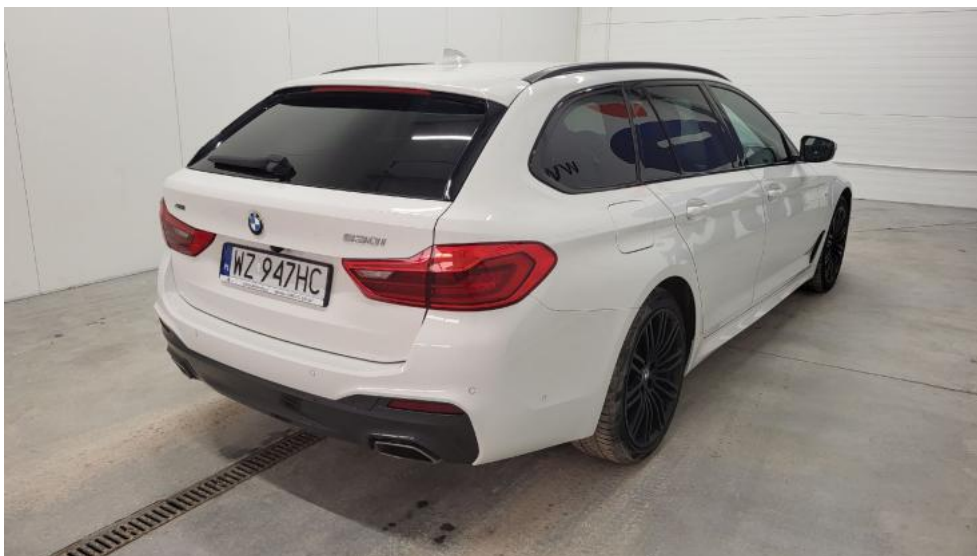
**Photo 6.**

Przekątna tylna prawa

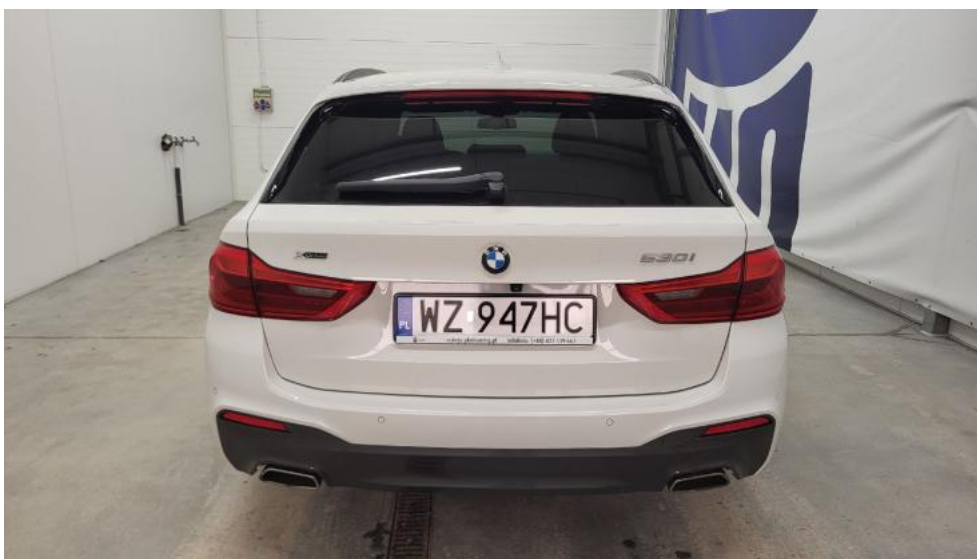
**Photo 7.**

Tył

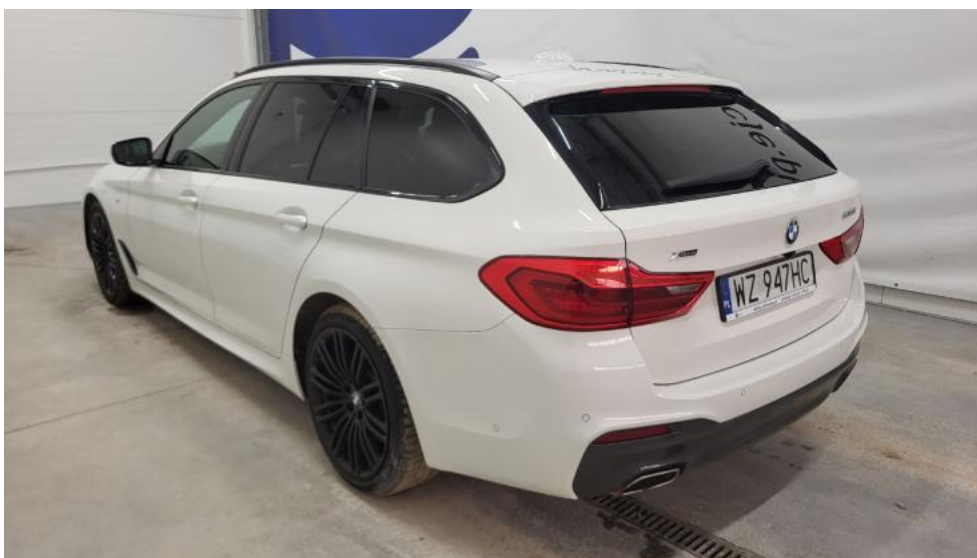
**Photo 8.**

Przekątna tylna lewa

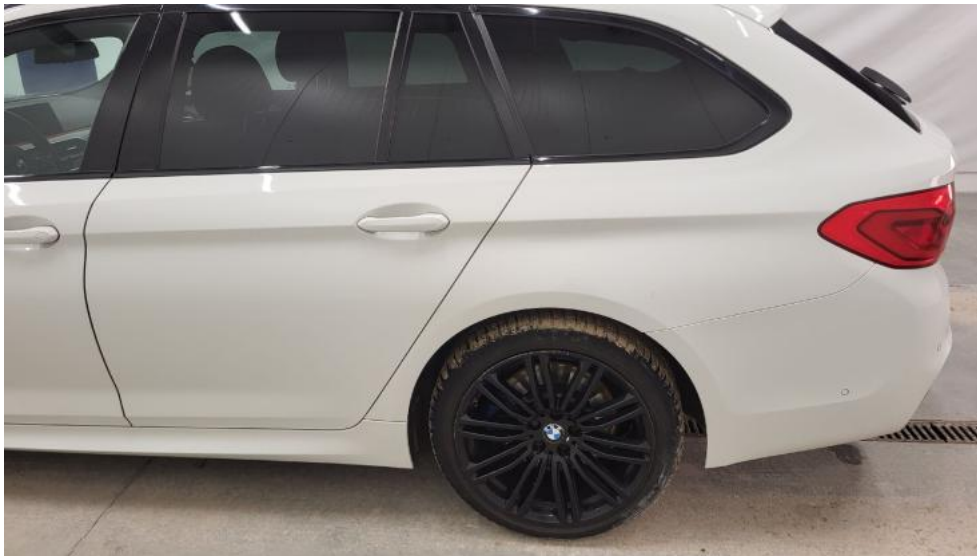
**Photo 9.**

Bok lewy z tyłu

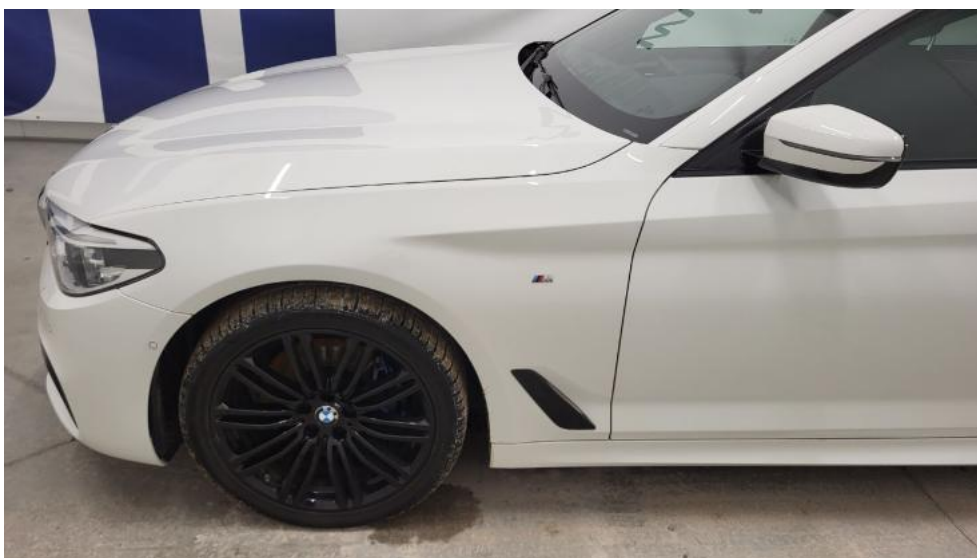
**Photo 10.**

Bok lewy z przodu

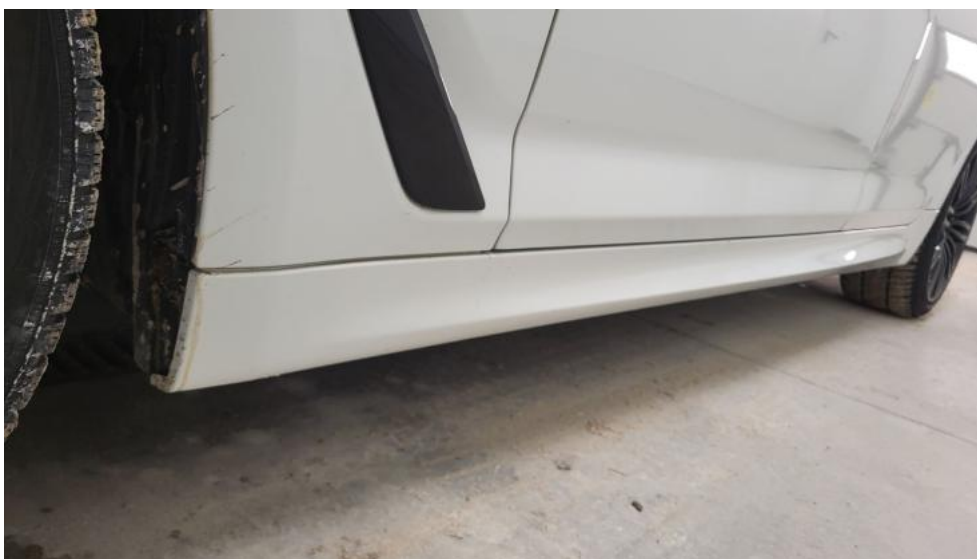
**Photo 11.**

Próg lewy (widok od przodu)

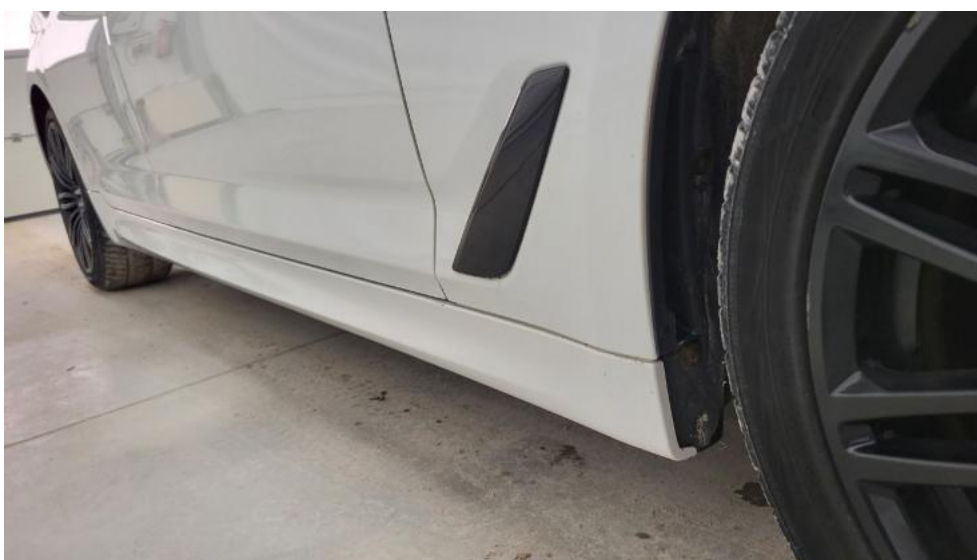
**Photo 12.**

Próg prawy (widok od przodu)

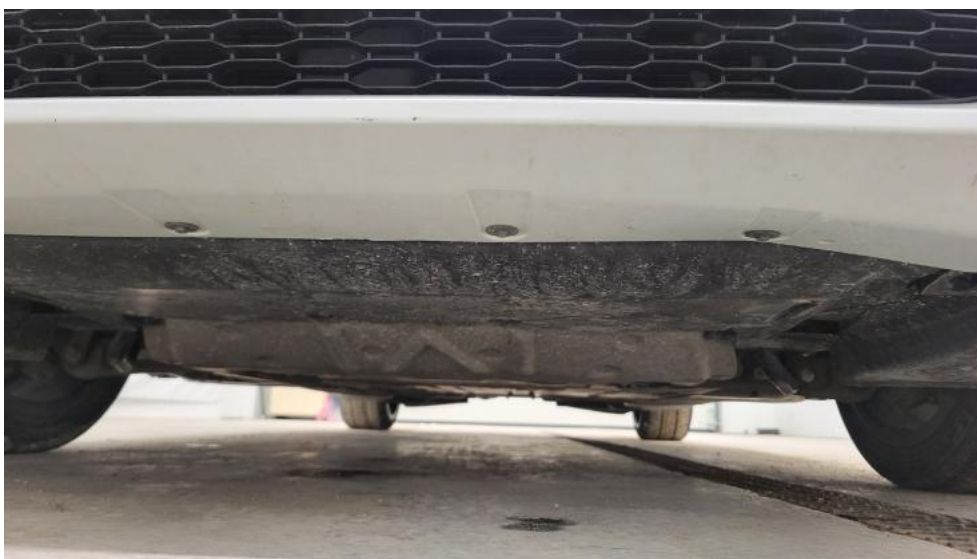
**Photo 13.**  
Spód pojazdu przód

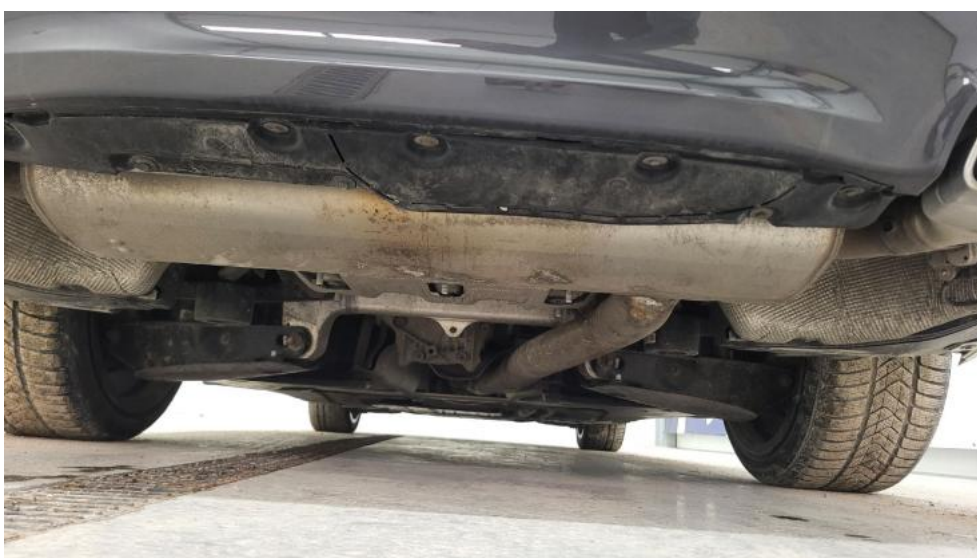
**Photo 14.**  
Spód pojazdu tył

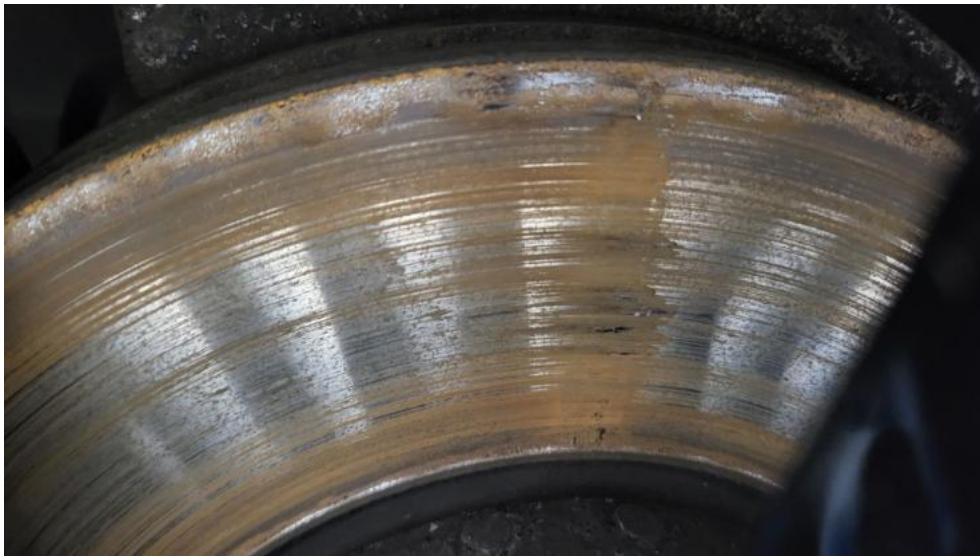
**Photo 15.**

Tarcza hamulcowa przednia prawa

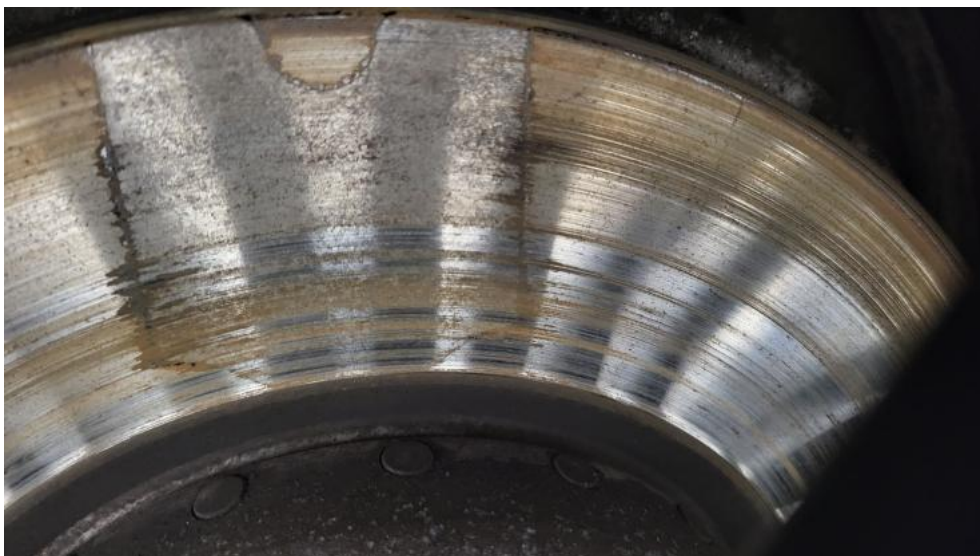
**Photo 16.**

Tarcza hamulcowa tylna prawa

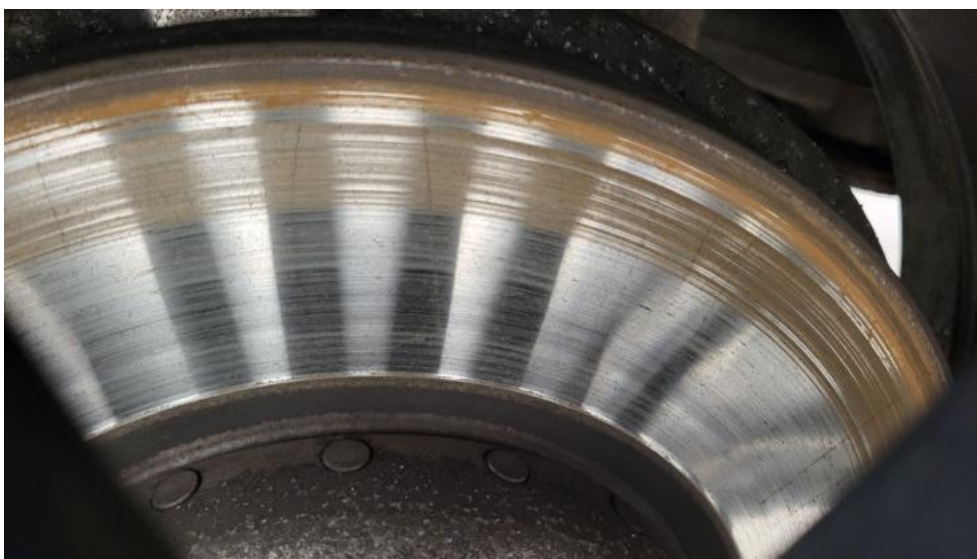
**Photo 17.**

Tarcza hamulcowa tylna lewa

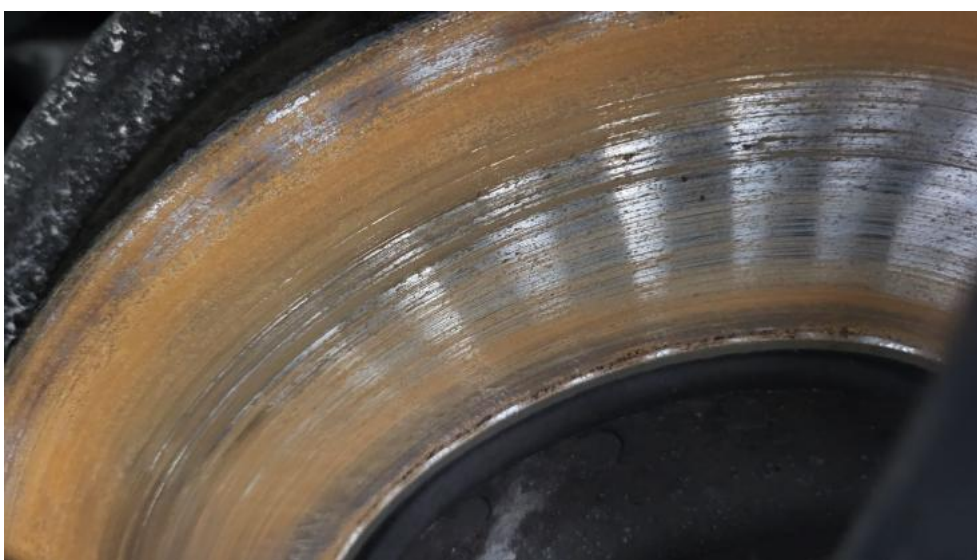
**Photo 18.**

Tarcza hamulcowa przednia lewa

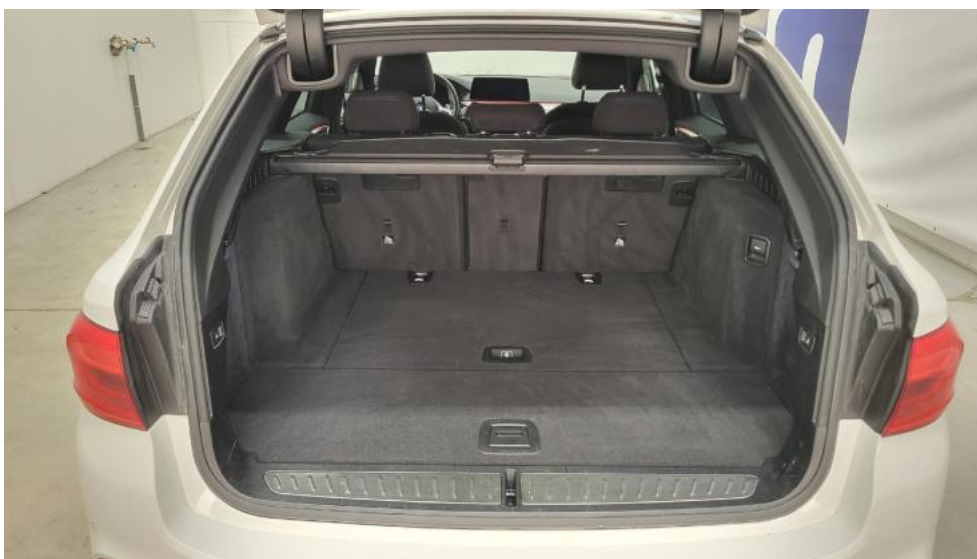
**Photo 19.**  
Bagażnik

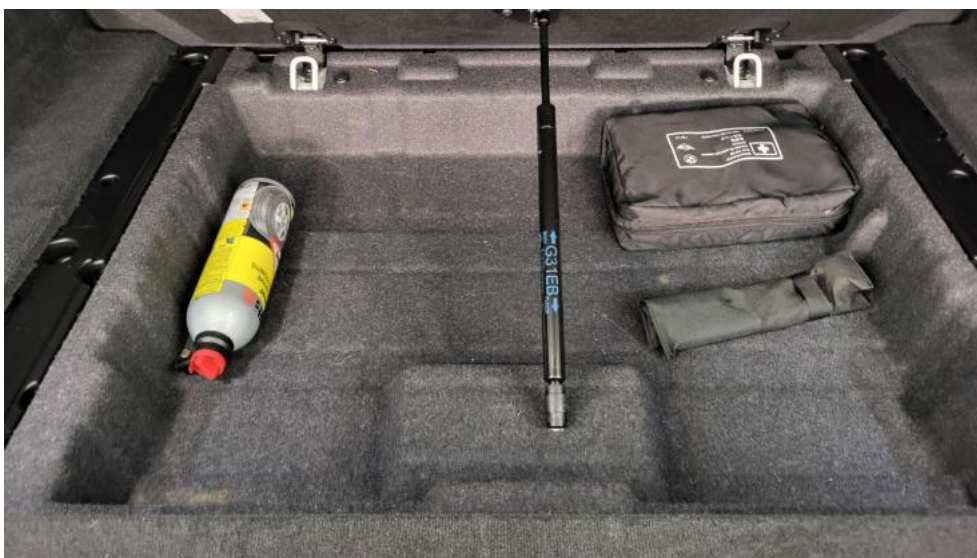
**Photo 20.**  
Koło zapasowe

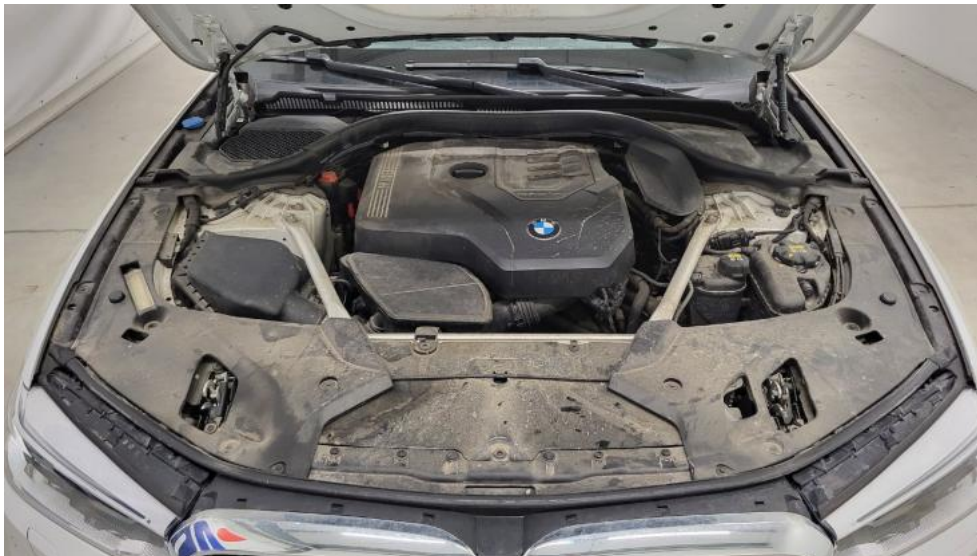
**Photo 21.**  
Komora silnika

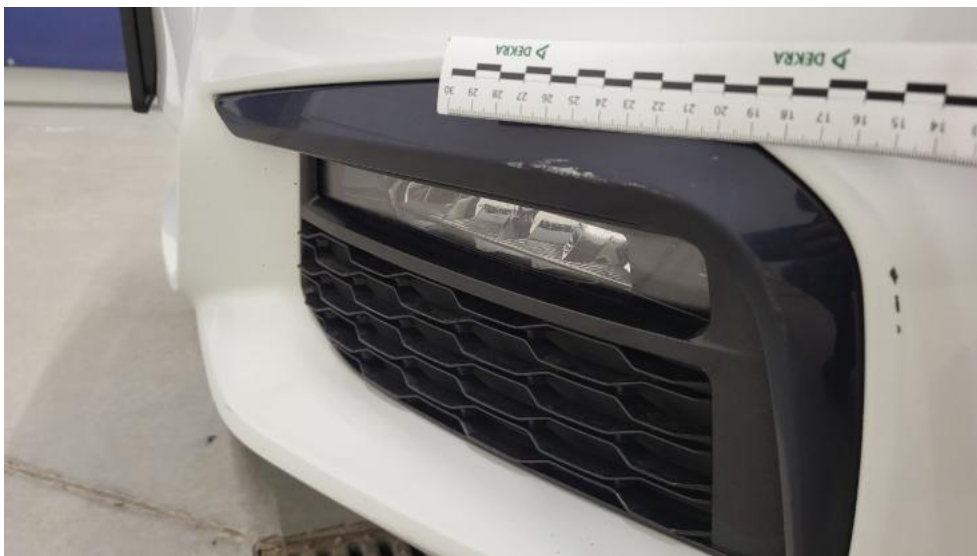
**Photo 40.**

Kratka/zaślepka halogenu L - Rysa/odprysk 1

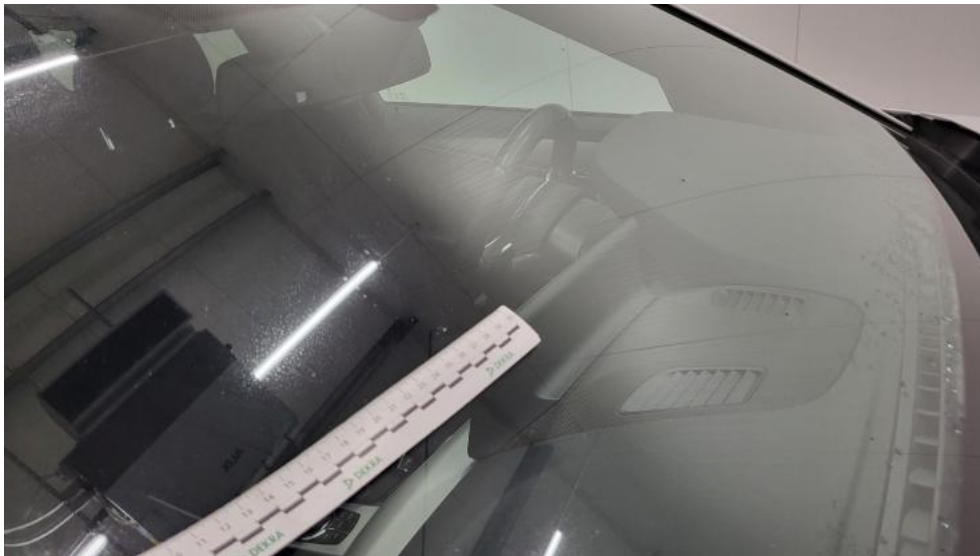
**Photo 43.**

Szyba czołowa - zdjęcie poglądowe 1

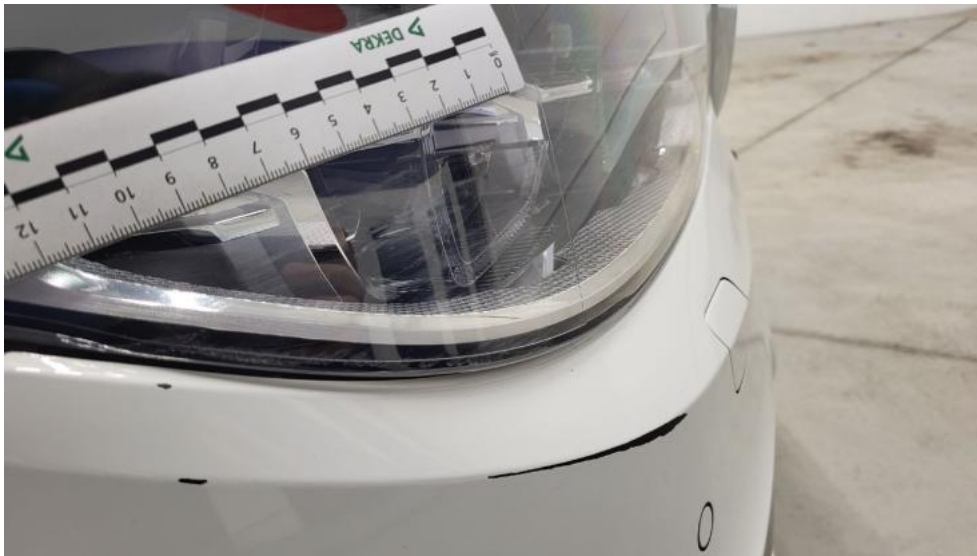
**Photo 51.**

Reflektor P - Rysa/odprysk 1

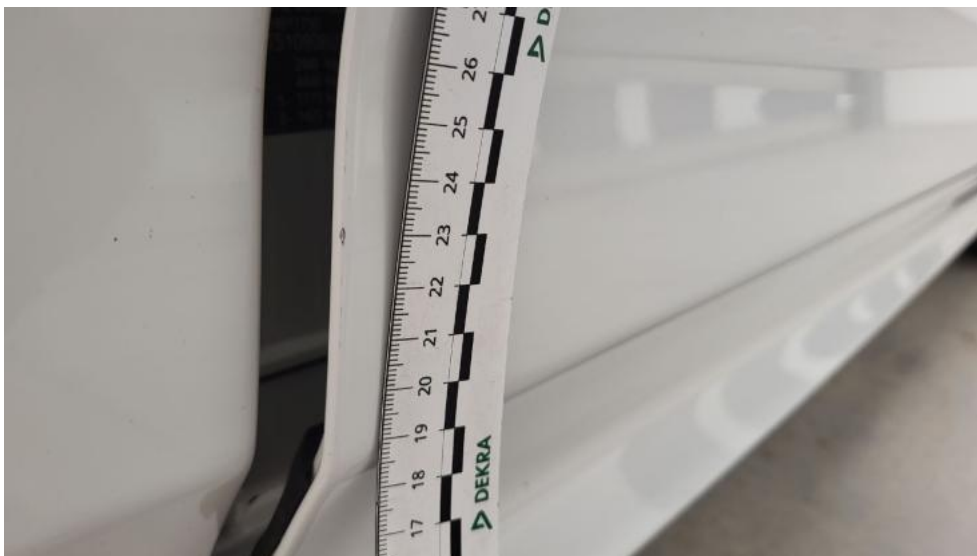
**Photo 52.**

Drzwi przednie P - Rysa/odprysk 1

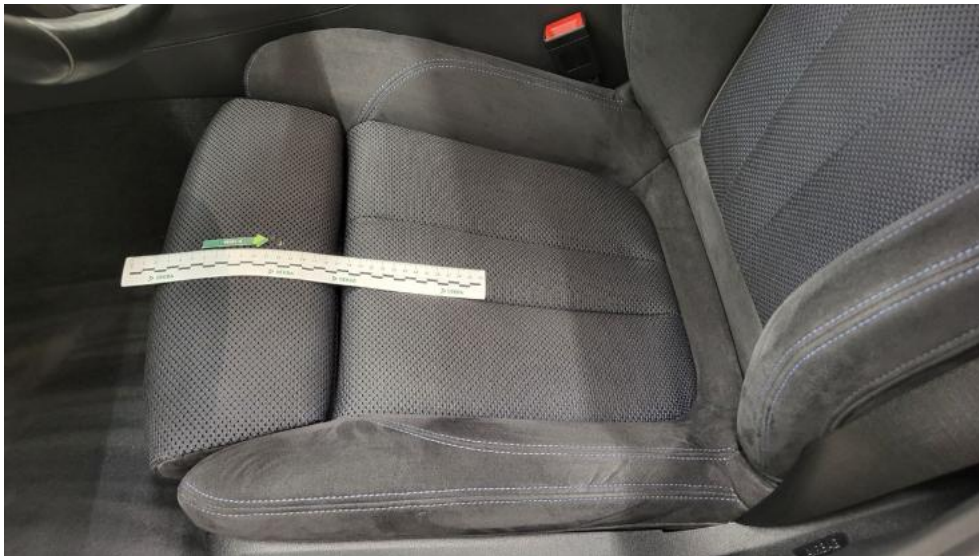
**Photo 69.**

Fotel prz. lew. - zdjęcie poglądowe 1

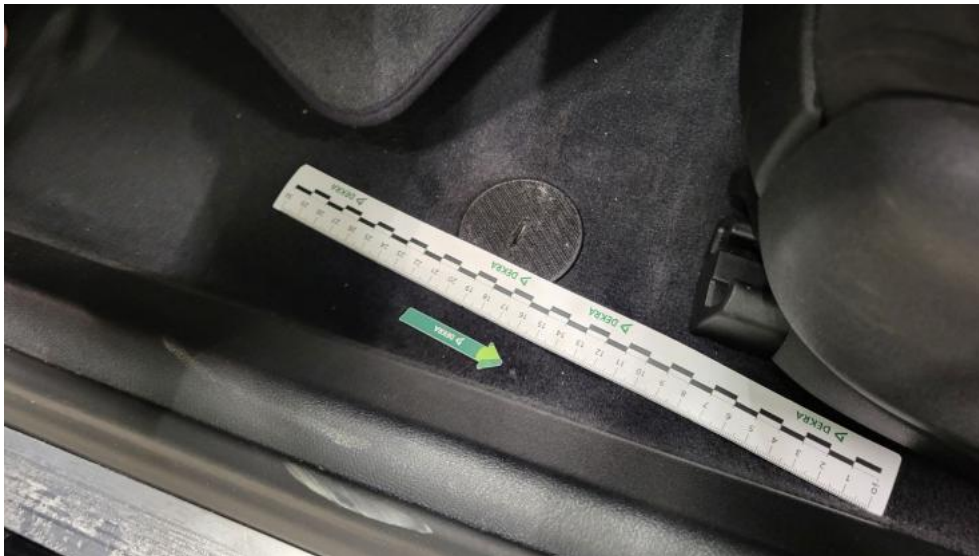
**Photo 75.**

Wykładzina podłogi - zdjęcie poglądowe 1
