DEKRA's commission No. : PKOL(W)/LODZ/93647/24/12/04
 commission/ damage No. : 22/006093
 Date of commission: 04-12-2024

Vehicle data

Measurement of thickness of the vehicle lacquer coating

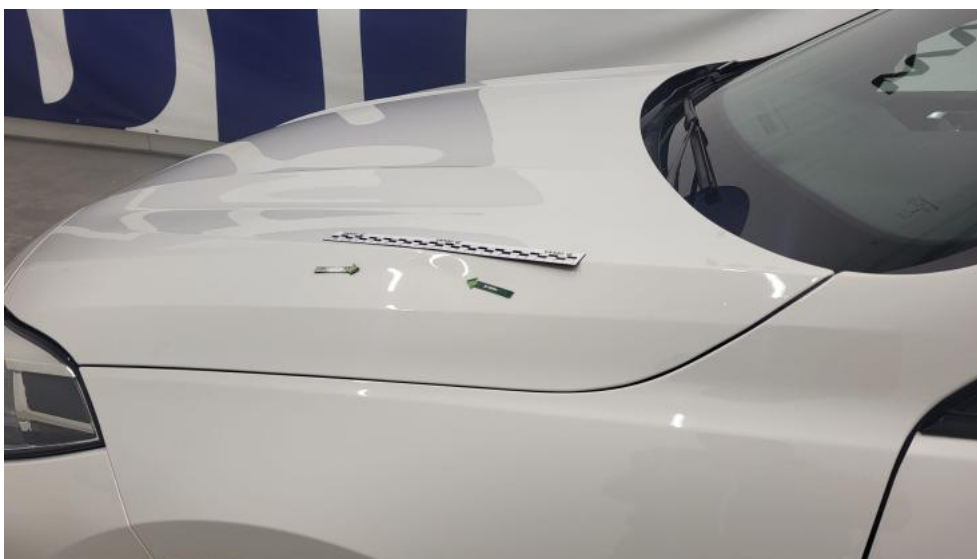
Photo 39.
Pokrywa komory silnika - zdjęcie poglądowe 1
