DEKRA's commission No. : PKOL(W)/LODZ/12684/25/02/19
commission/ damage No. : 20/050074
Date of commission: 19-02-2025

Group of objects (Eurotax)	cars
EC code (Eurotax)	0116850
Manufacturer	JAGUAR
Model	XF 15-20
Type / version	XF 2.0 i4D R-Sport aut
Body type	sedan
Number of doors / seats	4/5
Curb weight [kg]	1734
Gross vehicle weight [kg]	2250
Wheelbase 1/2	2960
Engine type	Automatic ignition
Pollution reduction system	DPF
Engine capacity [ccm]	1999
Engine Power [hp/kW]	180/132
Gearbox	automatic 8- gear
Registration /record No.	WZ417GA
VIN / serial number	SAJBB4BN3KCY75904
Date of first registration	14-03-2019
Date of next. tech. test	04-01-2026
Year of manufacture	2019
Readout [km]	100 651 (read)
Body color / type of coating	black/METALIK

Measurement of thickness of the vehicle lacquer coating

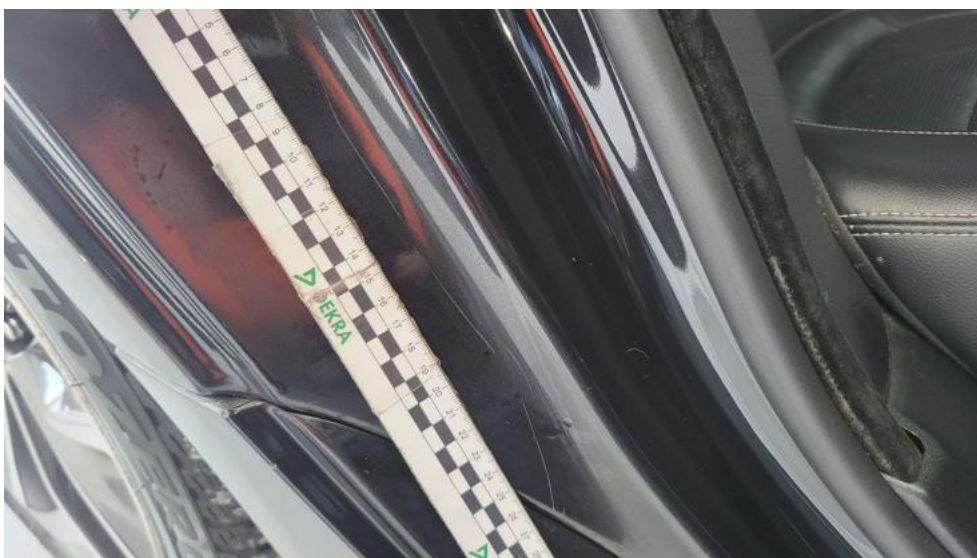
Photo 60.
Błotnik tylny P / Ściana boczna P - Rysa/odprysk 1
