DEKRA's commission No. : PKOL(W)/LODZ/67390/24/09/02  
commission/ damage No. : 02359/LF/20  
Date of commission: 02-09-2024

**Client :**  
PKO Leasing Finance  
PKO Leasing SA  
Al. Śmigłego-Rydza 20  
93-281 Łódź

Group of objects (Eurotax)	cars
EC code (Eurotax)	0114897
Manufacturer	BMW
Model	Seria 7 [G11, G12] 15-19
Type / version	750i xDrive
Body type	sedan
Number of doors / seats	4/5
Curb weight [kg]	1870
Gross vehicle weight [kg]	2575
Wheelbase 1/2	3070
Engine type	spark ignition
Pollution reduction system	three-way catalytic converter
Engine capacity [ccm]	4395
Engine Power [hp/kW]	450/330
Gearbox	automatic 8- gear
Registration /record No.	GD777VT
VIN / serial number	WBA7B01070GD54869
Date of first registration	30-12-2015
Date of next. tech. test	19-10-2024
Year of manufacture	2015 (year has been verified with the manufacturer's base)
Readout [km]	159 472 (read)
Body color / type of coating	black/METALIK

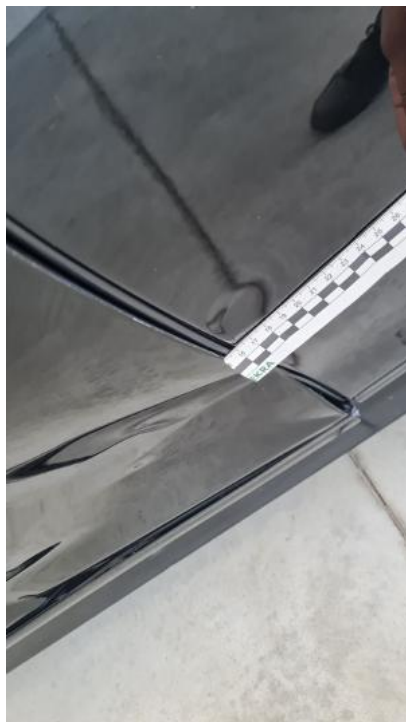
**Photo 65.**

Drzwi tylne L - Wgniecenie/odkształcenie 1

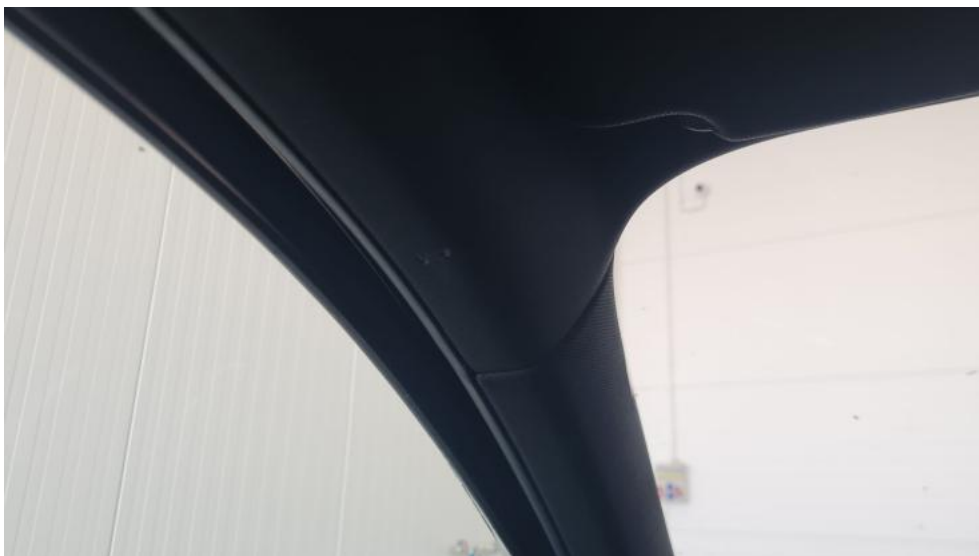
**Photo 75.**

Podsufitka - zdjęcie poglądowe 1

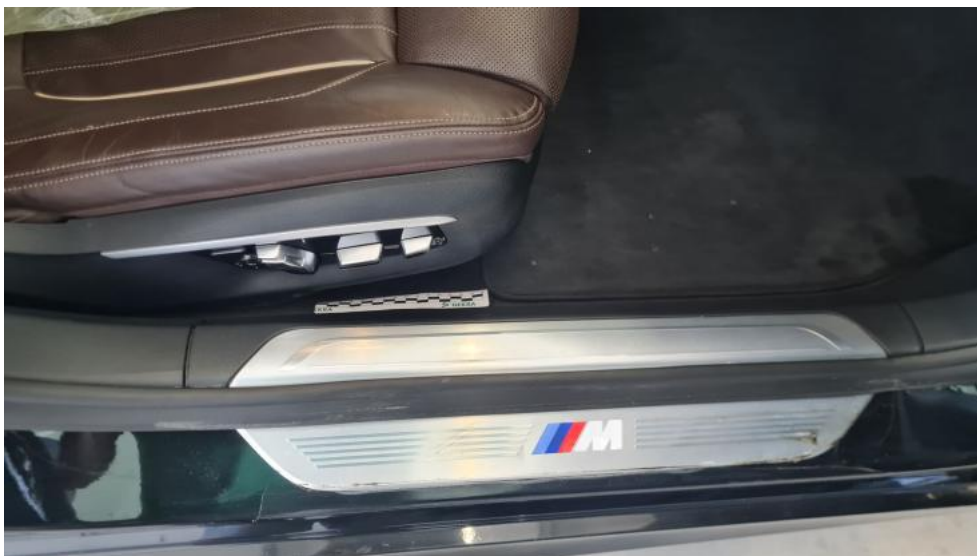
**Photo 77.**

Wykładzina podłogi - zdjęcie poglądowe 1

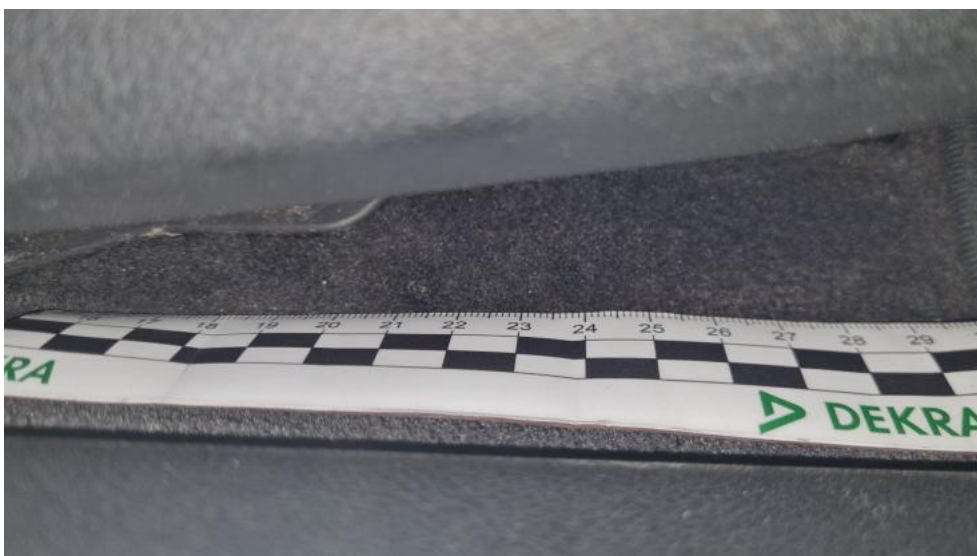
**Photo 78.**

Wykładzina podłogi - Inne 1

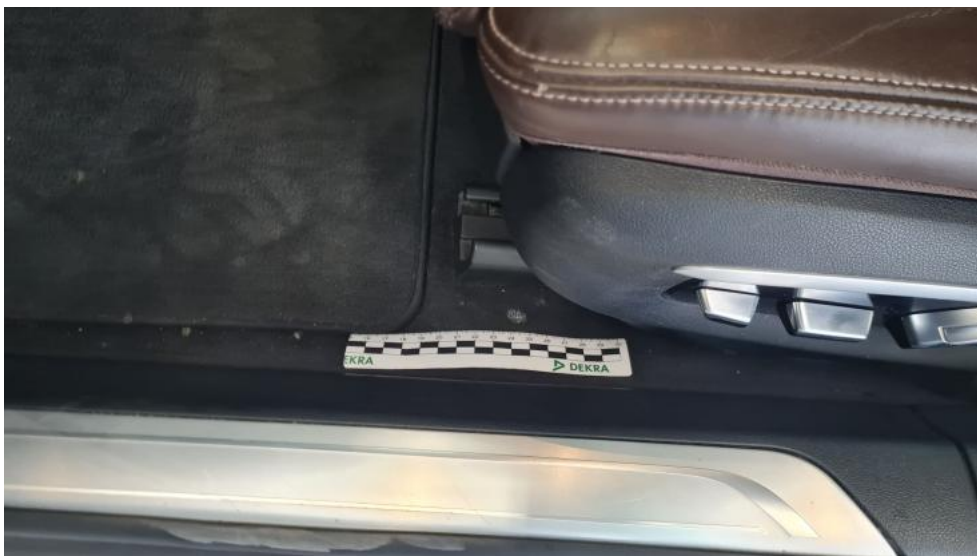
**Photo 79.**

Wykładzina podłogi - Inne 2
