DEKRA's commission No. : PKOL(W)/LODZ/16813/26/02/24  
commission/ damage No. : 22/003913  
Date of commission: 24-02-2026

| Manufacturer | FORD |
| Model | Mustang Mach-E 21- |
| Registration /record No. | DLU93043 |

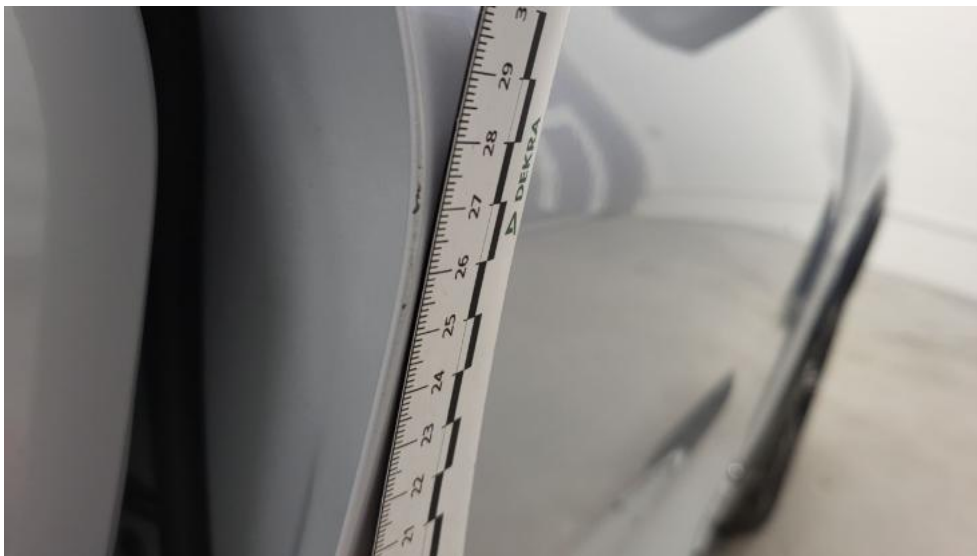
**Photo 47.**

Drzwi przednie P - Rysa/odprysk 1

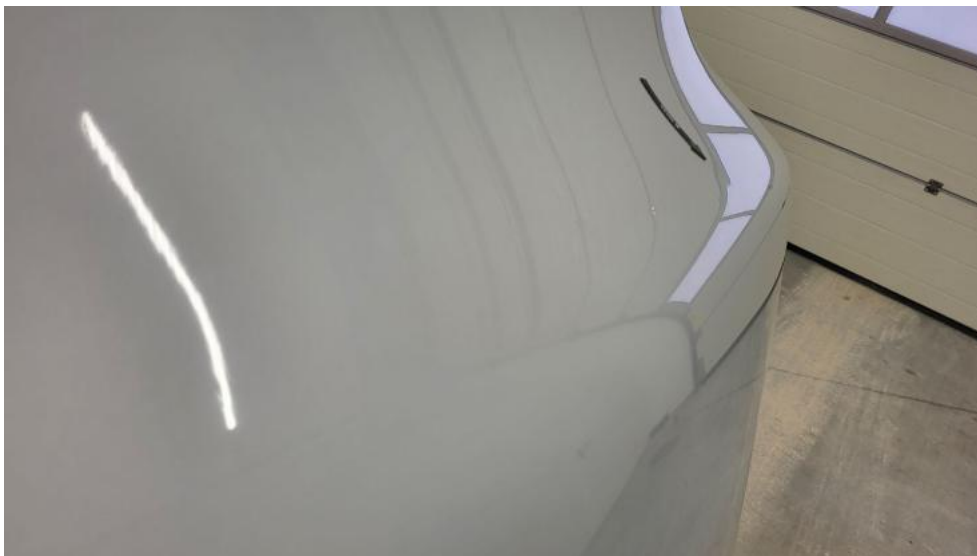
**Photo 53.**  
Błotnik tylny L / Ściana boczna L - Wgniecenie/odkształcenie 1

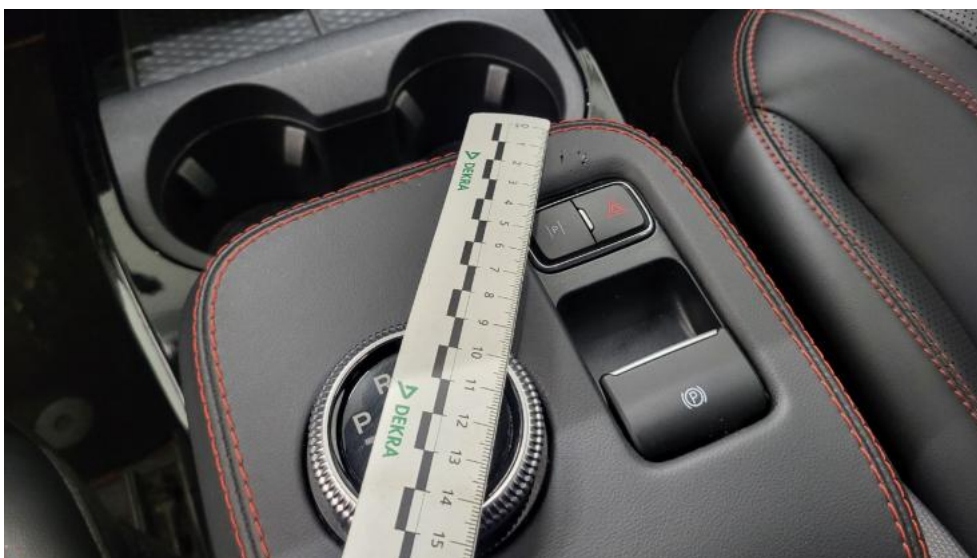
**Photo 60.**  
Konsola tunelu śr. - zdjęcie poglądowe 1

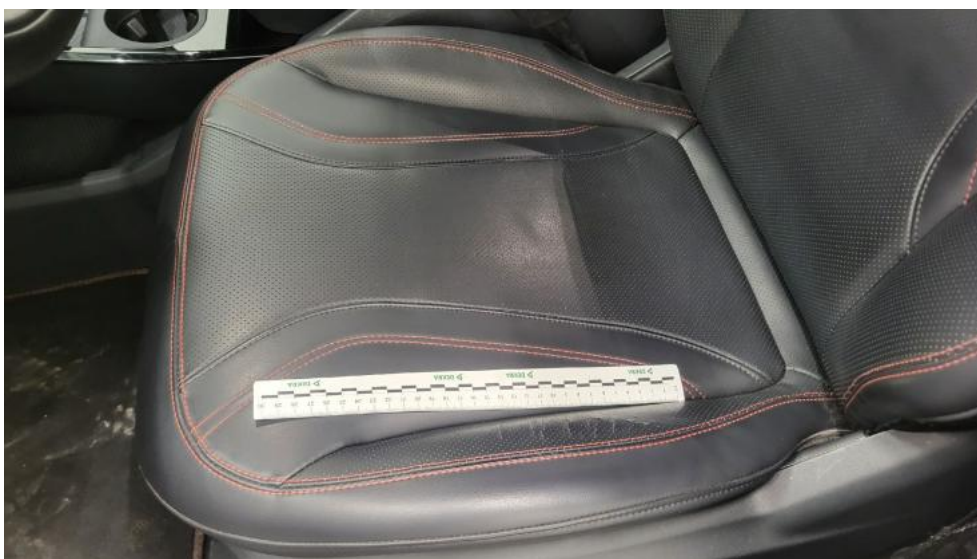
**Photo 63.**  
Fotel prz. lew. - zdjęcie poglądowe 1

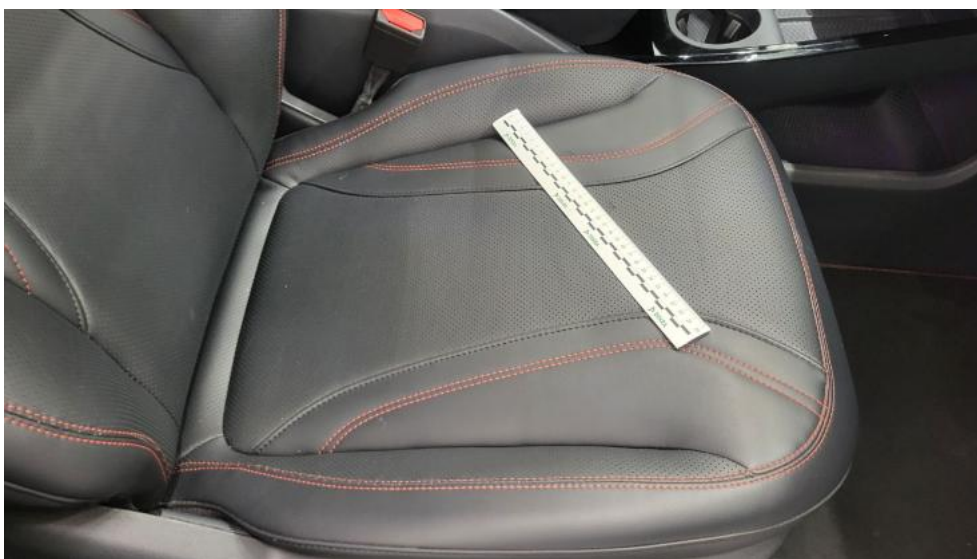
**Photo 65.**

Fotel prz. praw. - zdjęcie poglądowe 1

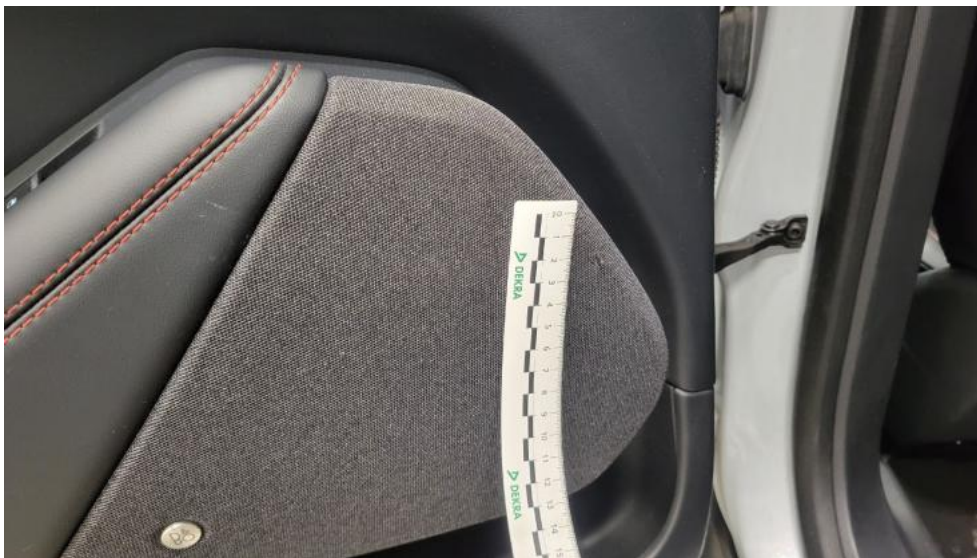
**Photo 67.**

Tapicerka drzwi tylnych L - zdjęcie poglądowe 1

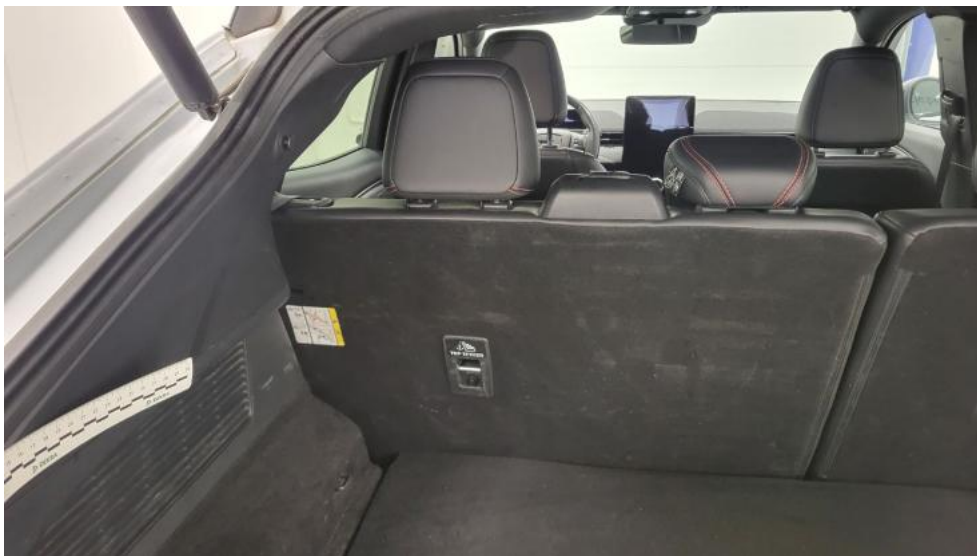
Pojazd elektryczny. Brak kompresora zestawu naprawczego. Brak półki bagażnika. Aktywna kontrolka ubytku ciśnienia w kołach. Rysy na samochodzie. Odpryski na szybie czołowej.

**Photo 73.**  
Półka/roleta tylna - Inne 1
