DEKRA's commission No. : PKOL(W)/LODZ/83675/24/10/29  
commission/ damage No. : 49053  
Date of commission: 29-10-2024

**Vehicle data**

Group of objects (Eurotax)	cars
EC code (Eurotax)	0128698
Manufacturer	VOLKSWAGEN
Model	Passat Alltrack [B8] 15-19
Type / version	Passat Alltrack 2.0 TDI SCR 4Mot. DSG7
Body type	KOM
Number of doors / seats	5/5
Curb weight [kg]	1700
Gross vehicle weight [kg]	2320
Wheelbase 1/2	2789
Engine type	Automatic ignition
Supercompression	turbocompressor with intercooler
Pollution reduction system	KSC
Emission standard	EURO 6
Engine capacity [ccm]	1968
Engine Power [hp/kW]	190/140
Gearbox	automatic 7- gear
Registration /record No.	KR4KH41
VIN / serial number	WVWZZZ3CZKE044636
Date of first registration	05-03-2019
Date of next. tech. test	15-03-2025
Year of manufacture	2019
Readout [km]	85 022 (read)
Body color / type of coating	black/METALIK

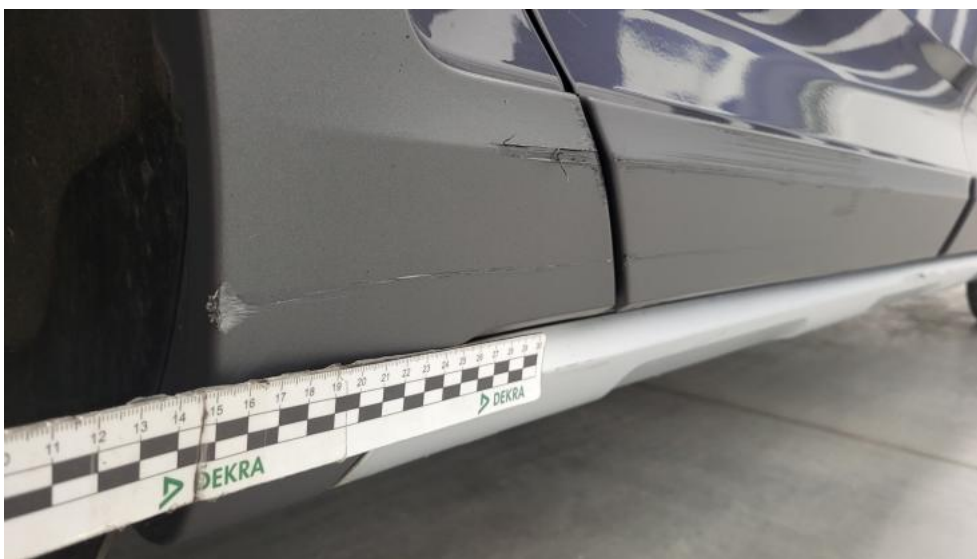
**Photo 59.**

Próg P - zdjęcie poglądowe 1

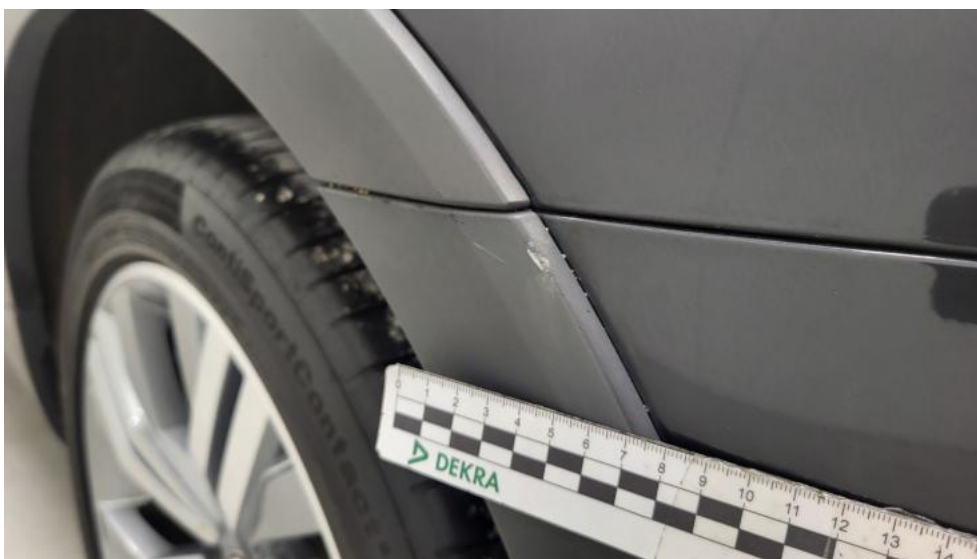
**Photo 69.**  
Zderzak tylny - zdjęcie poglądowe 2

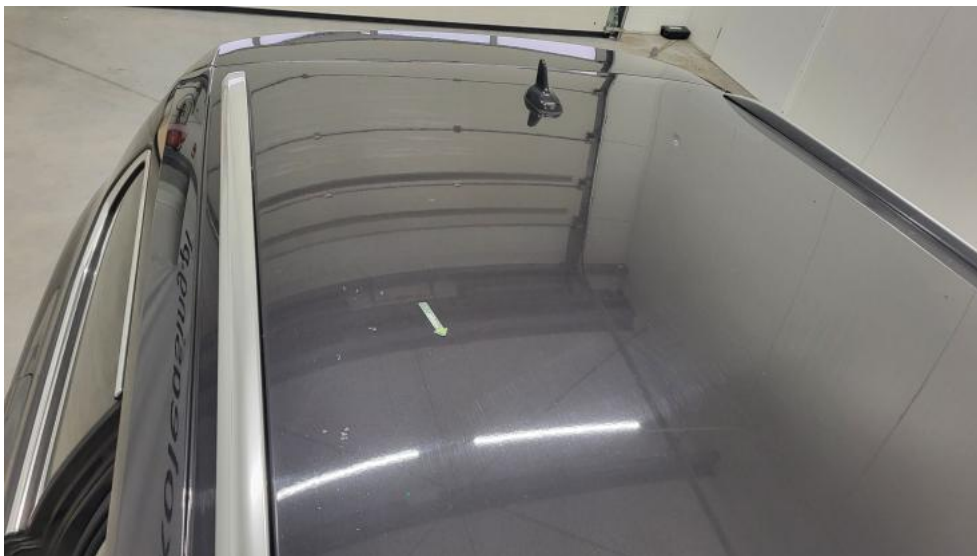
**Photo 73.**

Dach - zdjęcie poglądowe 1

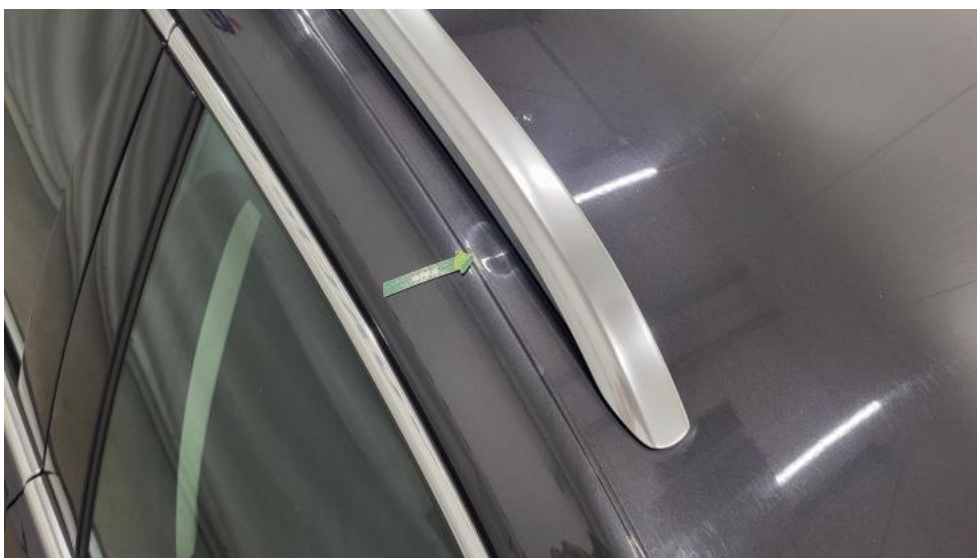
**Photo 74.**

Dach - Wgniecenie/odkształcenie 1

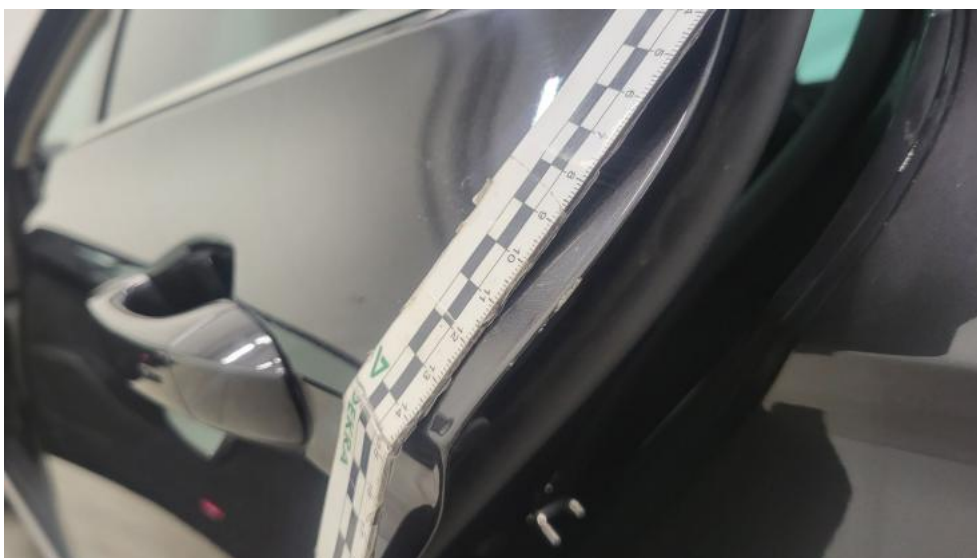
**Photo 80.**  
Drzwi tylne L - Rysa/odprysk 1

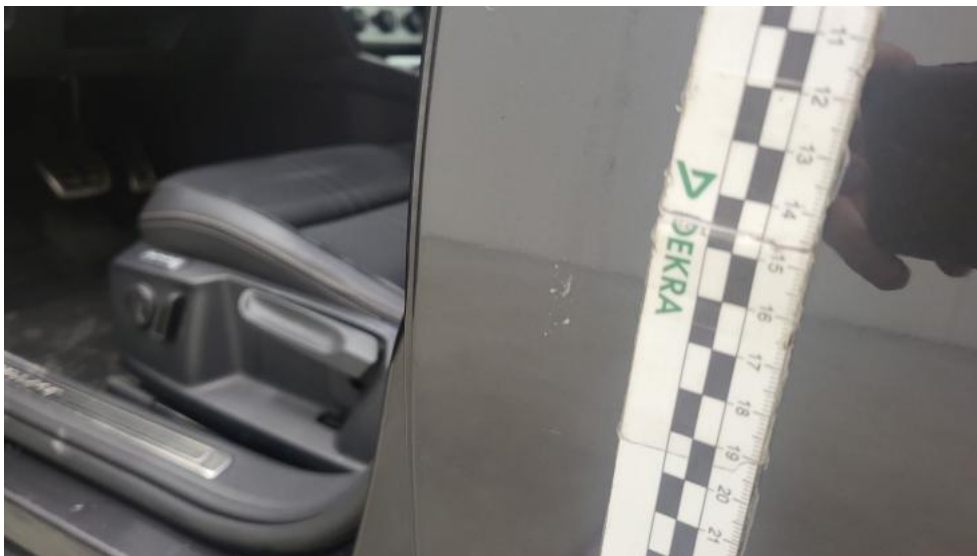
**Photo 81.**

Drzwi tylne L - Rysa/odprysk 2
