DEKRA's commission No. : PKOL(W)/LODZ/85332/26/09/11  
commission/ damage No. : 24/037897  
Date of commission: 11-09-2026

**DEKRA Poland - Headquarters**  
02-673 Warszawa, ul. Konstruktorska 12A

| Model | Arteon 20-23 |
| Type / version | Arteon 2.0 TSI Essence DSG |

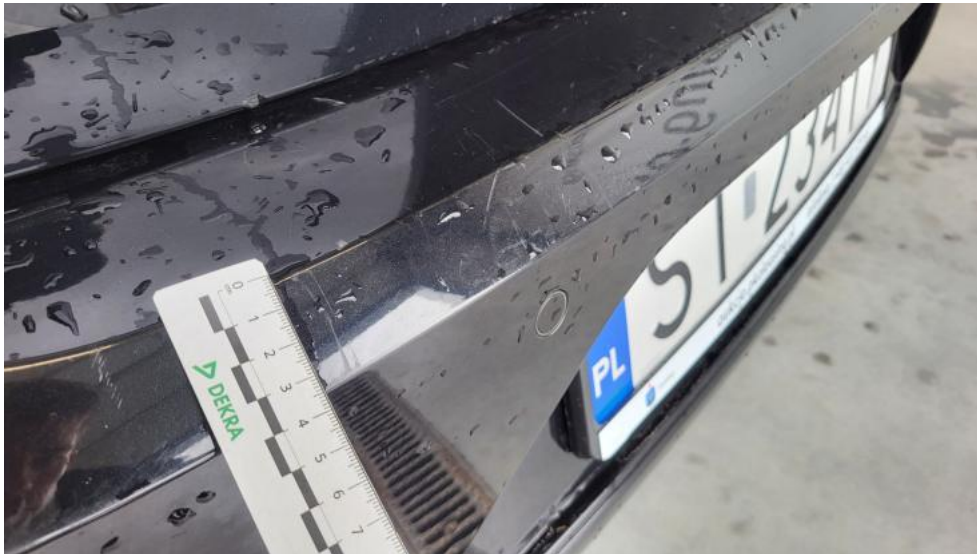
**Photo 51.**

Zderzak tylny() - Rysa/odprysk 3

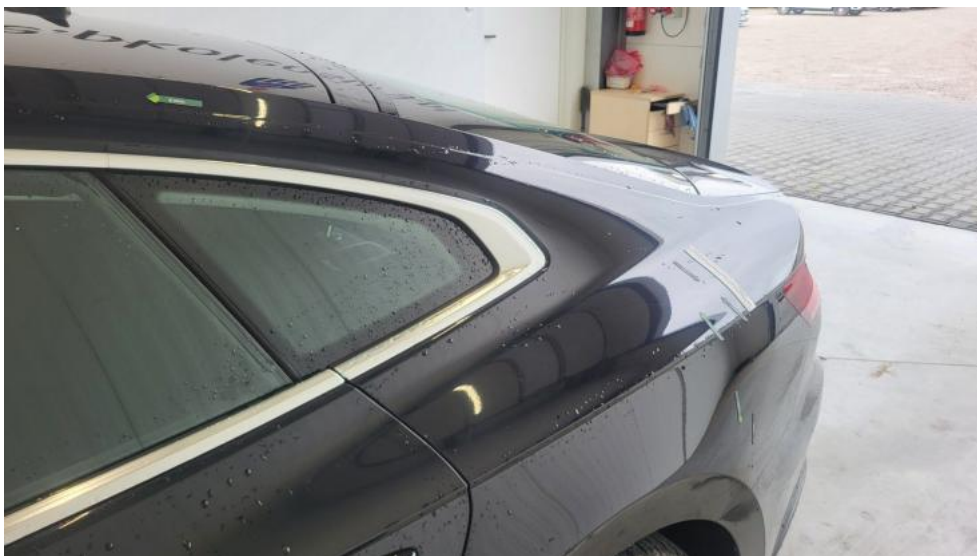
**Photo 52.**

Błotnik tylny L / Ściana boczna L - zdjęcie poglądowe 1

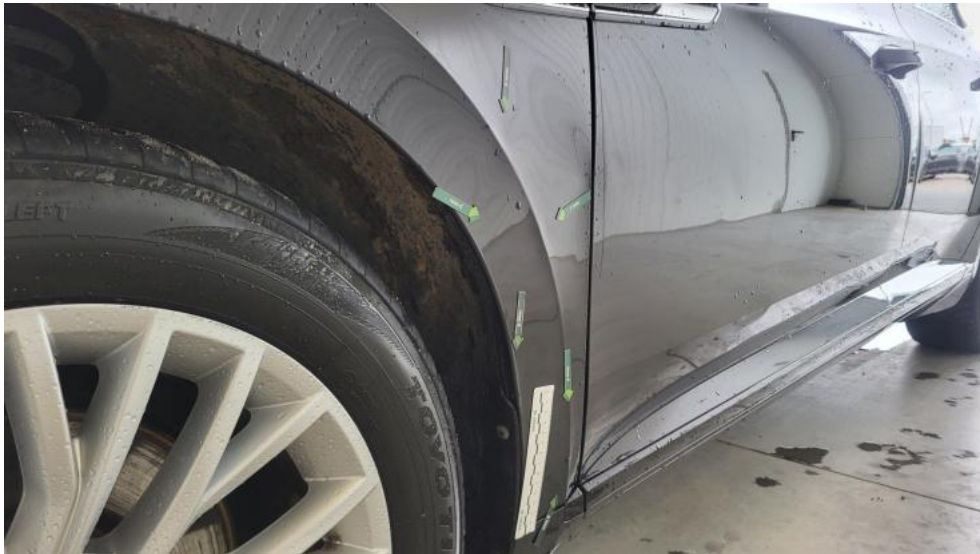
**Photo 61.**

Błotnik przedni L - zdjęcie poglądowe 1

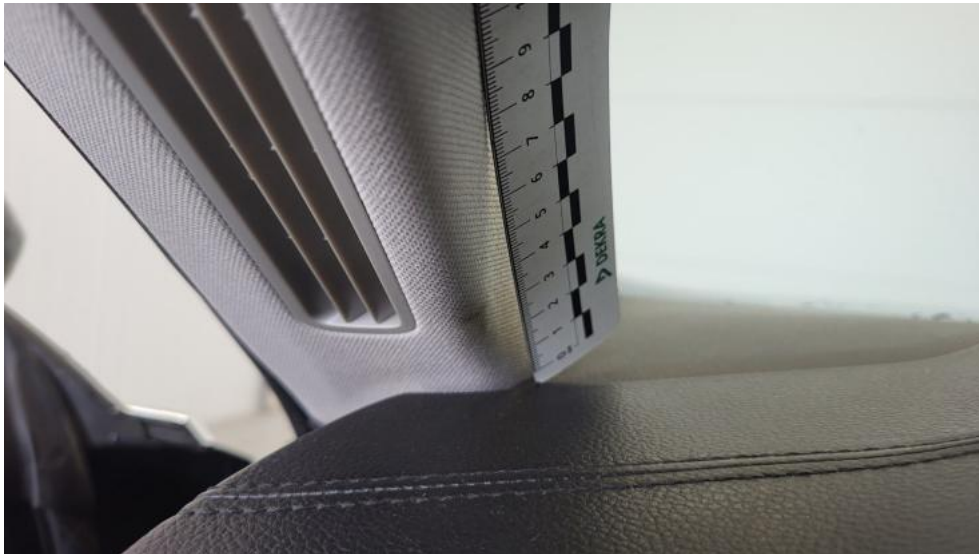
**Photo 71.**

Wykładzina(y) słupka przedniego L - Inne 1
