DEKRA's commission No. : PKOL(W)/LODZ/47487/26/05/22  
 commission/ damage No. : 20/K00302  
 Date of commission: 22-05-2026

**DEKRA Poland - Headquarters**  
 02-673 Warszawa, ul. Konstruktorska 12A

**Vehicle data**

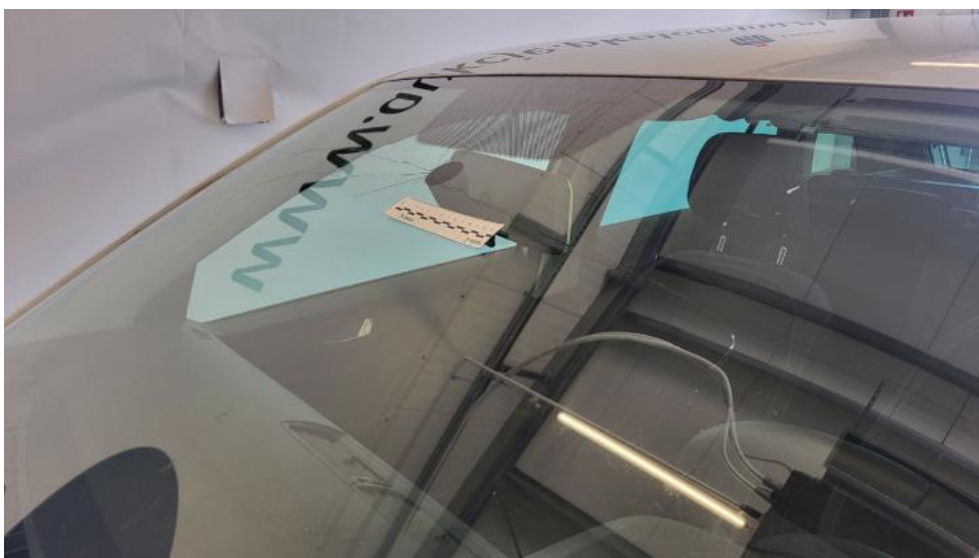
**Photo 42.**

Szyba czołowa - zdjęcie poglądowe 1
