DEKRA's commission No. : PKOL(W)/LODZ/84289/26/09/08  
commission/ damage No. : DW/WA/2009/001/D  
Date of commission: 08-09-2026

**DEKRA Poland - Headquarters**  
02-673 Warszawa, ul. Konstruktorska 12A

| Manufacturer | BMW |
| Model | Seria 3 Gran Turismo [F34] 16-20 |

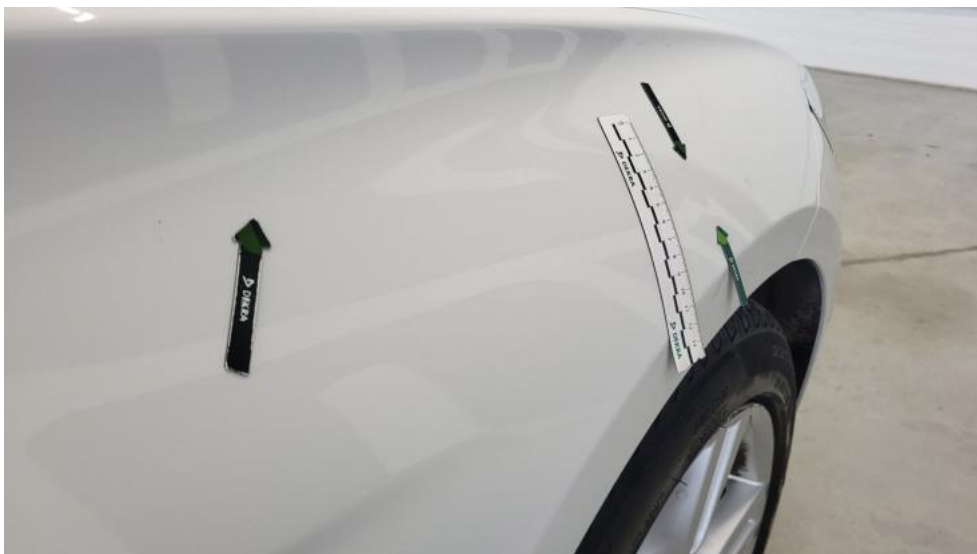
**Photo 45.**

Błotnik przedni P - Wgniecenie/odkształcenie 1

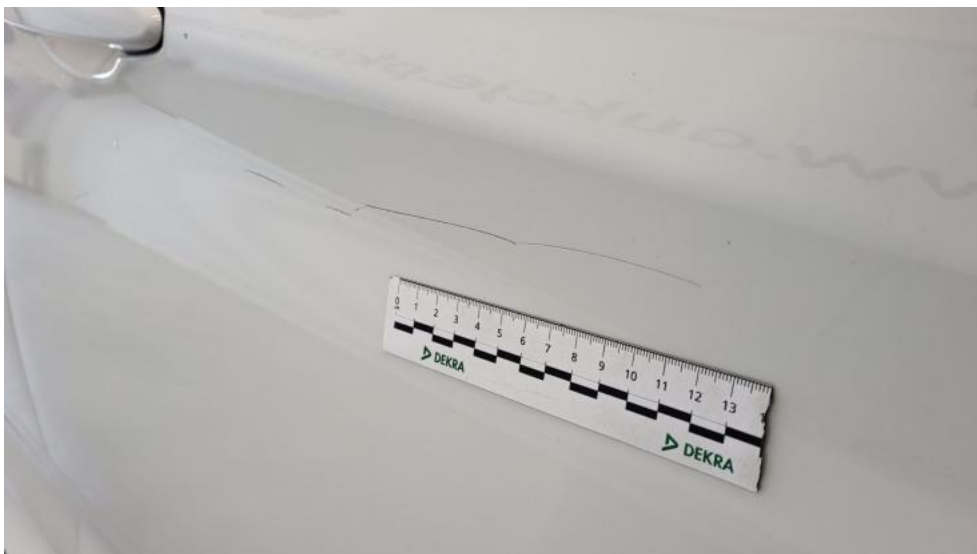
**Photo 47.**

Drzwi przednie P - Rysa/odprysk 1

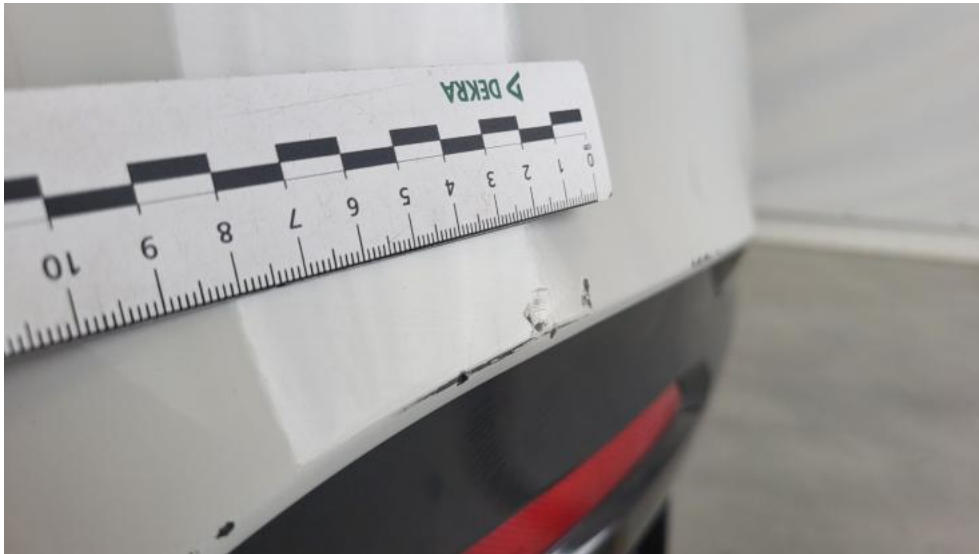
**Photo 61.**

Zderzak tylny - Wgniecenie/odkształcenie 1

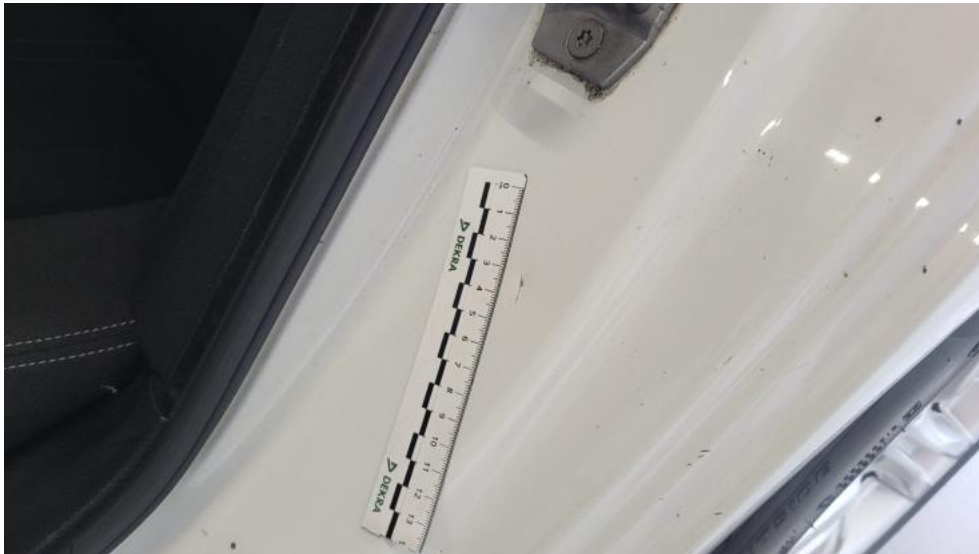
**Photo 65.**

Błotnik tylny L / Ściana boczna L - Rysa/odprysk 1

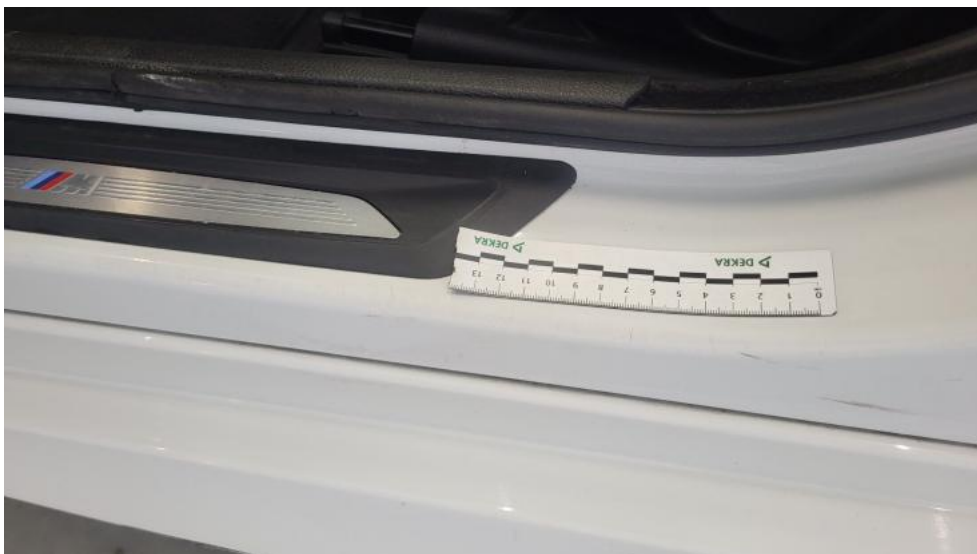
**Photo 75.**  
Próg L - Rysa/odprysk 1

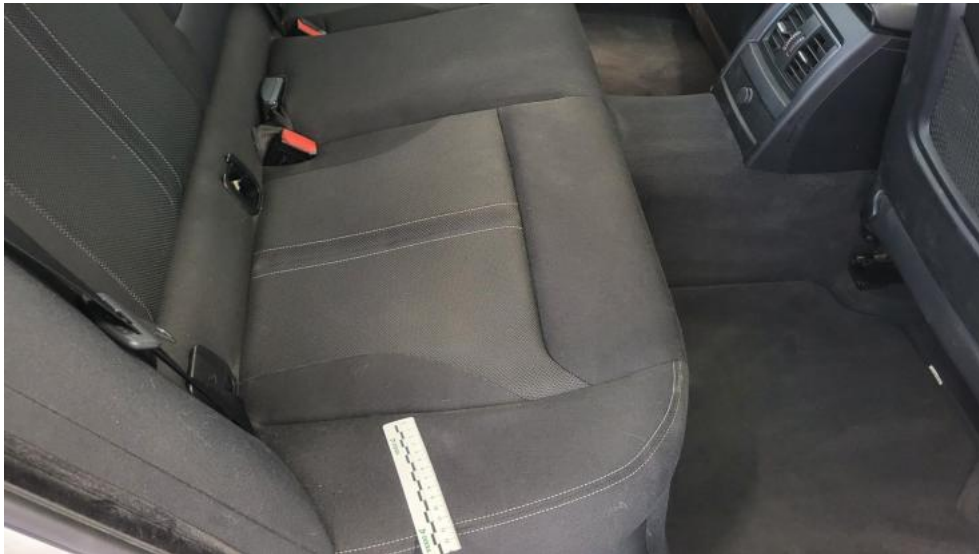
**Photo 79.**  
Kanapa tyl. - Inne 1

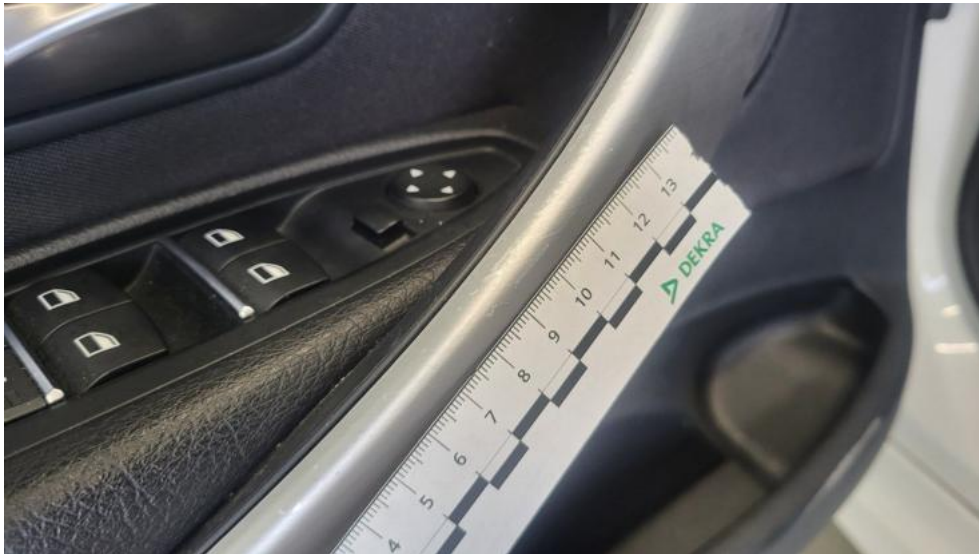
**Photo 81.**

Uchwyt drzwi prze L - Rysa/odprysk 1
