DEKRA's commission No. : PKOL(W)/LODZ/92961/25/11/28  
commission/ damage No. : 20/052783  
Date of commission: 28-11-2025

**DEKRA Poland - Headquarters**  
02-673 Warszawa, ul. Konstruktorska 12A

| Manufacturer | FORD |
| Model | Focus Kombi 18-21 |

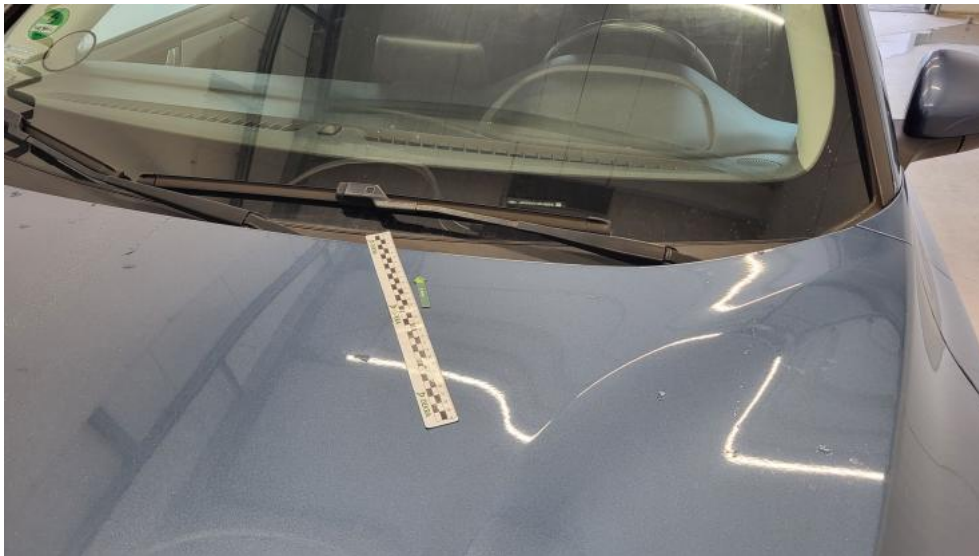
**Photo 37.**

Pokrywa komory silnika - zdjęcie poglądowe 1

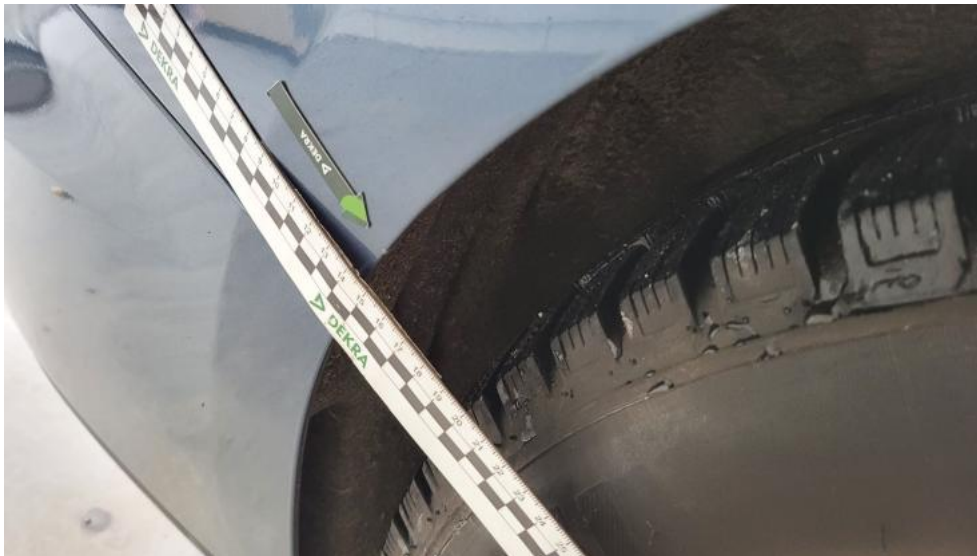
**Photo 45.**

Błotnik tylny P / Ściana boczna P - zdjęcie pogładowe 1

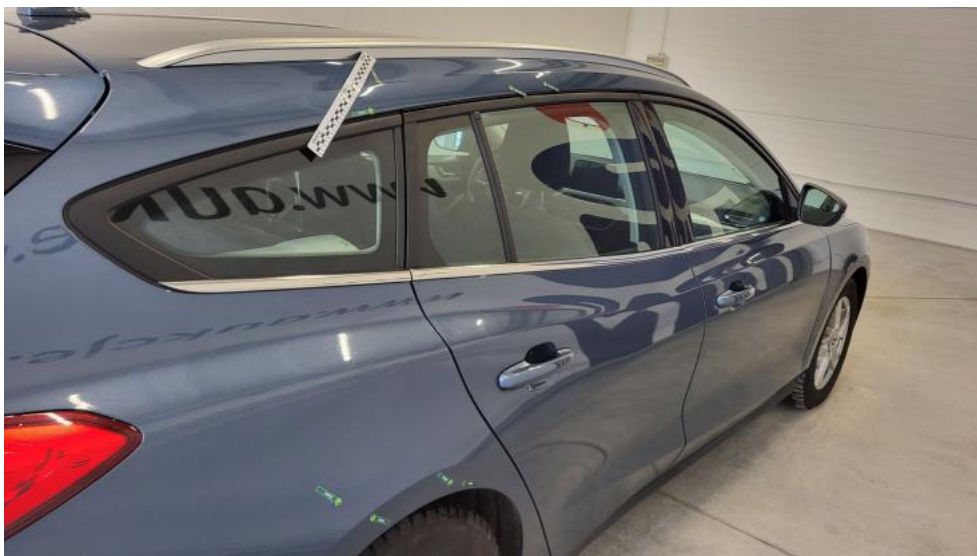
**Photo 46.**

Błotnik tylny P / Ściana boczna P - Wgniecenie/odkształcenie 1

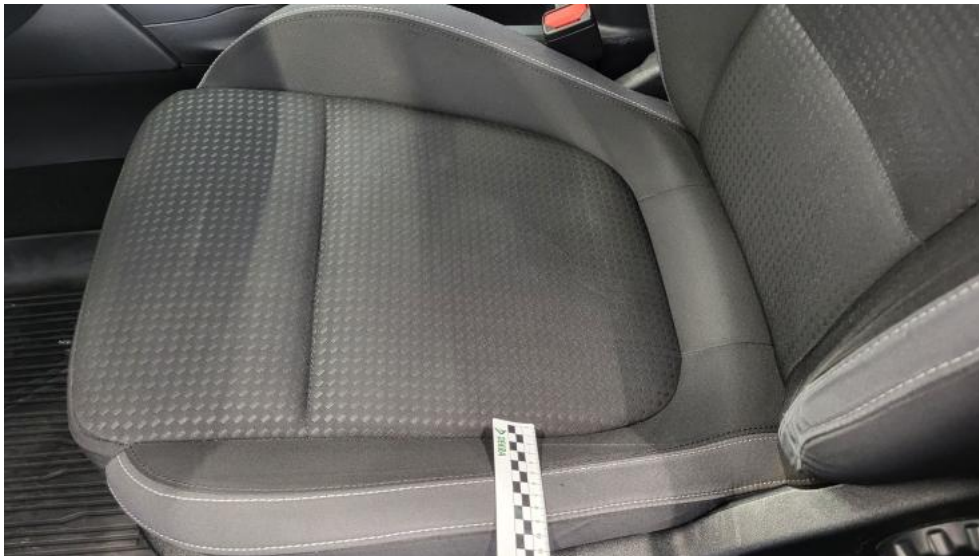
**Photo 59.**

Fotel prz. lew. - zdjęcie poglądowe 1

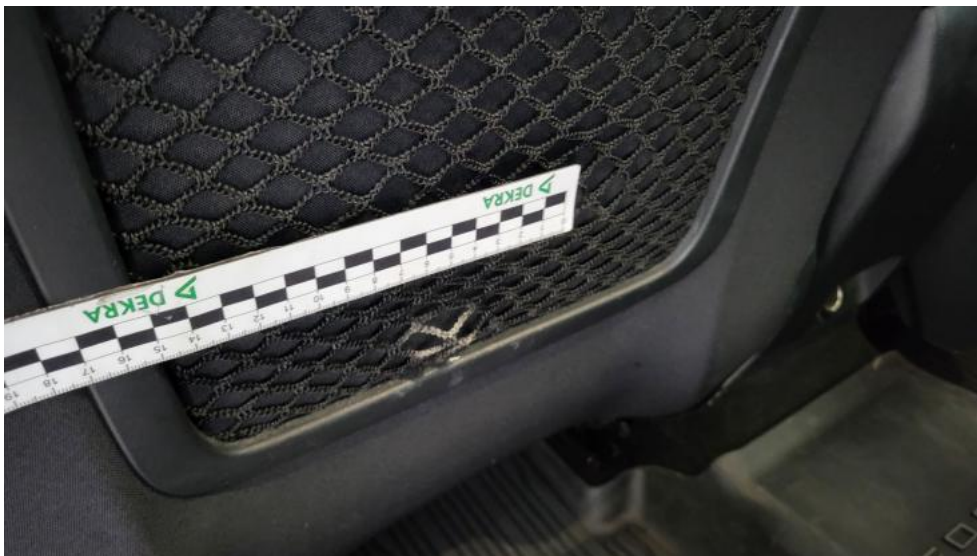
**Photo 61.**

Fotel prz. lew. - Inne 2

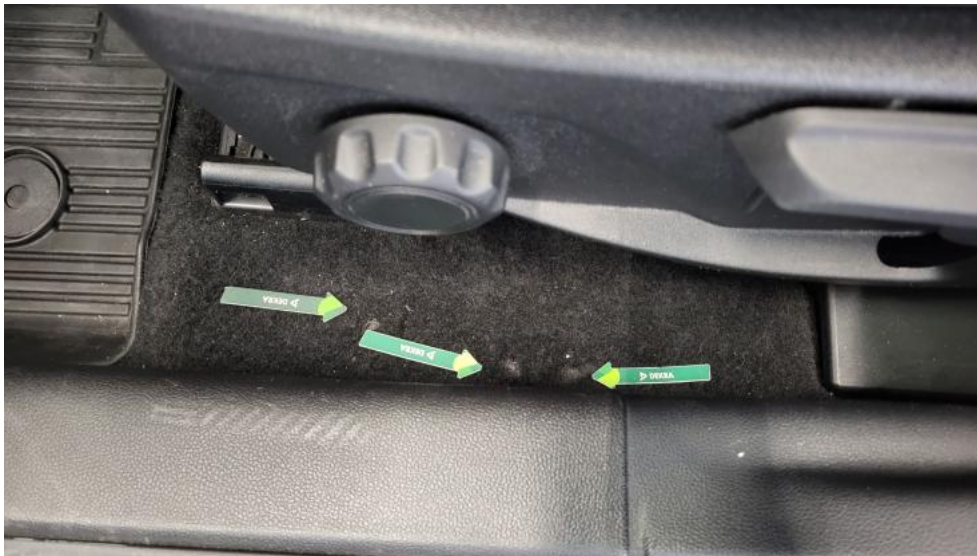
**Photo 73.**

Wykładzina podłogi - Inne 1

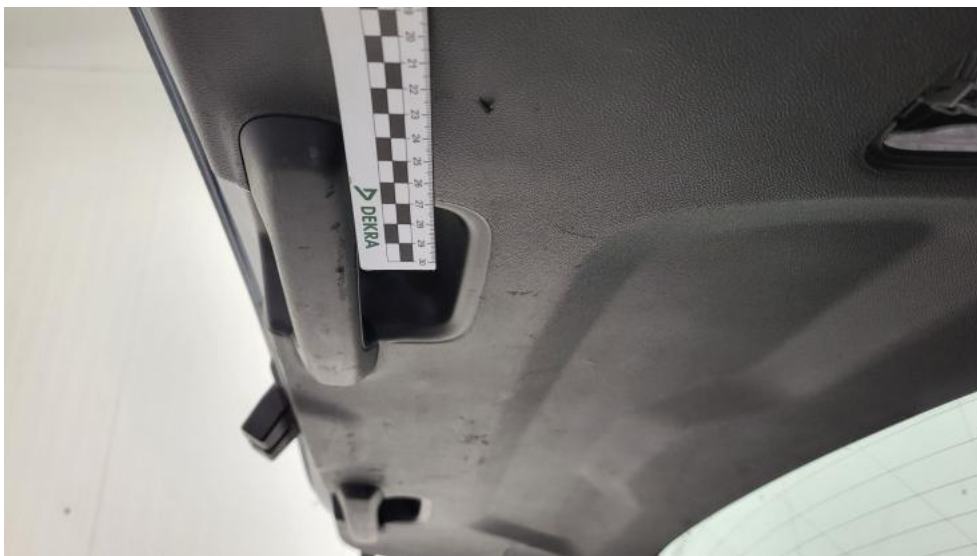
**Photo 74.**

Wykładzina pokrywy tylnej - Rysa/odprysk 1

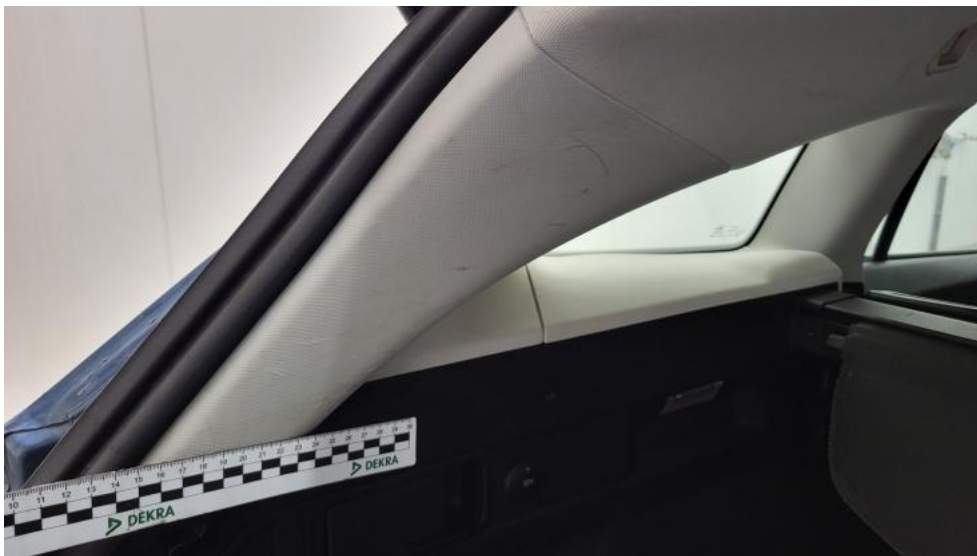
**Photo 77.**

Wykładzina przestrzeni bagażowej - Inne 2
