DEKRA's commission No. : PKOL(W)/LODZ/06717/26/01/27  
commission/ damage No. : FLOTA  
Date of commission: 27-01-2026

| Manufacturer | FORD |
| Type / version | Focus 1.0 EcoBoost mHEV ST-Line X |
| Registration /record No. | WZ066FX |

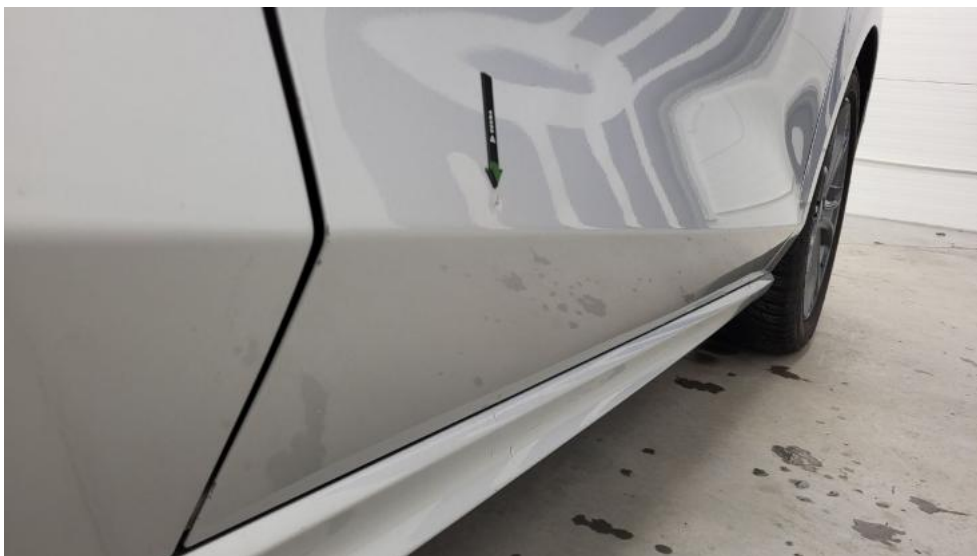
**Photo 46.**

Drzwi przednie P - Wgniecenie/odkształcenie 1

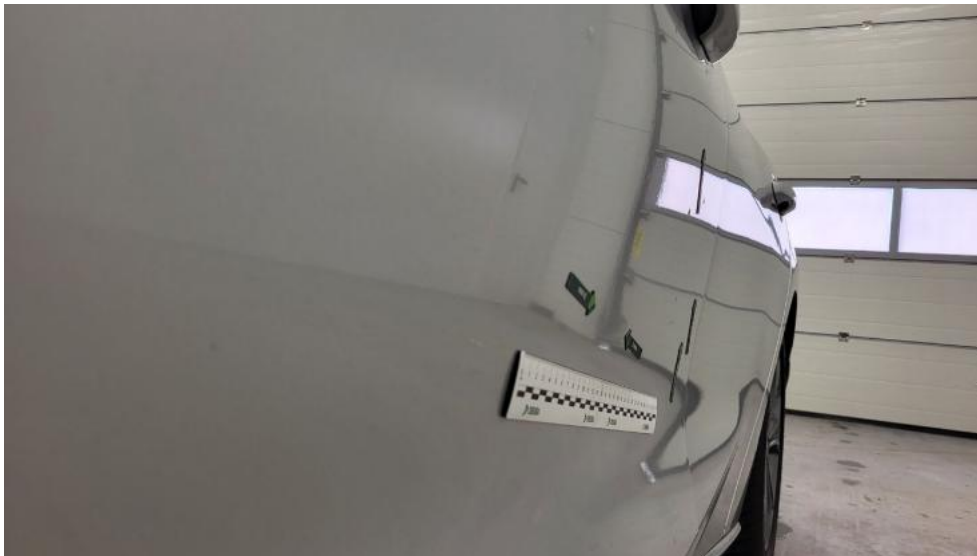
**Photo 61.**

Drzwi przed L - Wgniecenie/odkształcenie 1
