DEKRA's commission No. : PKOL(W)/LODZ/80270/26/08/27  
commission/ damage No. : 23/014881  
Date of commission: 27-08-2026

**DEKRA Poland - Headquarters**  
02-673 Warszawa, ul. Konstruktorska 12A

| Manufacturer | AUDI |
| Type / version | Q5 45 TFSI mHEV Quattro Sport |

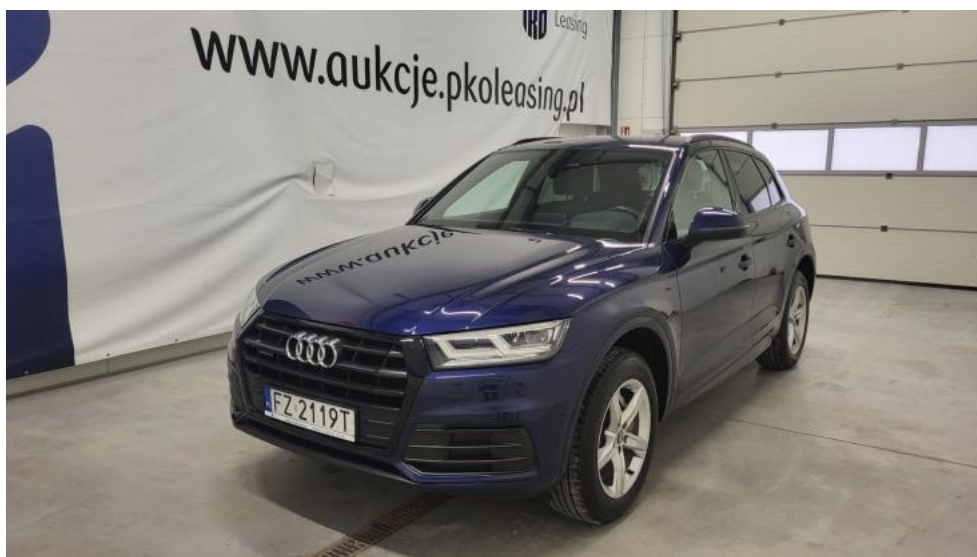
**Photo 1.**  
Przekątna przednia lewa

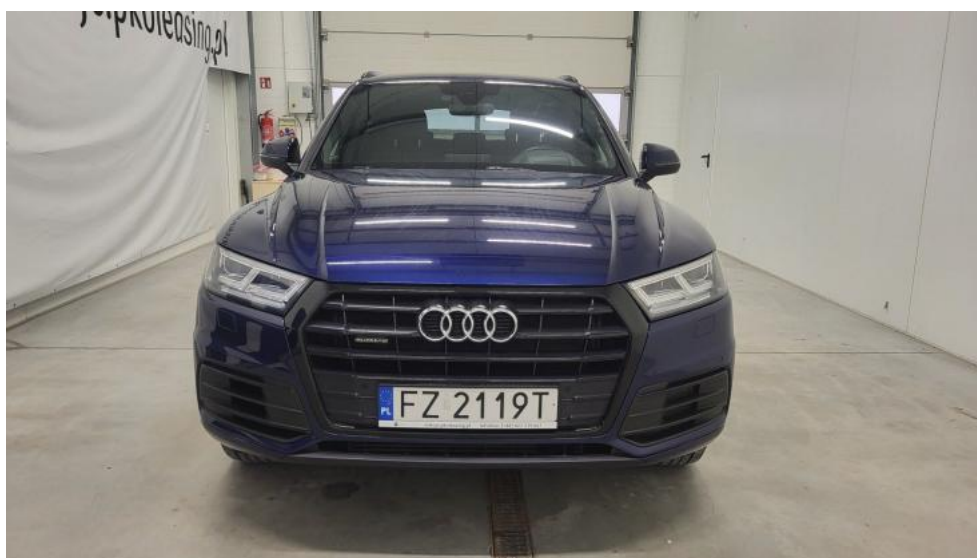
**Photo 2.**  
Przód

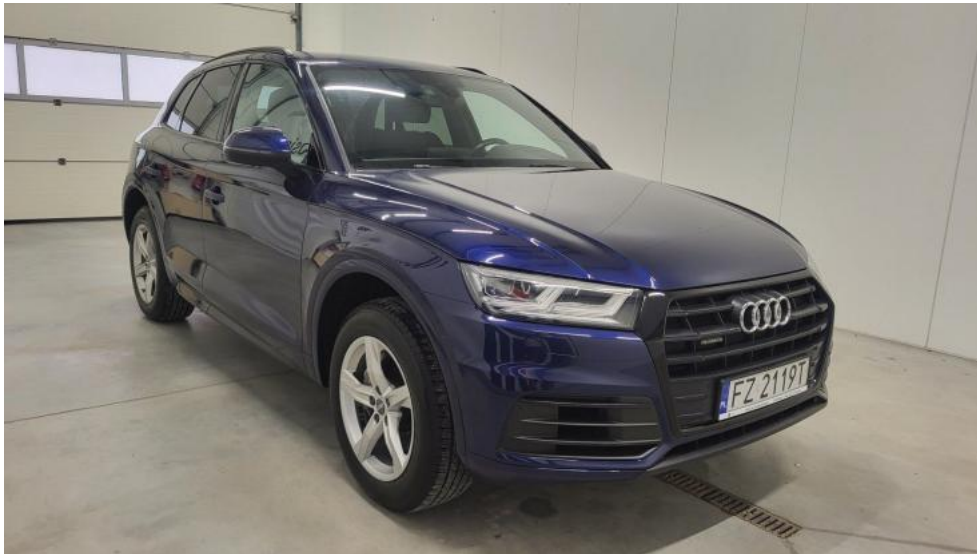
**Photo 3.**

Przekątna przednia prawa

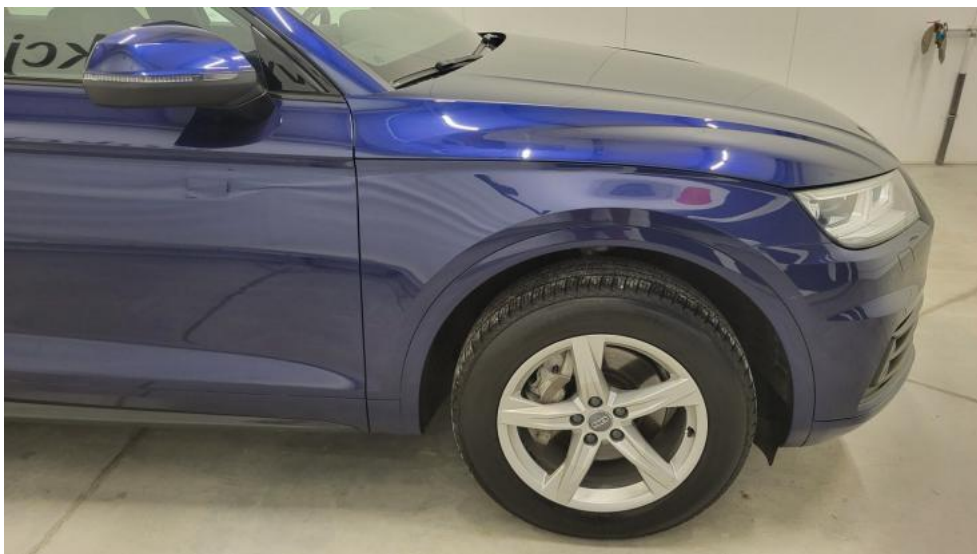
**Photo 4.**

Bok prawy z przodu

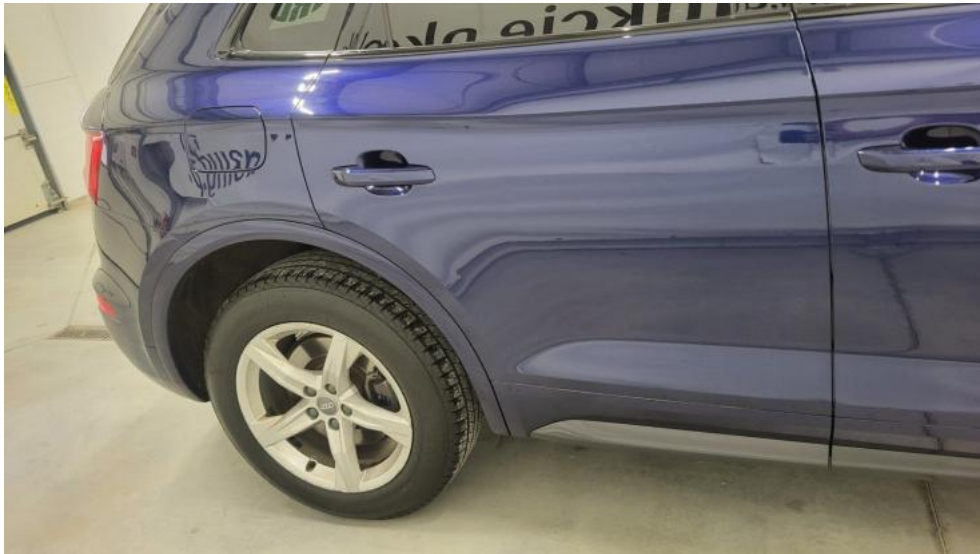
**Photo 5.**  
Bok prawy z tyłu

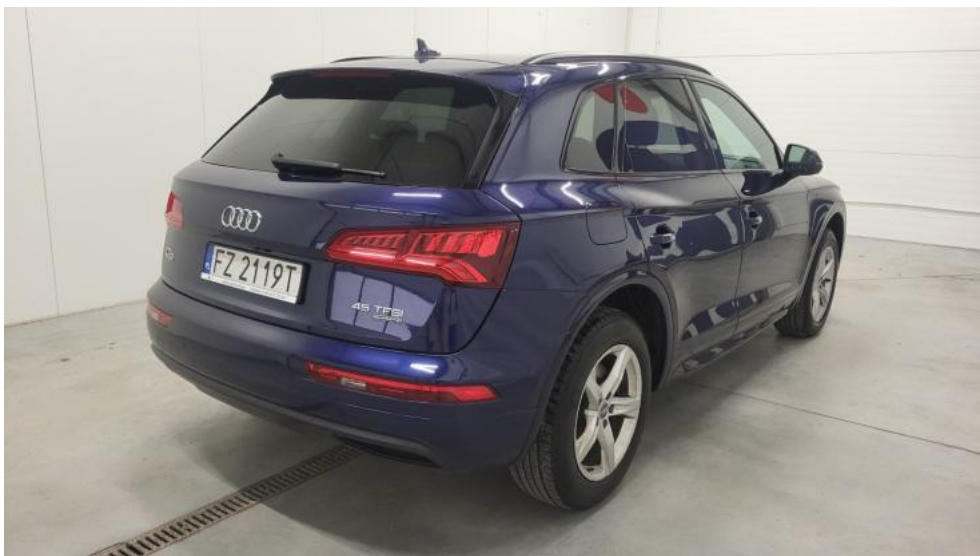
**Photo 6.**  
Przekątna tylna prawa

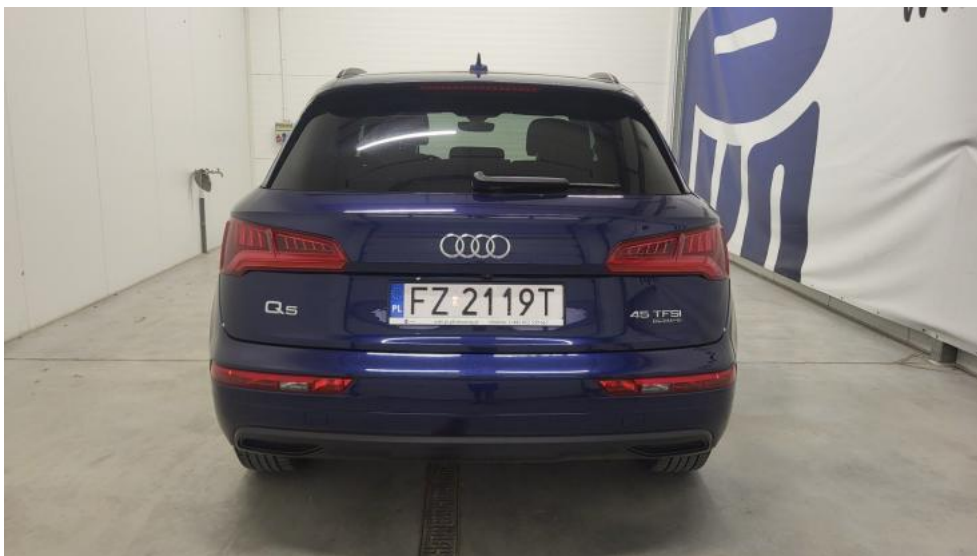
**Photo 7.**

Tył

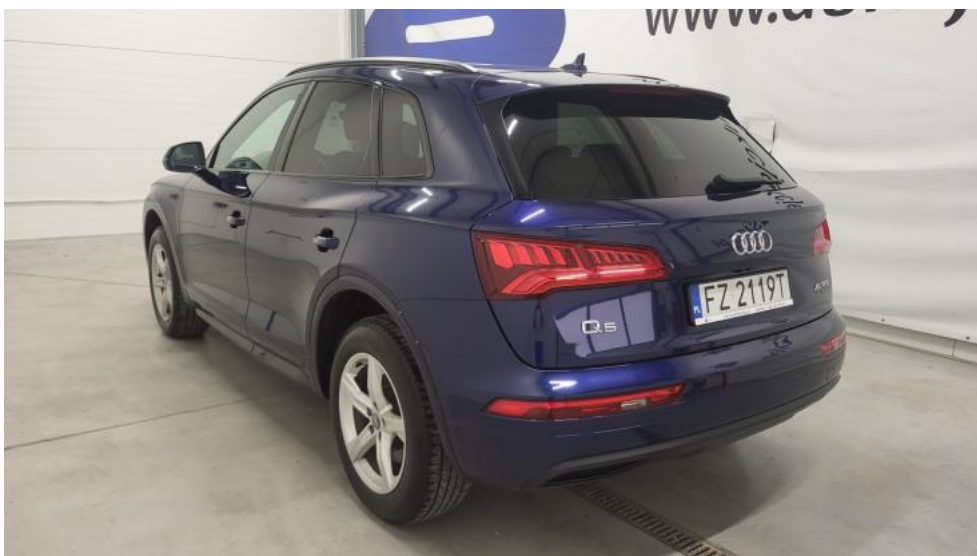
**Photo 8.**

Przekątna tylna lewa

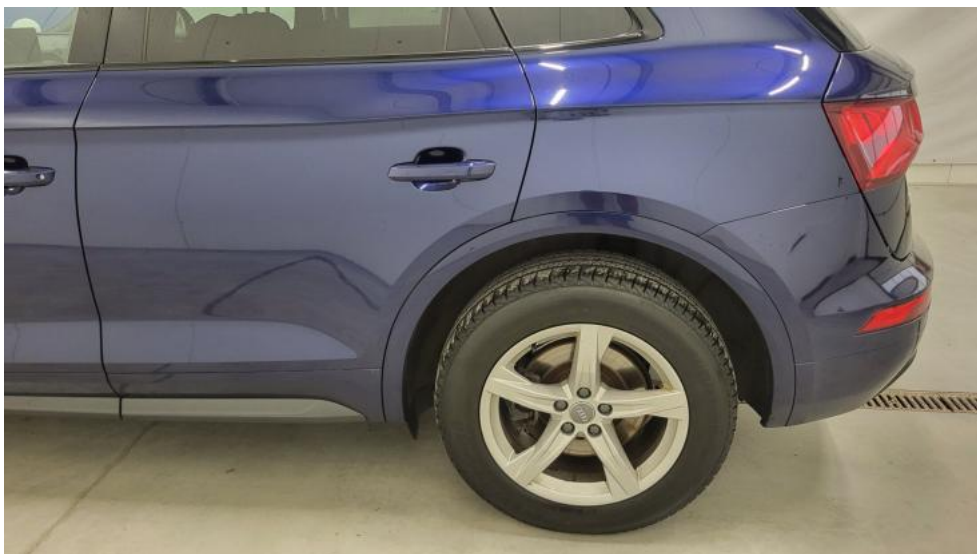
**Photo 9.**

Bok lewy z tyłu

Błotnik tylny L / Ściana boczna L - Rysa/odprysk 2

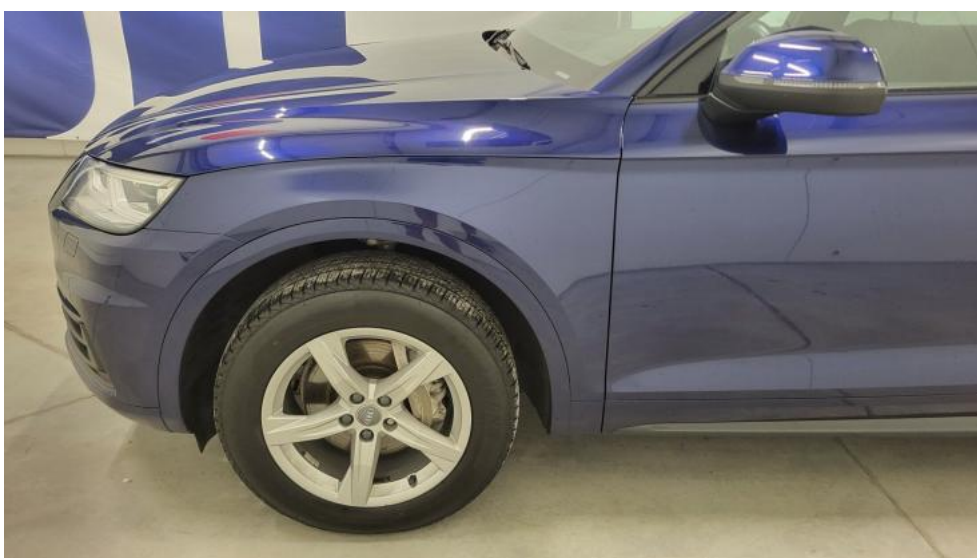
**Photo 10.**

Bok lewy z przodu

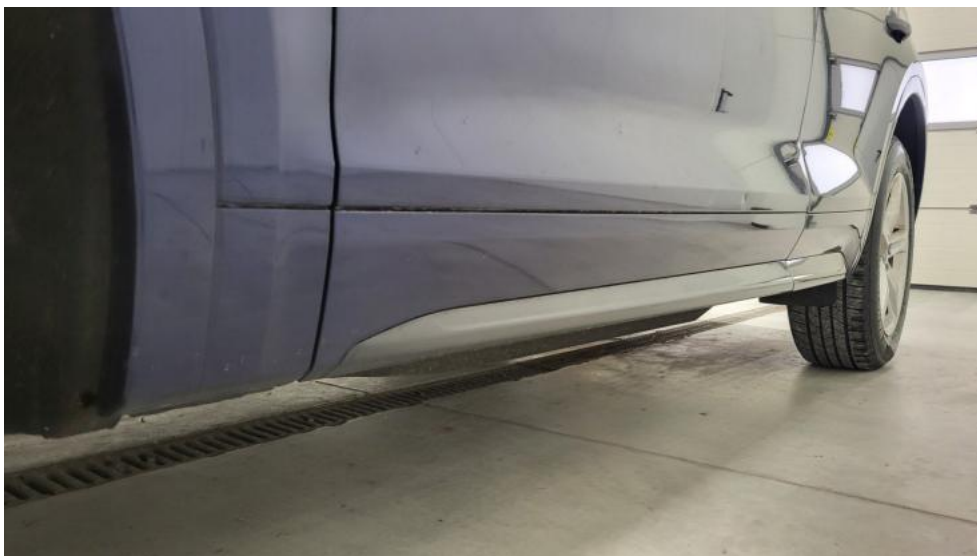
**Photo 11.**  
Próg lewy (widok od przodu)

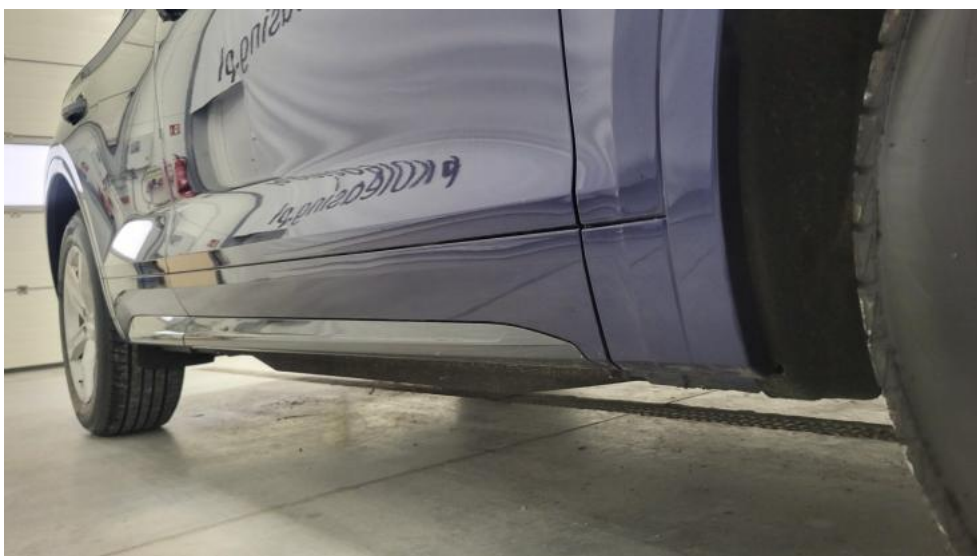
**Photo 12.**  
Próg prawy (widok od przodu)

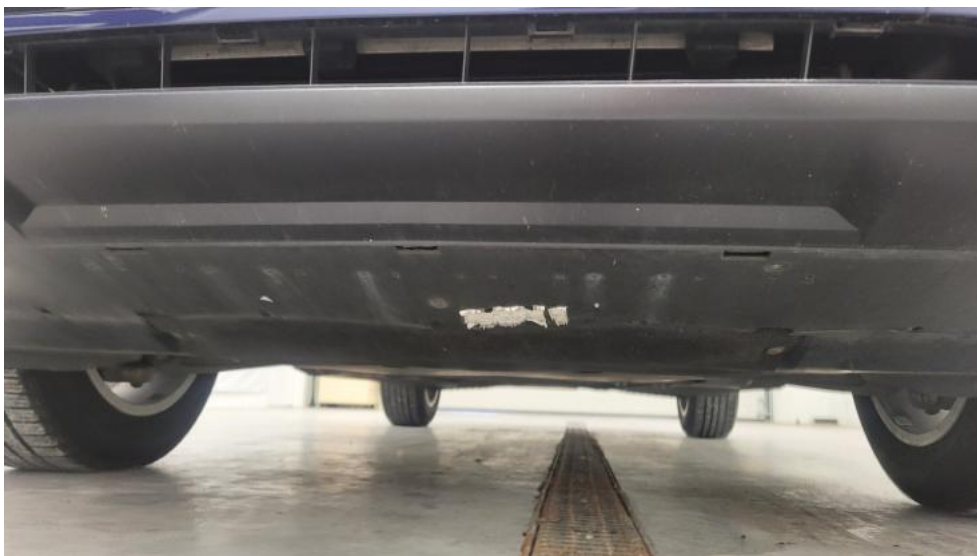
**Photo 13.**  
Spód pojazdu przód

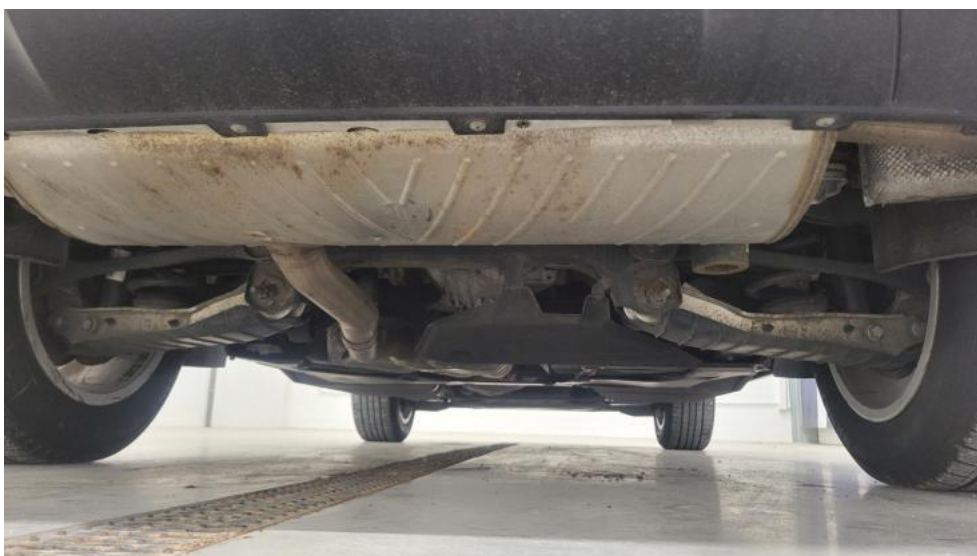
**Photo 14.**  
Spód pojazdu tył

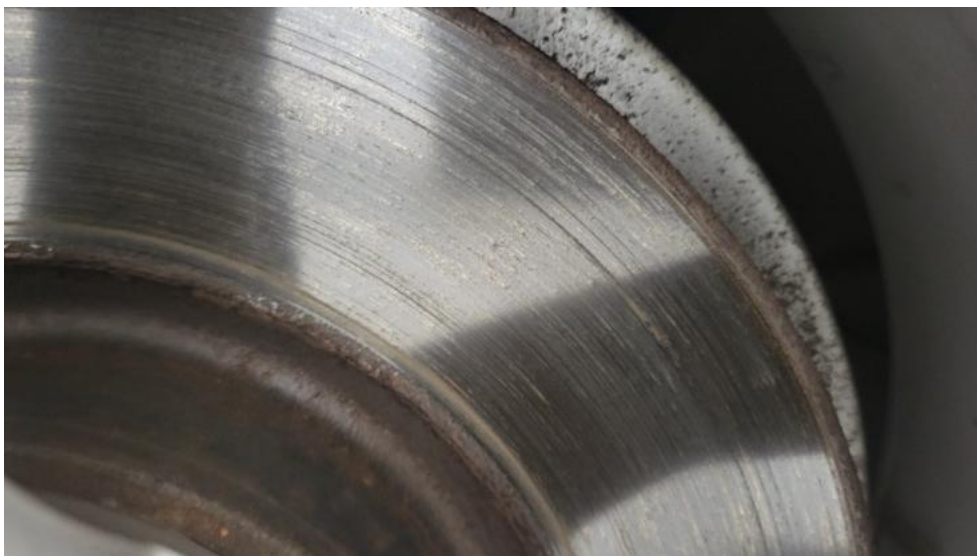
**Photo 15.**

Tarcza hamulcowa przednia prawa

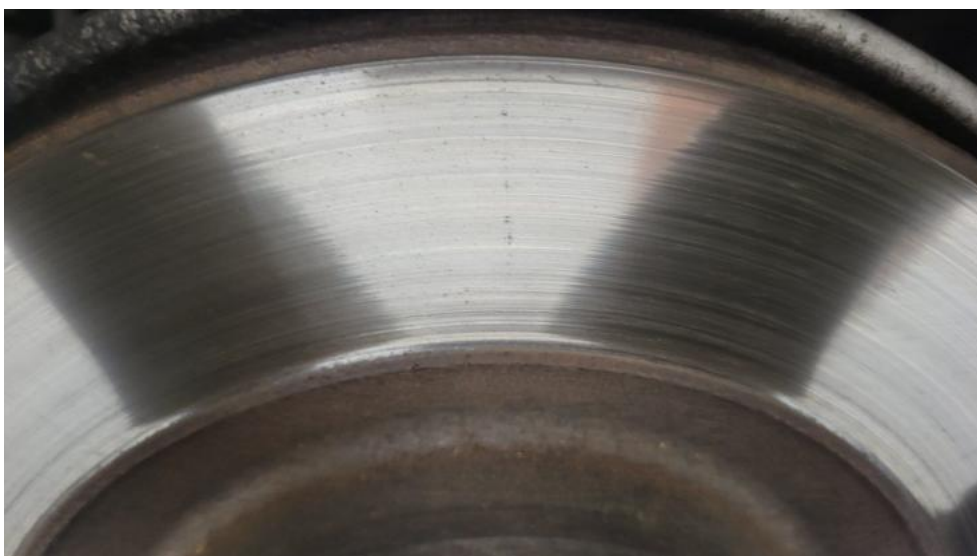
**Photo 16.**

Tarcza hamulcowa tylna prawa

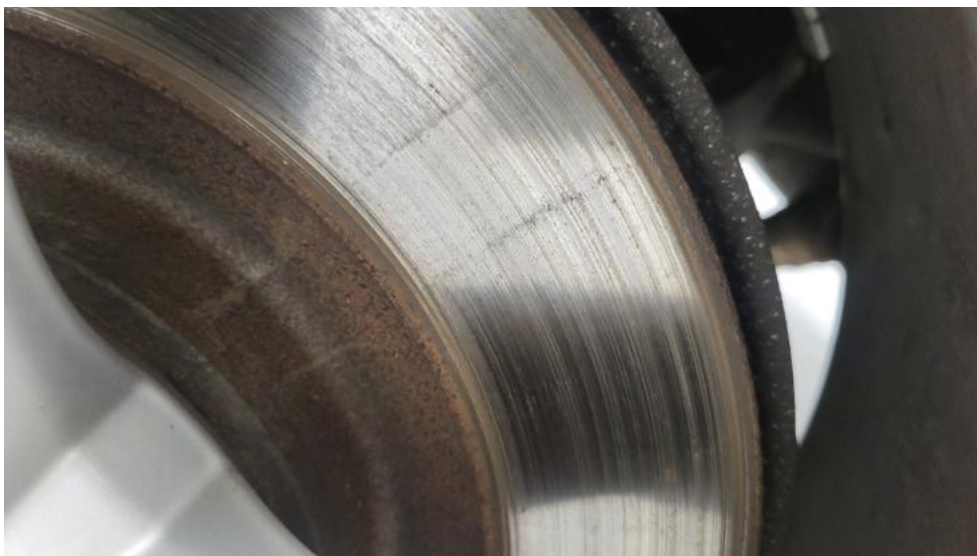
**Photo 17.**

Tarcza hamulcowa tylna lewa

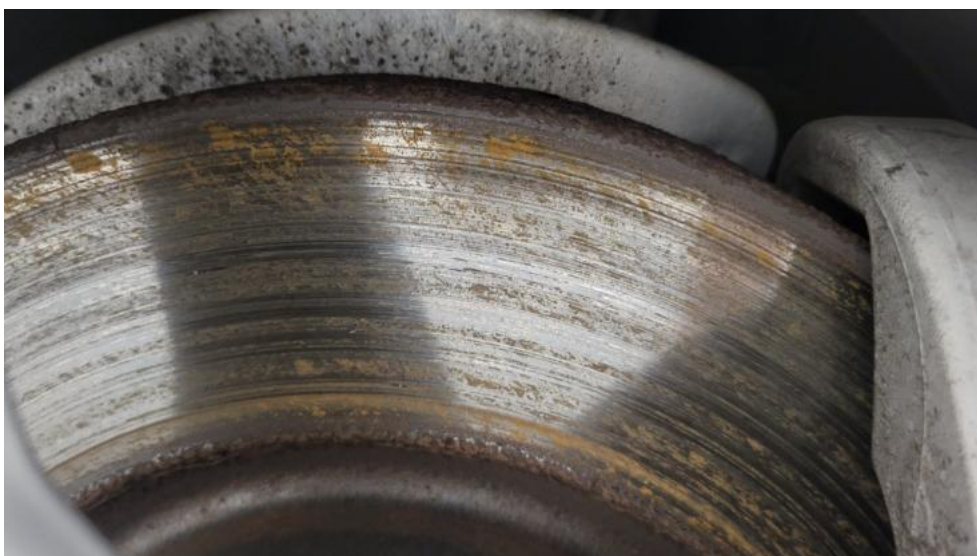
**Photo 18.**

Tarcza hamulcowa przednia lewa

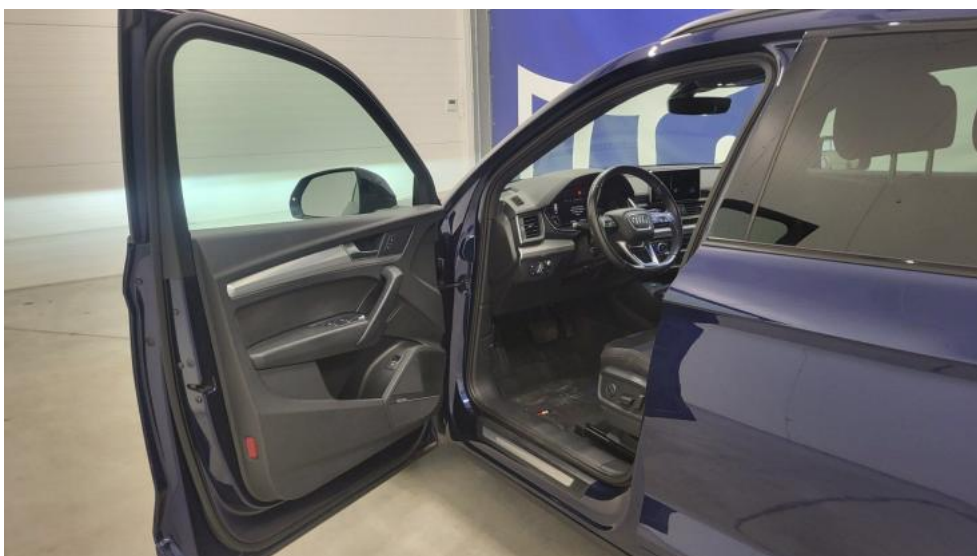
**Photo 26.**

Widok przez otwarte drzwi przednie lewe

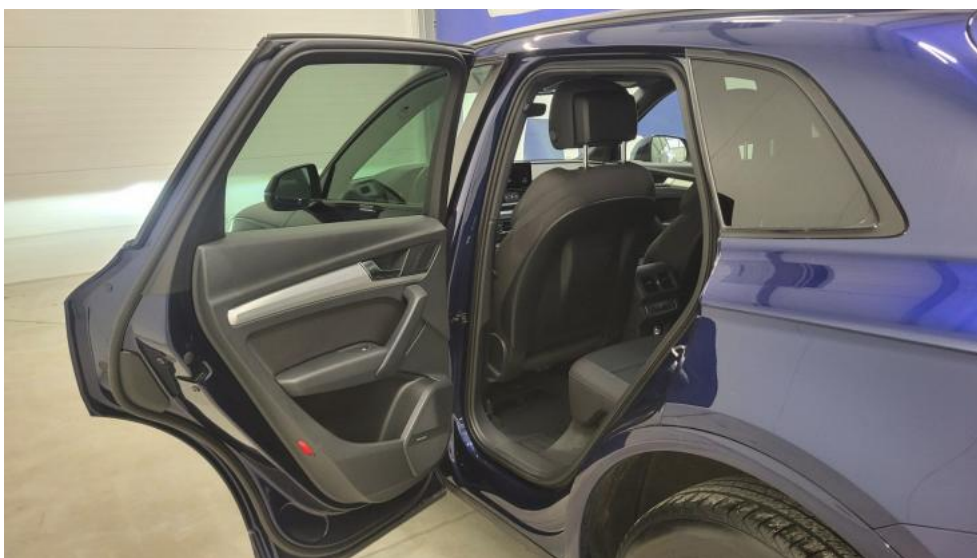
**Photo 28.**

Widok przez otwarte drzwi tylne lewe

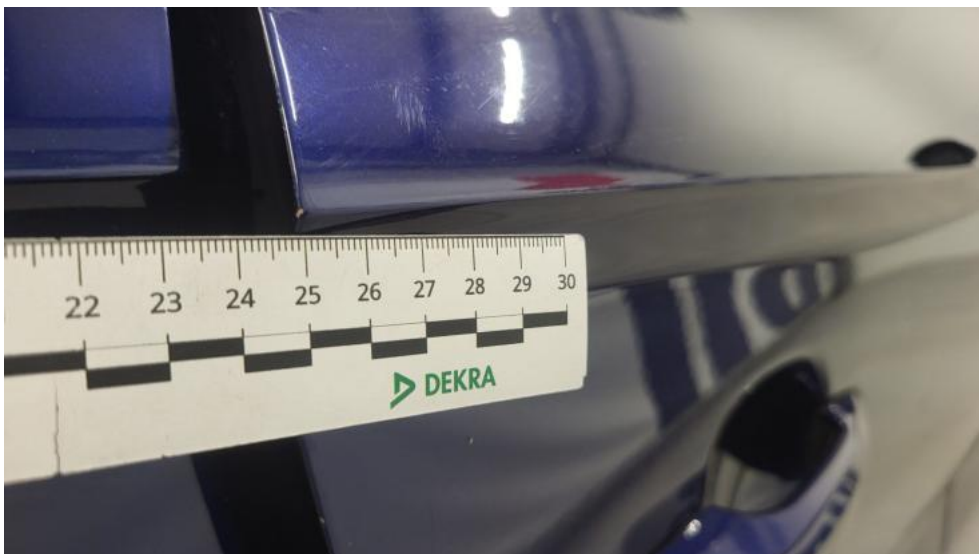
**Photo 46.**

Drzwi tylne P - zdjęcie poglądowe 1

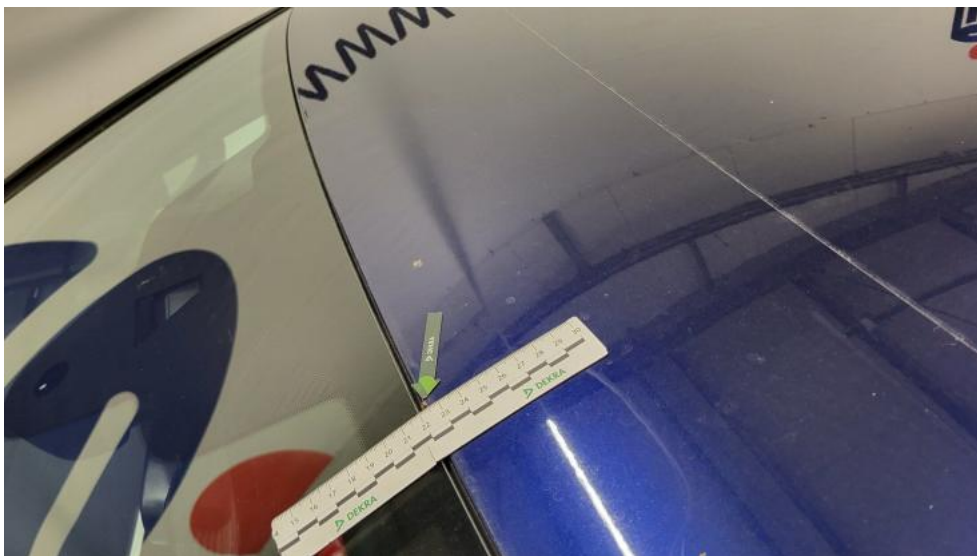
**Photo 55.**

Dach - zdjęcie poglądowe 1

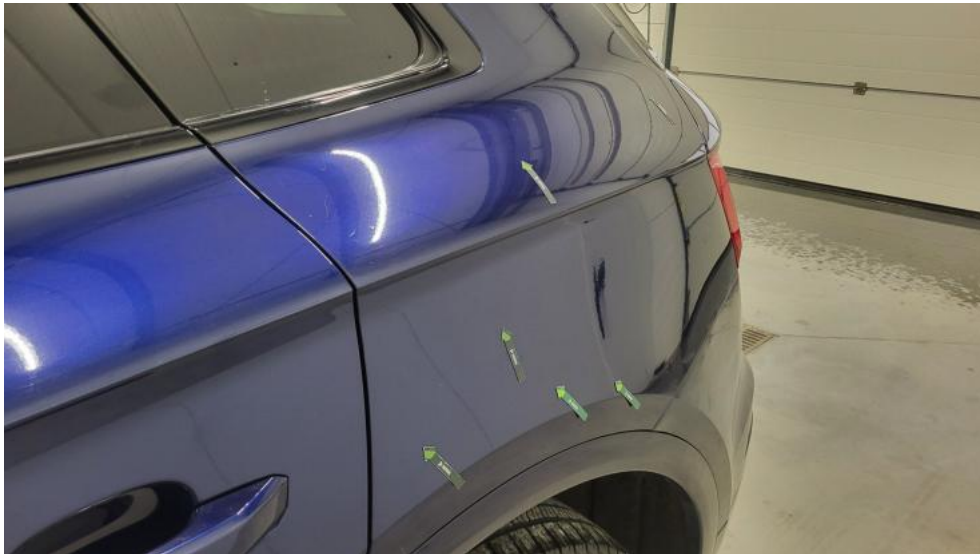
**Photo 57.**

Błotnik tylny L / Ściana boczna L - zdjęcie poglądowe 1

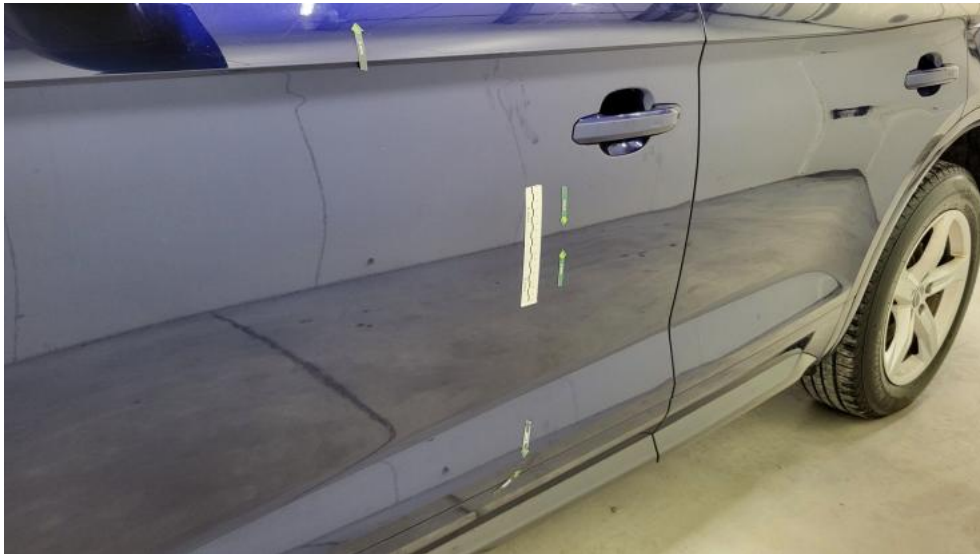
**Photo 61.**

Drzwi przed L - zdjęcie poglądowe 1

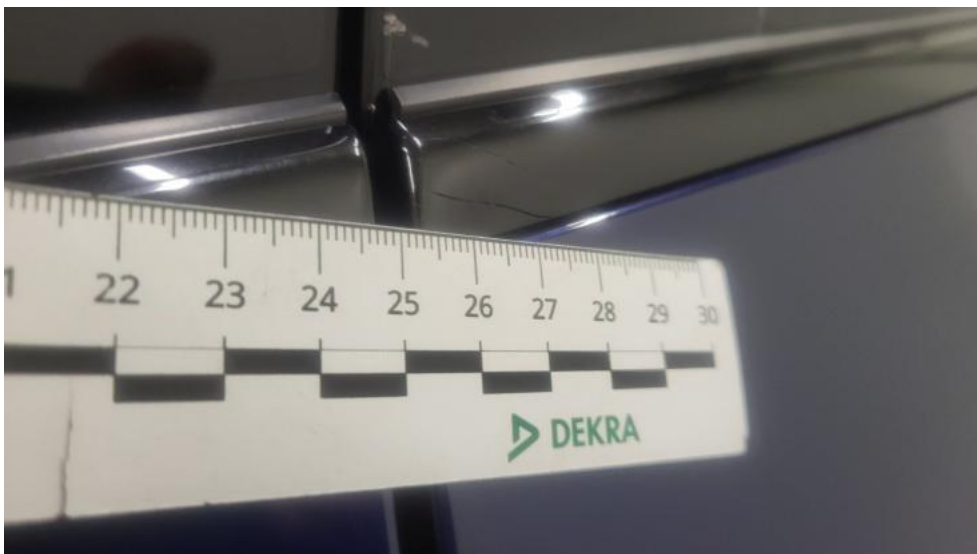
**Photo 69.**

Listwa drzwi tylnych L - Rysa/odprysk 1

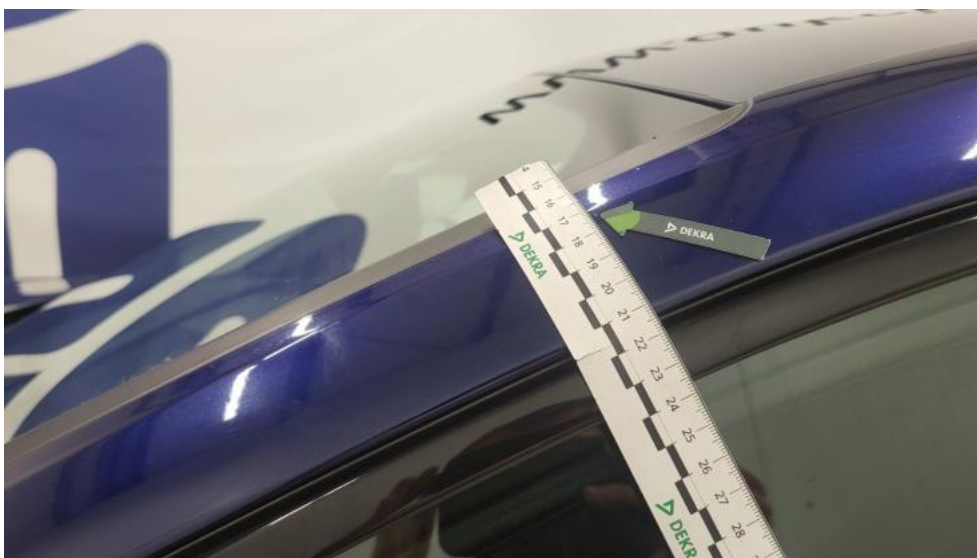
**Photo 70.**

Słupek przedni L - zdjęcie poglądowe 1
