DEKRA's commission No. : PKOL(W)/LODZ/84131/24/10/30
 commission/ damage No. : 00472/LF/23
 Date of commission: 30-10-2024

Vehicle data

Measurement of thickness of the vehicle lacquer coating

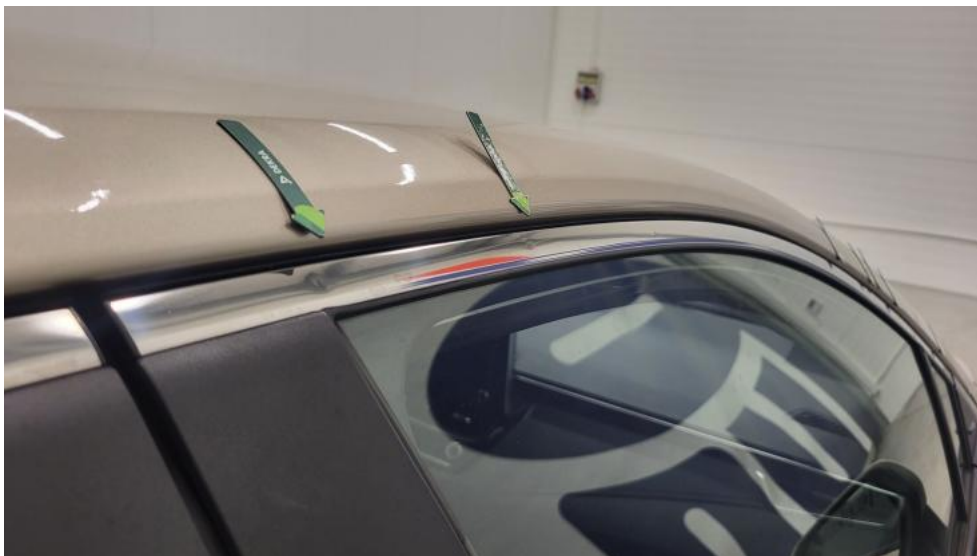
Photo 47.

Drzwi przednie P - Wgniecenie/odkształcenie 2

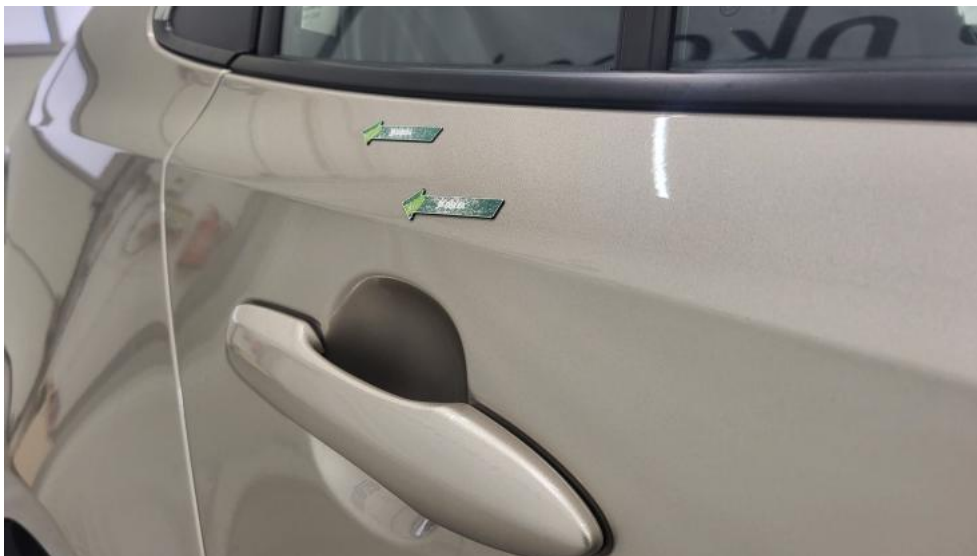
Photo 53.

Drzwi tylne P() - Wgniecenie/odkształcenie 3

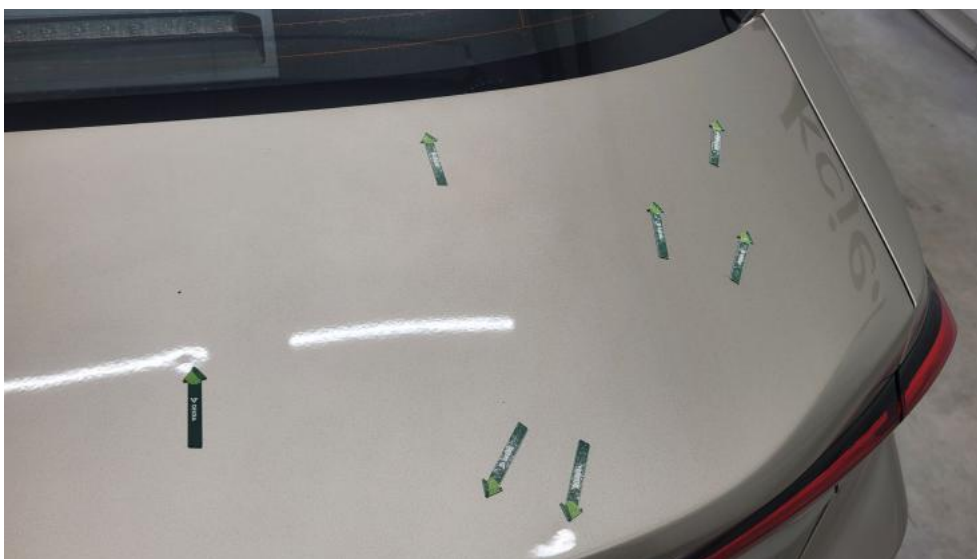
Photo 59.

Pokrywy bagażnika - zdjęcie poglądowe 1

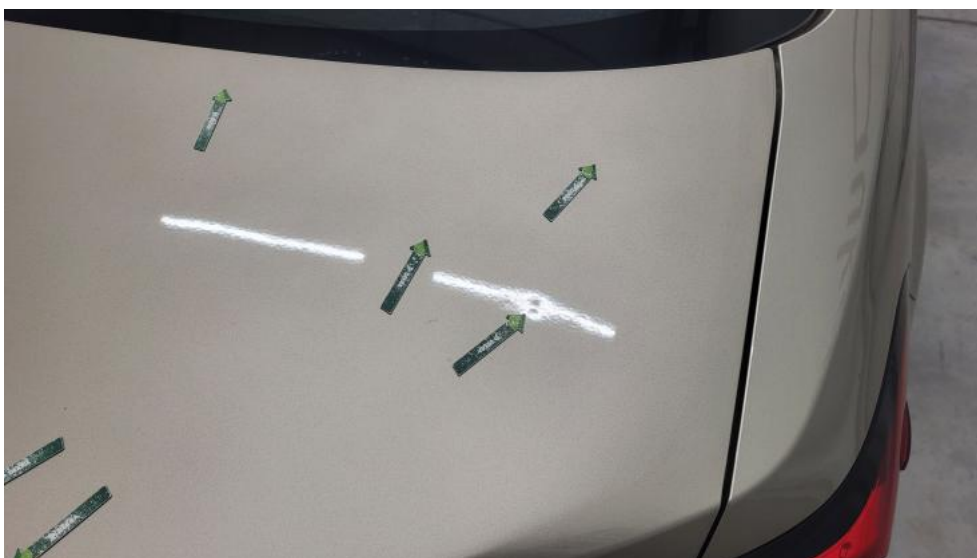
Photo 60.

Pokrywy bagażnika - zdjęcie poglądowe 2

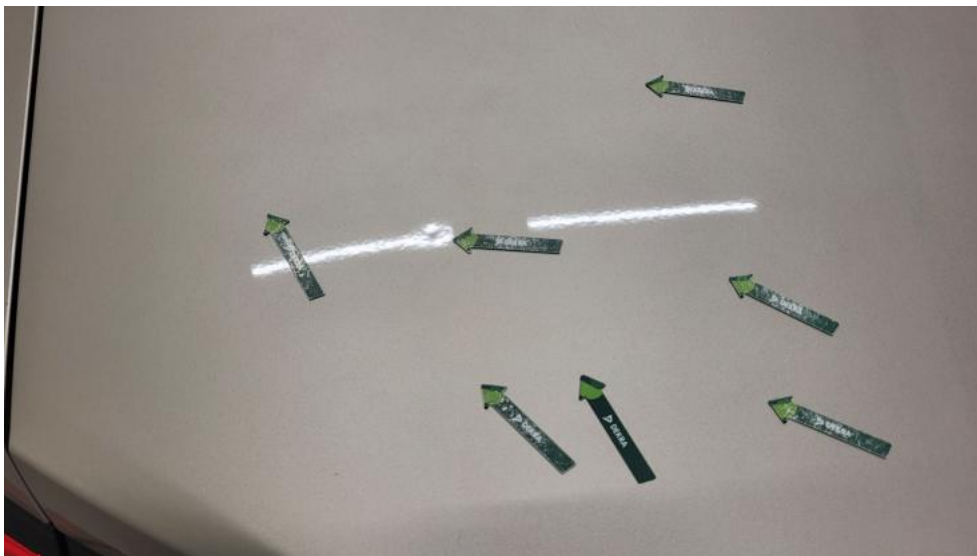
Photo 63.
Pokrywy bagażnika() - Wgniecenie/odkształcenie 3

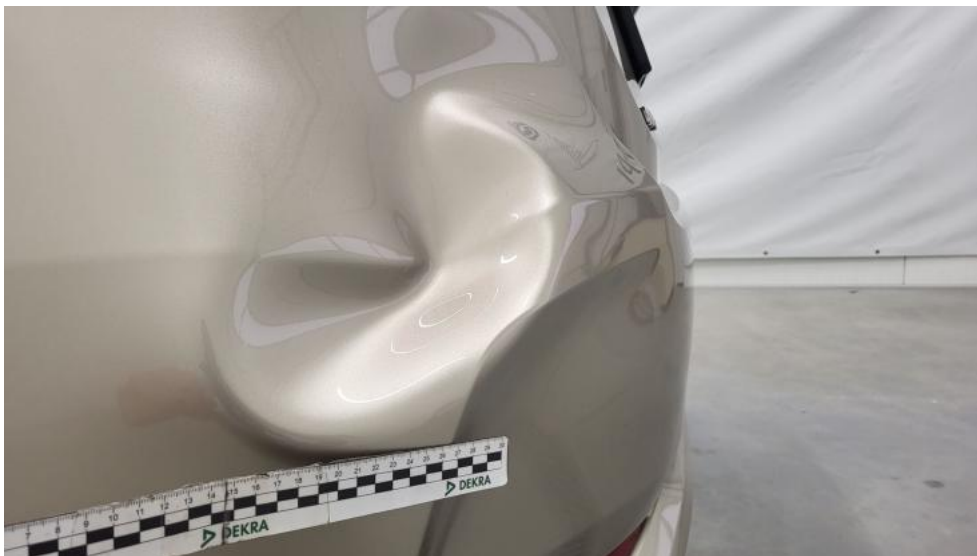
Photo 65.
Zderzak tylny - Wgniecenie/odkształcenie 1

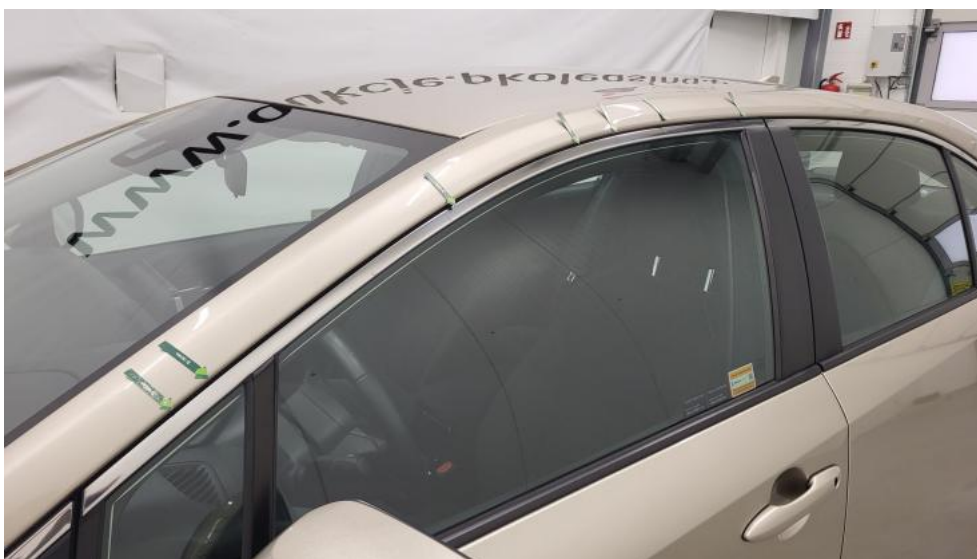
Photo 75.

Drzwi przed L - zdjęcie poglądowe 1
