DEKRA's commission No. : PKOL(W)/LODZ/74711/24/09/27
commission/ damage No. : 22/025248
Date of commission: 27-09-2024

Vehicle data

Measurement of thickness of the vehicle lacquer coating

PHOTOGRAPHIC DOCUMENTATION

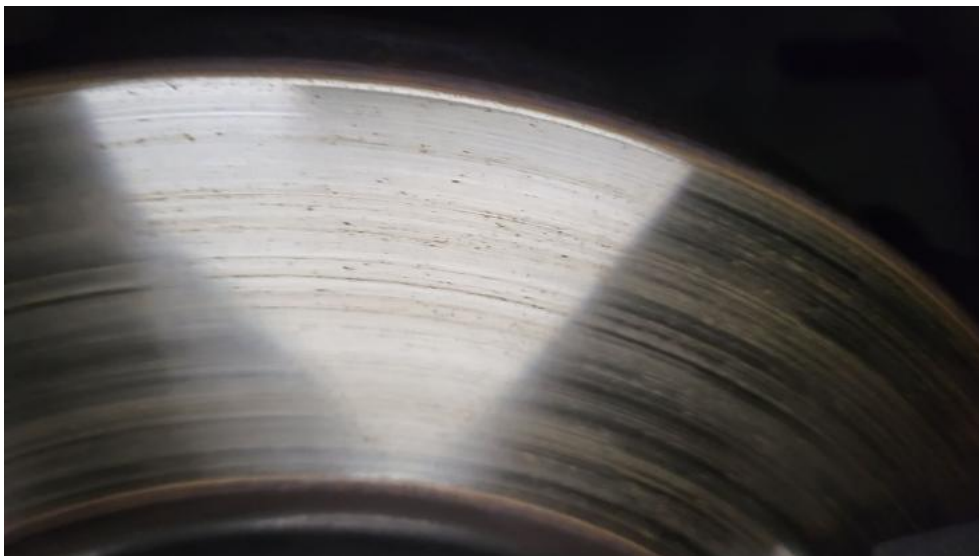
Photo 15.

Tarcza hamulcowa przednia prawa

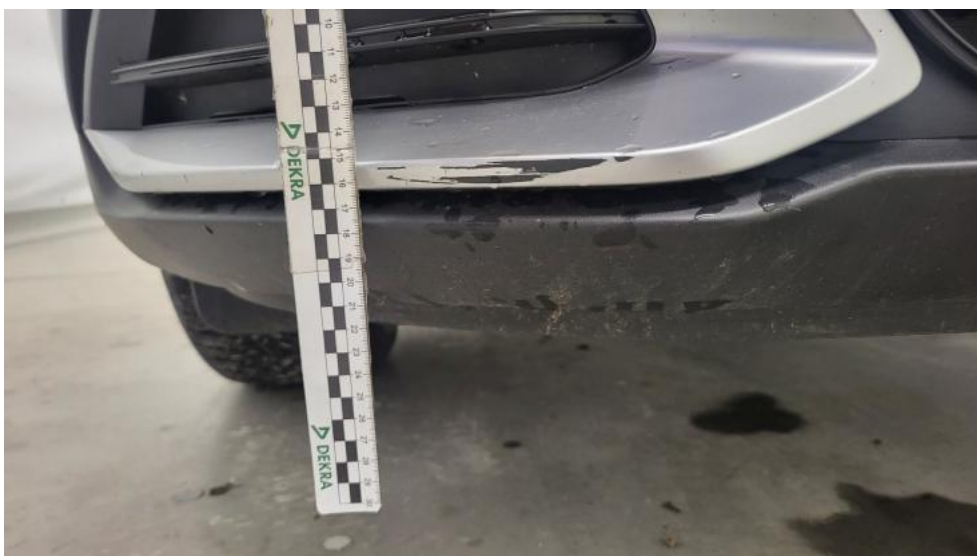
Photo 36.
Zderzak - zdjęcie poglądowe 1

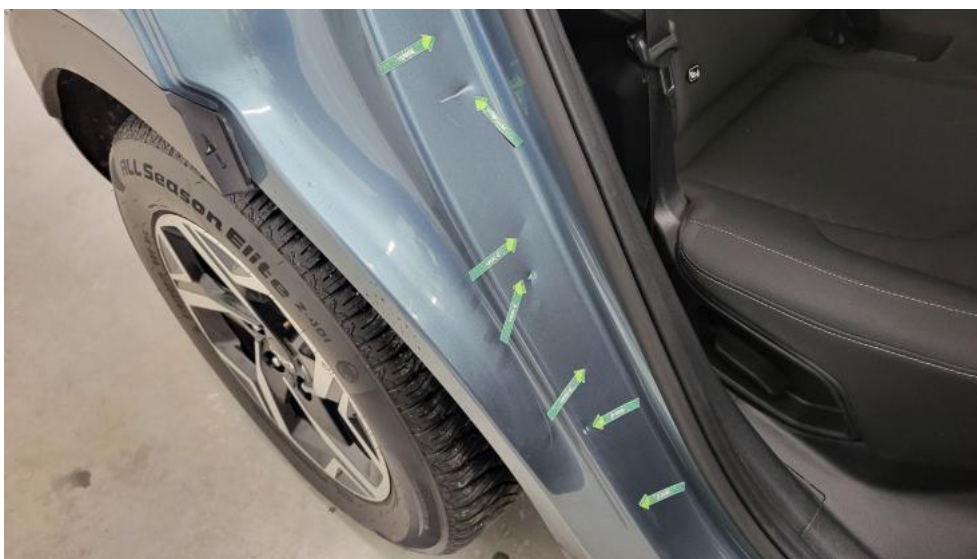
Photo 45.
Błotnik tylny P / Ściana boczna P - zdjęcie poglądowe 1

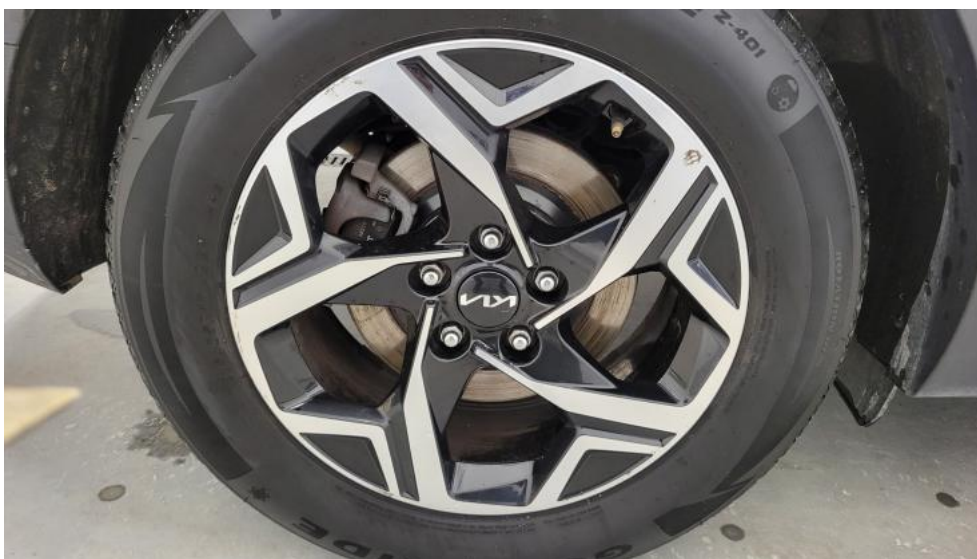
Photo 51.
Felga aluminiowa tylna P - zdjęcie poglądowe 1

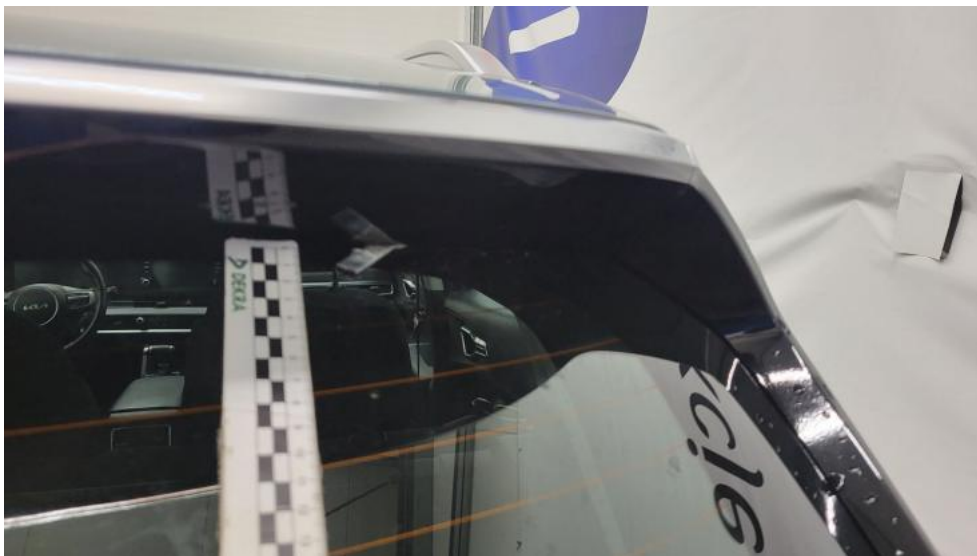
Photo 53.

Pokrywy bagażnika - zdjęcie poglądowe 1

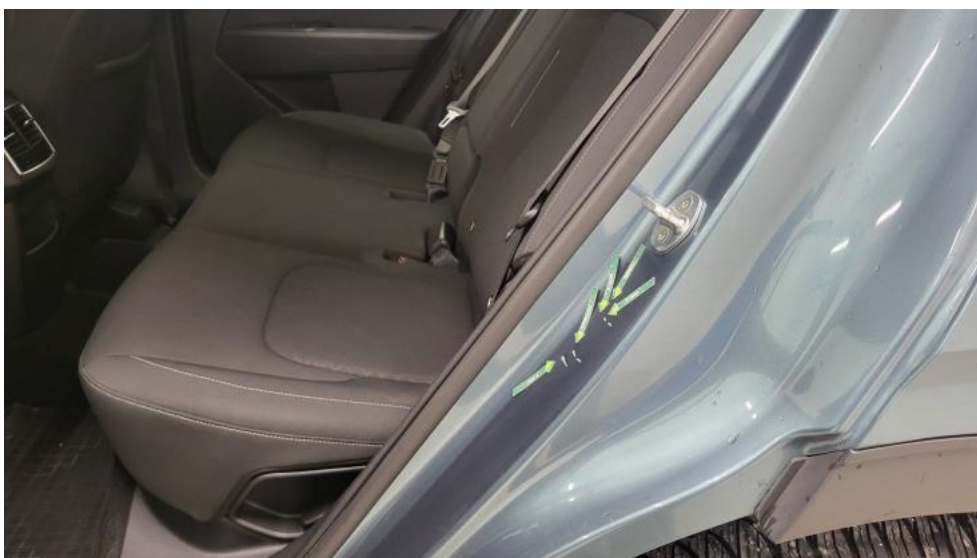
Photo 58.
Błotnik tylny L / Ściana boczna L - zdjęcie pogładowe 1
