DEKRA's commission No. : PKOL(W)/LODZ/02576/25/01/13
commission/ damage No. : PS21/04310
Date of commission: 13-01-2025

Vehicle data

Measurement of thickness of the vehicle lacquer coating

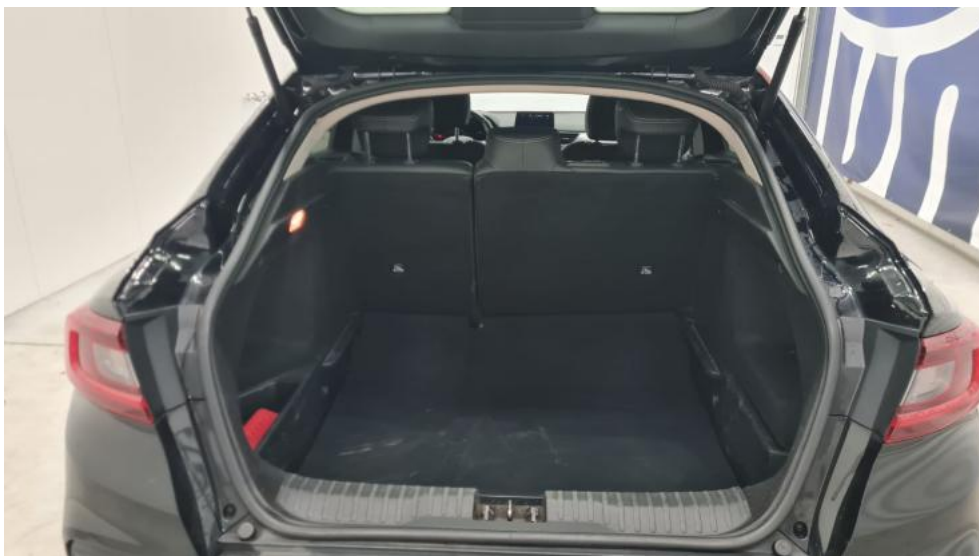
Brak półki bagażnika. Rysy, odpryski i wgniecenia na samochodzie. Rzeczoznawca dokonał oględzin pojazdu w warunkach parkingowych, co mogło ograniczyć pełną ocenę jego stanu technicznego. Dodatkowo, jeżeli jazda próbna została przeprowadzona (informacje w treści raportu), to wykonano ją w warunkach parkingowych, z niewielką prędkością, co może nie odzwierciedlać pełnych warunków eksploatacyjnych. Istnieje możliwość, że w innych okolicznościach ujawnią się dodatkowe uszkodzenia lub usterki, których nie można było wykryć podczas obecnych oględzin.

Photo 19.
Bagażnik

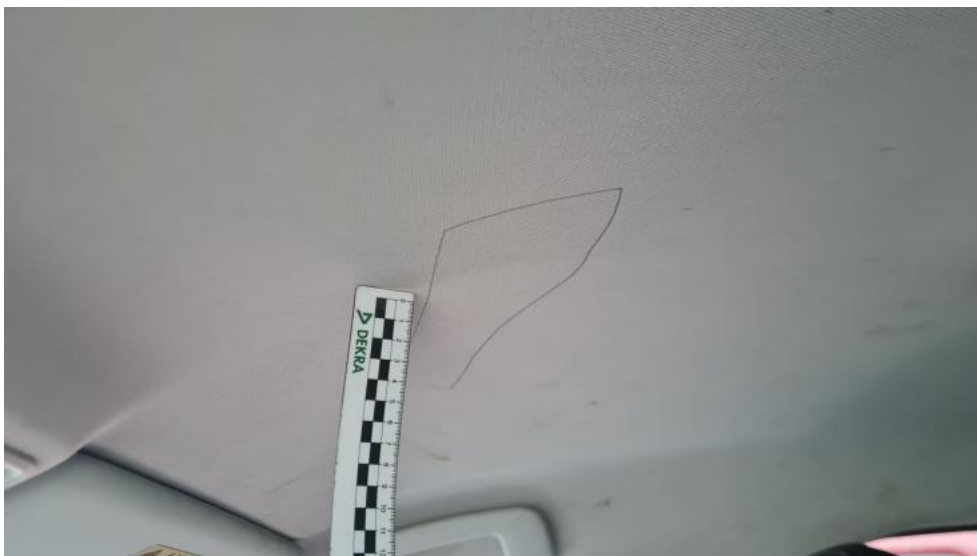
Photo 75.
Podsufitka - Inne 1
