DEKRA's commission No. : PKOL(W)/LODZ/24306/25/04/02  
commission/ damage No. : 22/014581  
Date of commission: 02-04-2025

**Vehicle data**

| Manufacturer | AUDI |
| Type / version | SQ7 4.0 TDI Quattro Tiptr. |

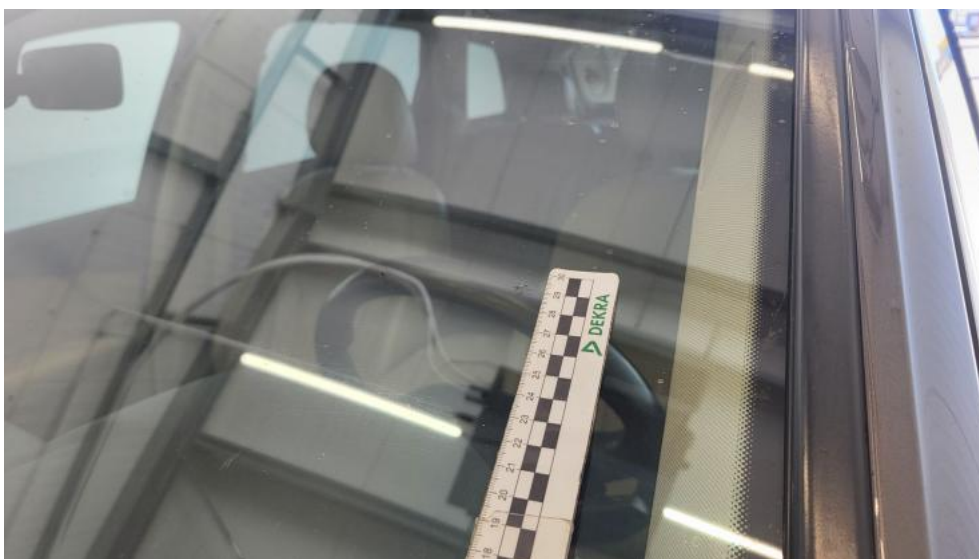
**Photo 43.**

Szyba czołowa - zdjęcie pogładowe 1

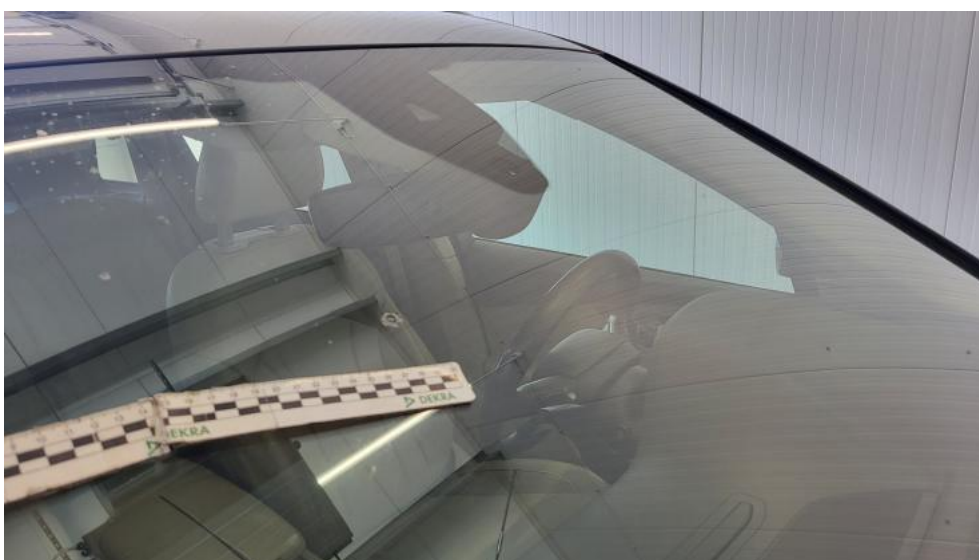
**Photo 44.**

Szyba czołowa - zdjęcie pogładowe 2

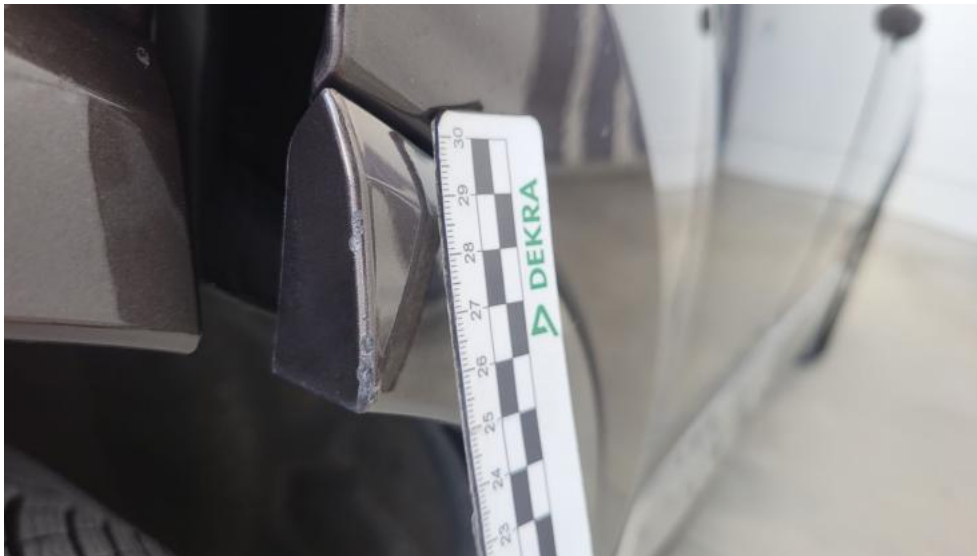
**Photo 57.**

Listwa drzwi tylnych P - Rysa/odprysk 1

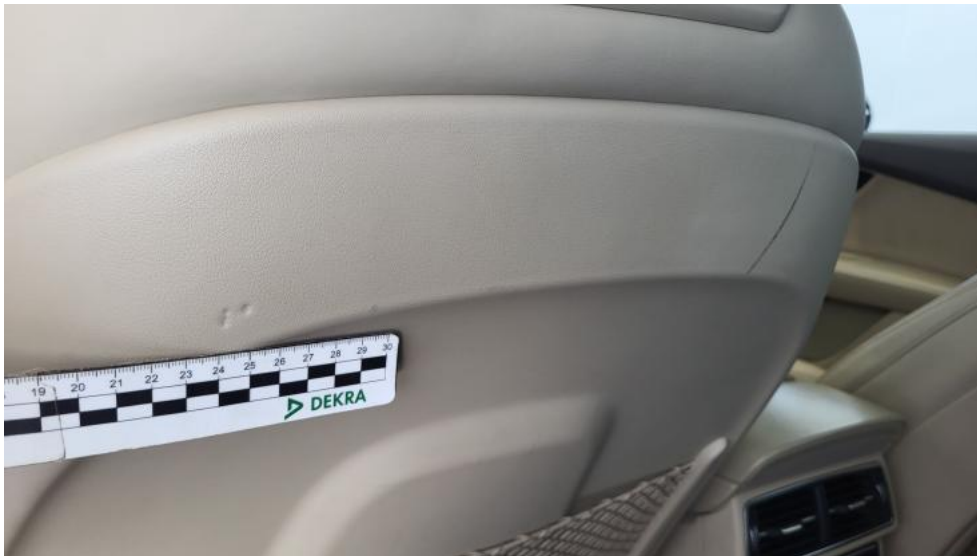
**Photo 75.**

Fotel prz. lew. - Wgniecenie/odkształcenie 1

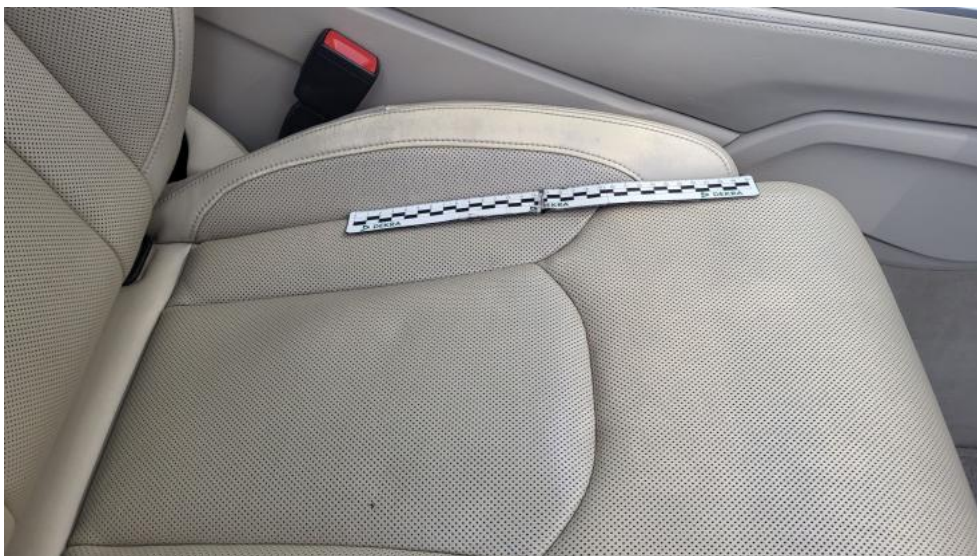
**Photo 76.**

Fotel prz. lew. - Inne 1

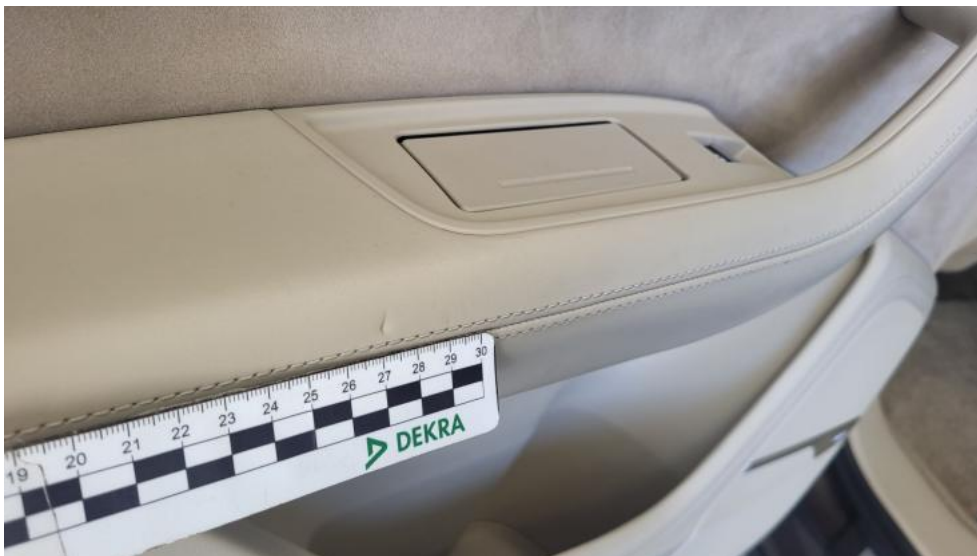
**Photo 81.**

Tapicerka drzwi tylnych L - Wgniecenie/odkształcenie 1
