DEKRA's commission No. : PKOL(W)/LODZ/19999/25/03/19
commission/ damage No. : 21/023301
Date of commission: 19-03-2025

Group of objects (Eurotax)	jeeps
EC code (Eurotax)	0131131
Manufacturer	JAGUAR
Model	I-Pace 18-23
Type / version	I-Pace EV400 AWD HSE
Body type	KOM
Number of doors / seats	5/5
Curb weight [kg]	2229
Gross vehicle weight [kg]	2670
Wheelbase 1/2	2990
Engine type	elektryczny
Pollution reduction system	-
Engine capacity [ccm]	0
Engine Power [hp/kW]	400/294
Gearbox	automatic 1- gear
Registration /record No.	DW5HK01
VIN / serial number	SADHA2B16L1F78787
Date of first registration	27-05-2019
Date of next. tech. test	06-03-2026
Year of manufacture	2019 (year has been verified with the manufacturer's base)
Readout [km]	129 930 (read)
Body color / type of coating	black/2-warstwowy metalik

Measurement of thickness of the vehicle lacquer coating

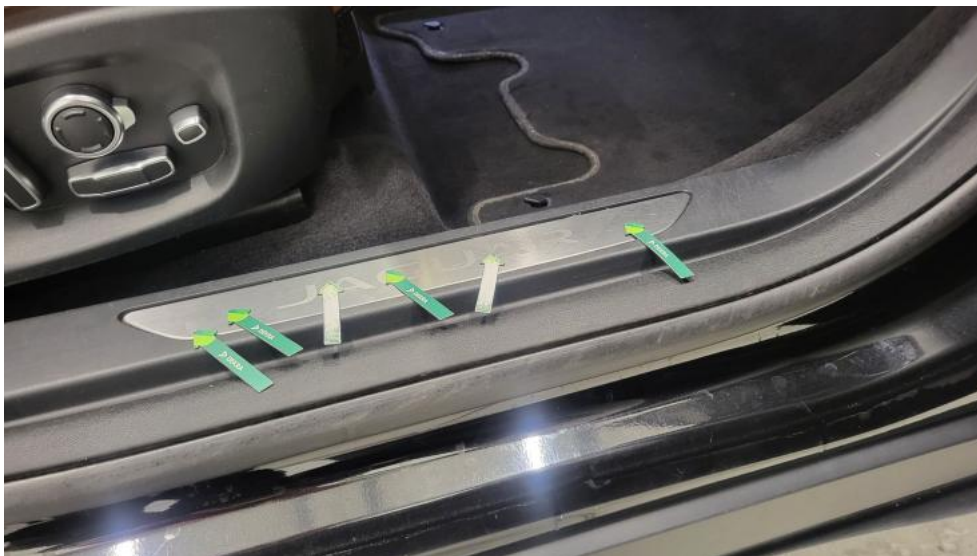
Photo 73.

Listwy progowe praw. - Wgniecenie/odkształcenie 1
