DEKRA's commission No. : PKOL(W)/LODZ/92996/25/11/28  
commission/ damage No. : 22/033482  
Date of commission: 28-11-2025

| Manufacturer | BMW |
| Model | X6 [F16/F86] 14-19 |
| VIN / serial number | WBAKV610400W37594 |

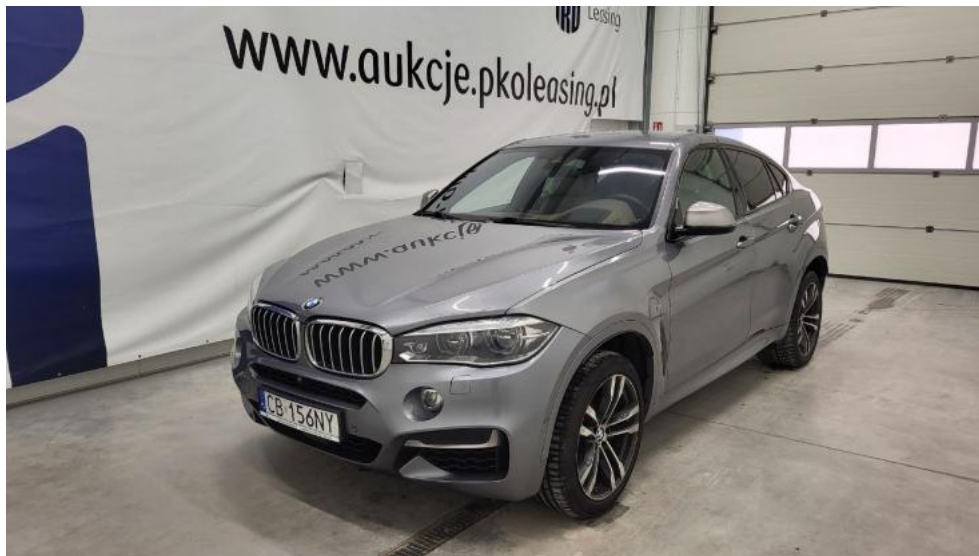
**Photo 1.**

Przekątna przednia lewa

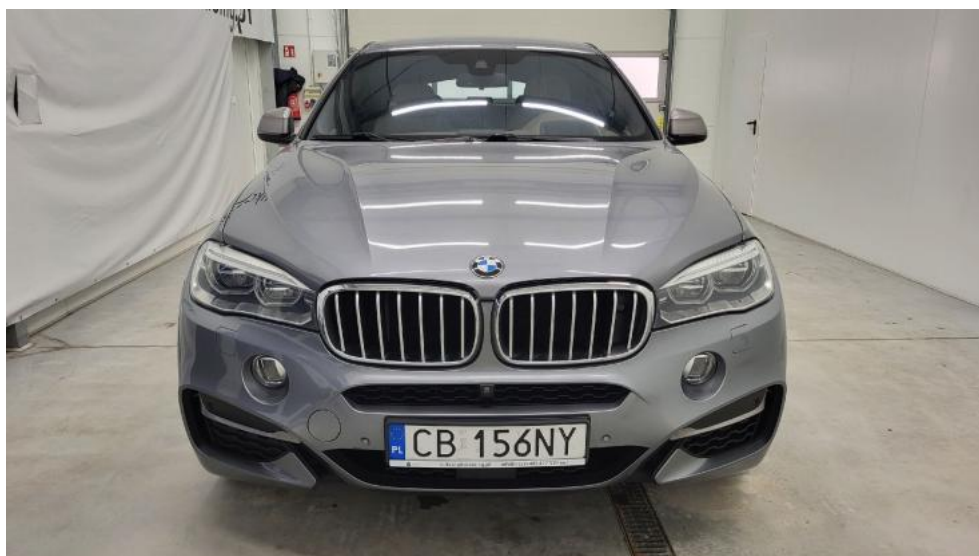
**Photo 2.**

Przód

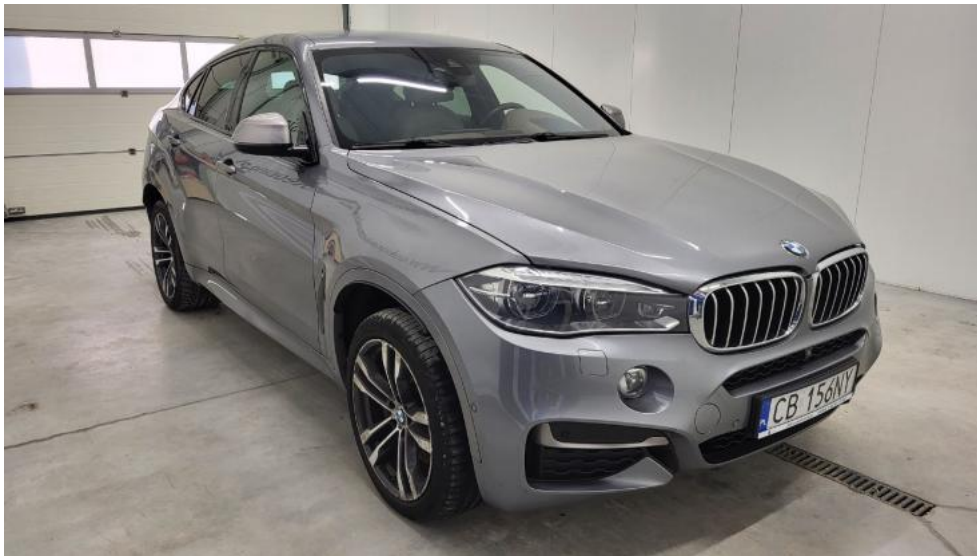
**Photo 3.**

Przekątna przednia prawa

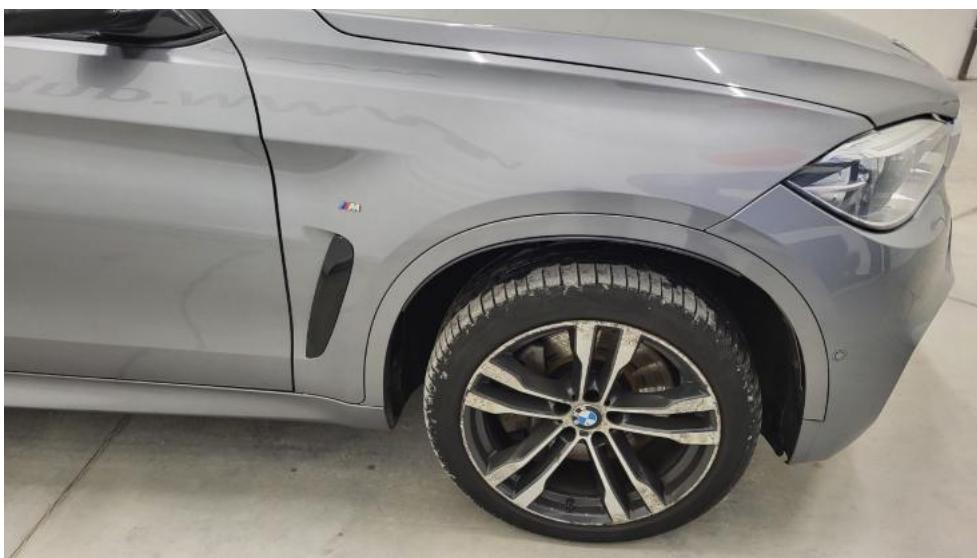
**Photo 4.**

Bok prawy z przodu

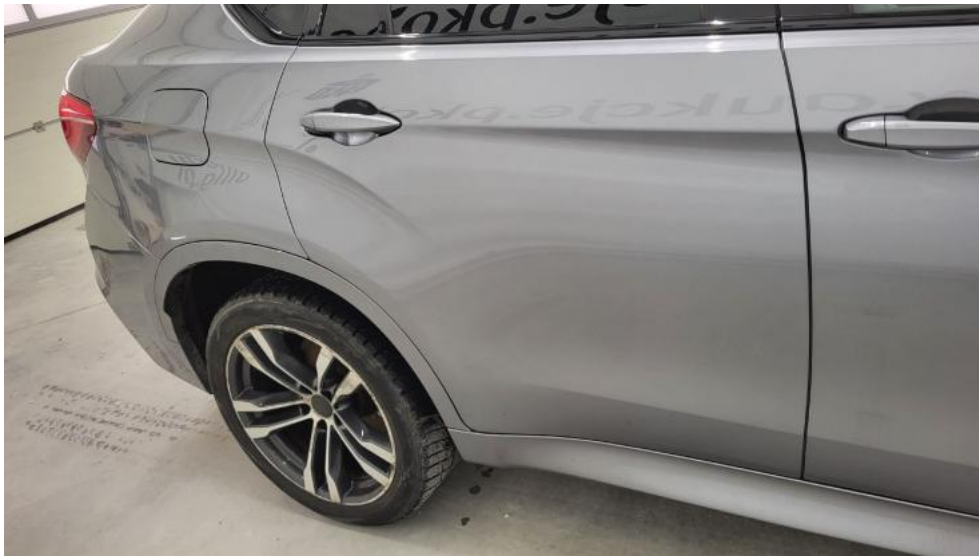
**Photo 5.**  
Bok prawy z tyłu

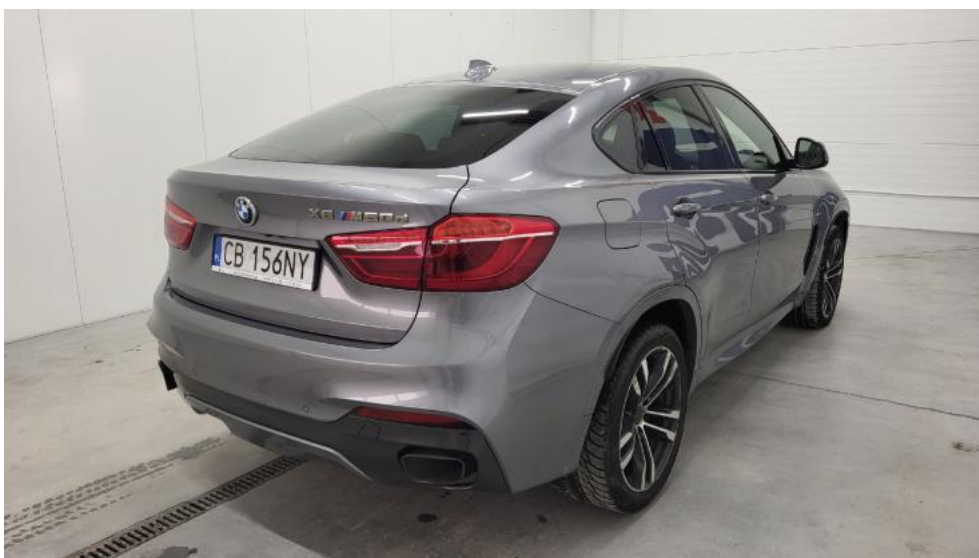
**Photo 6.**  
Przekątna tylna prawa

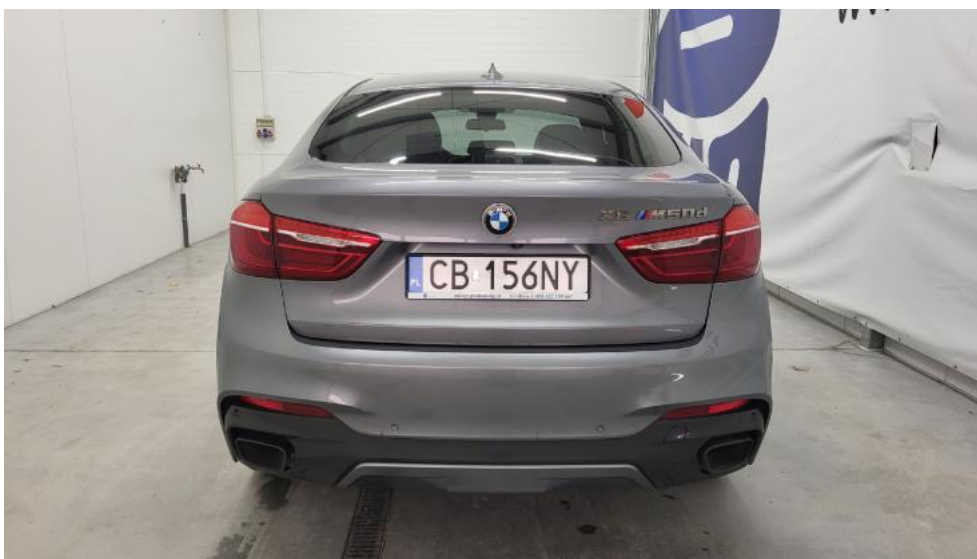
**Photo 7.**

Tył

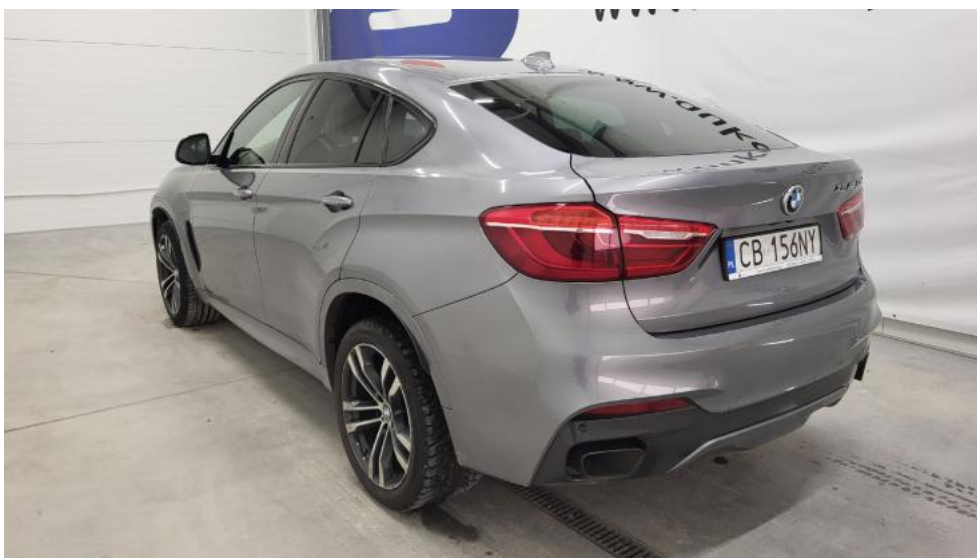
**Photo 8.**

Przekątna tylna lewa

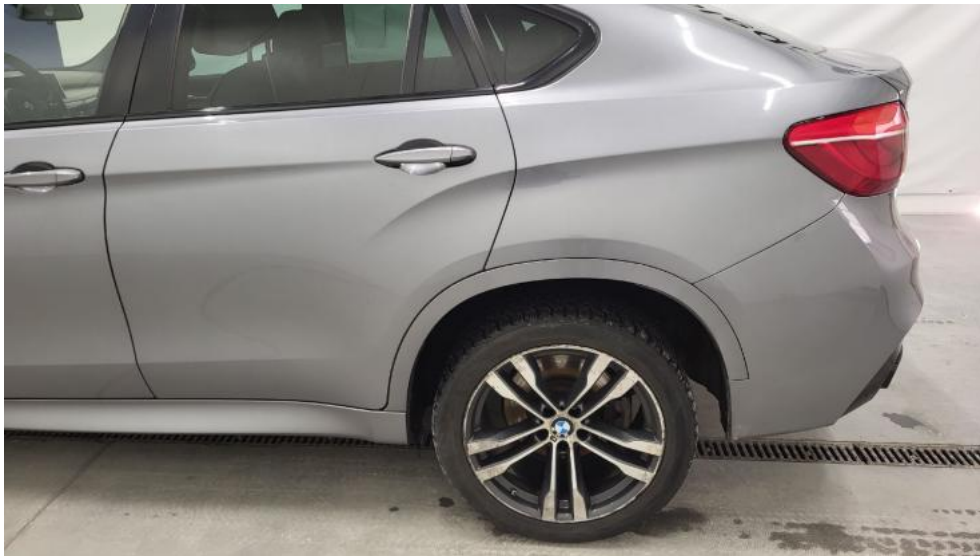
**Photo 9.**

Bok lewy z tyłu

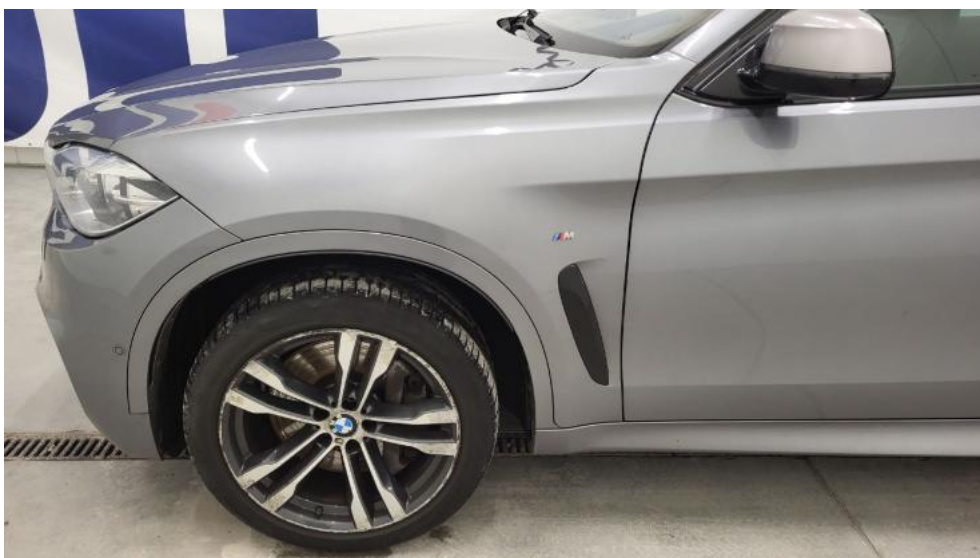
**Photo 10.**

Bok lewy z przodu

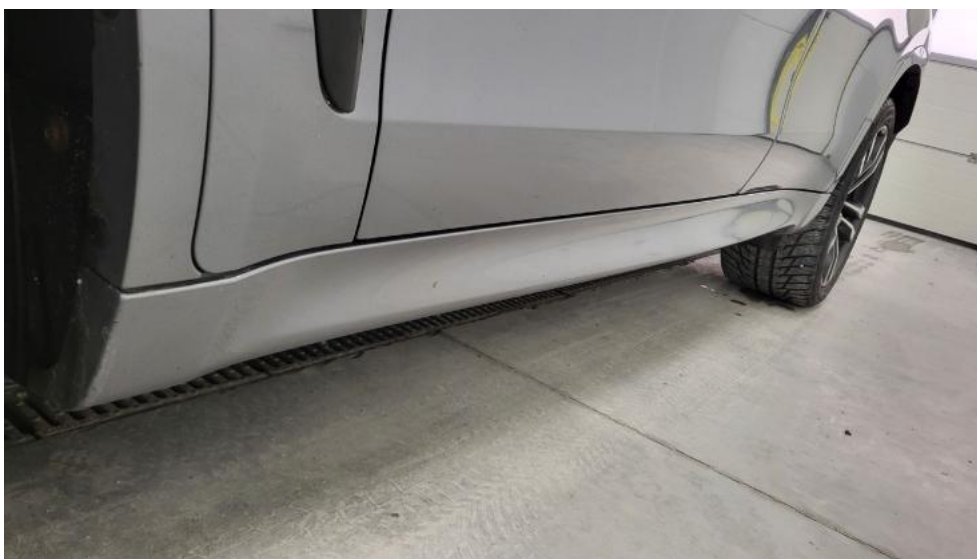
**Photo 11.**  
Próg lewy (widok od przodu)

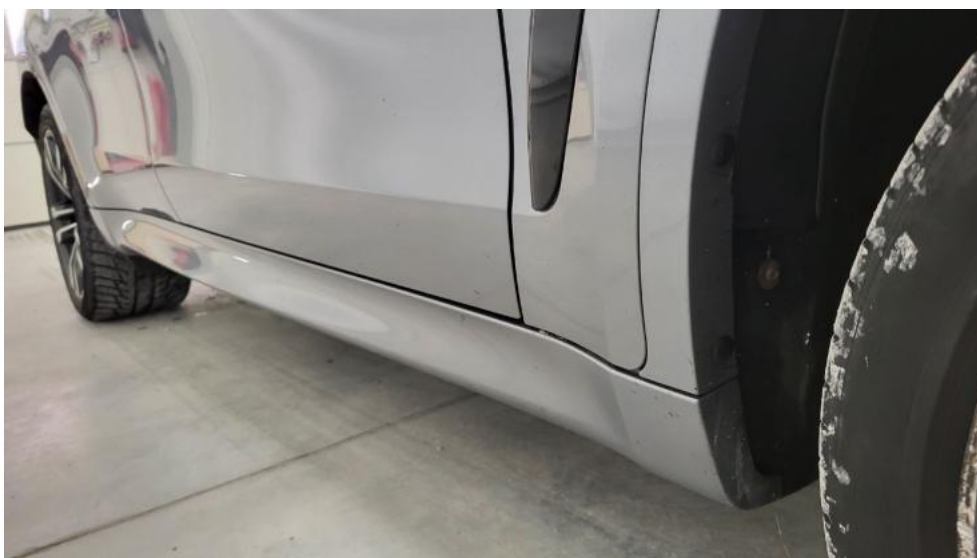
**Photo 12.**  
Próg prawy (widok od przodu)

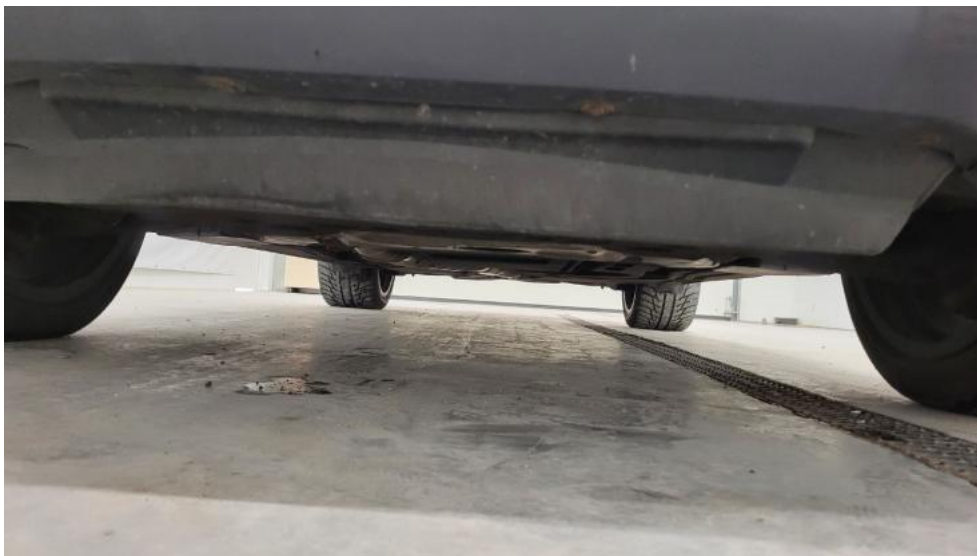
**Photo 13.**  
Spód pojazdu przód

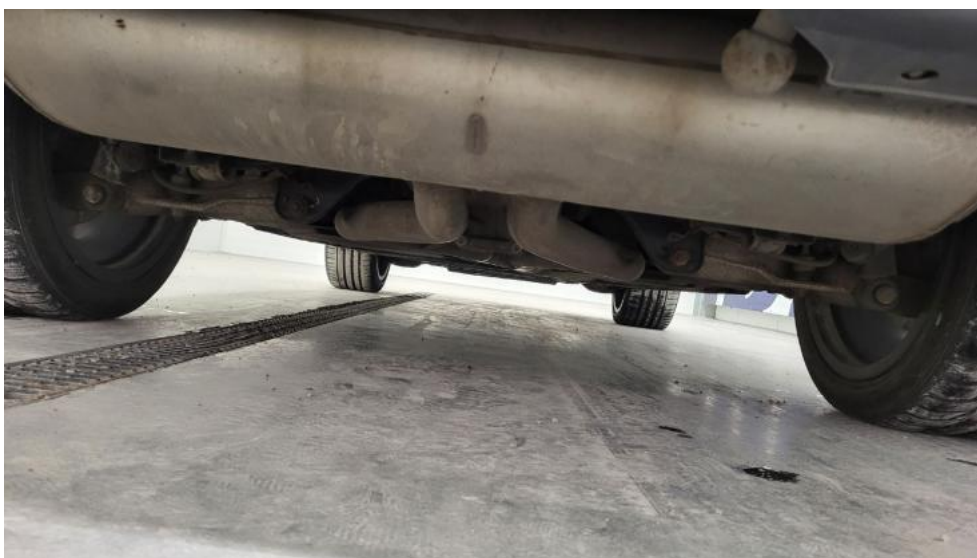
**Photo 14.**  
Spód pojazdu tył

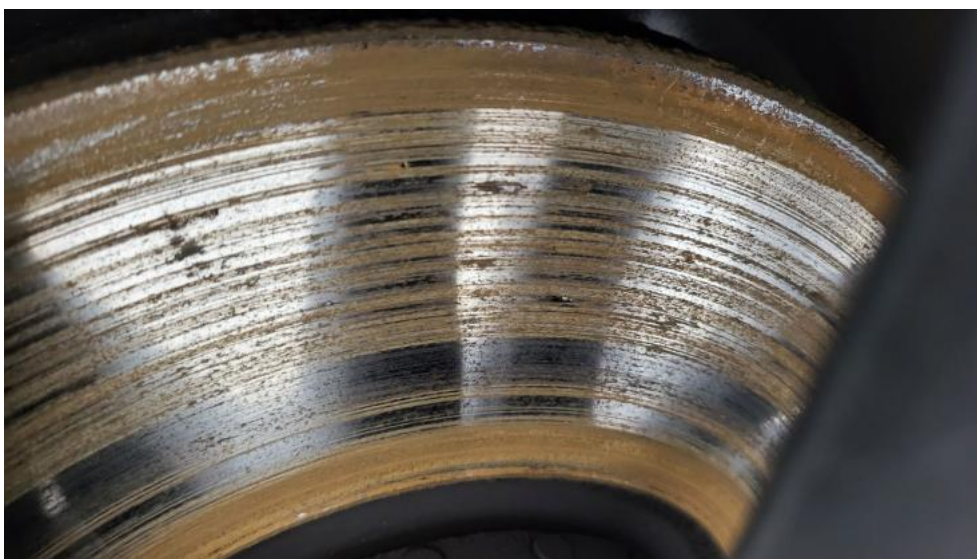
**Photo 15.**

Tarcza hamulcowa przednia prawa

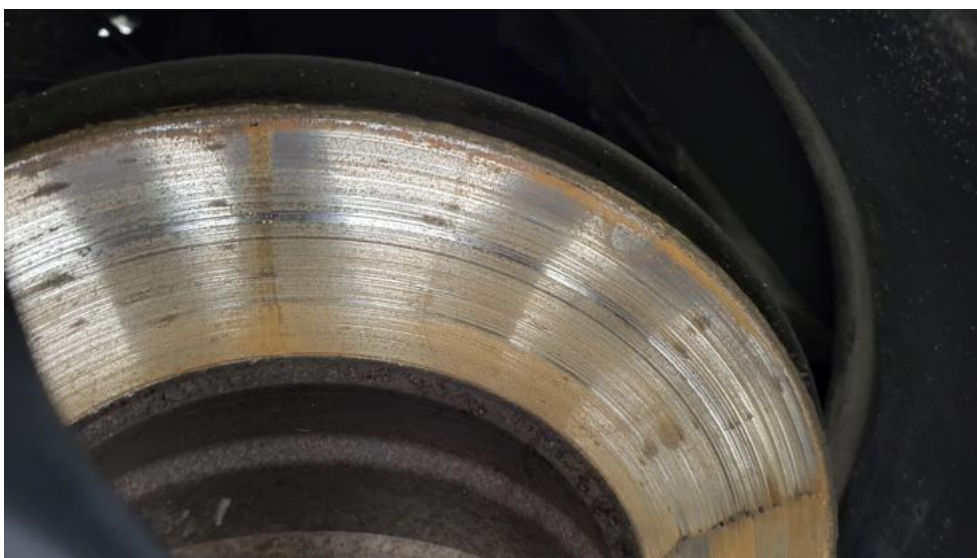
**Photo 16.**

Tarcza hamulcowa tylna prawa

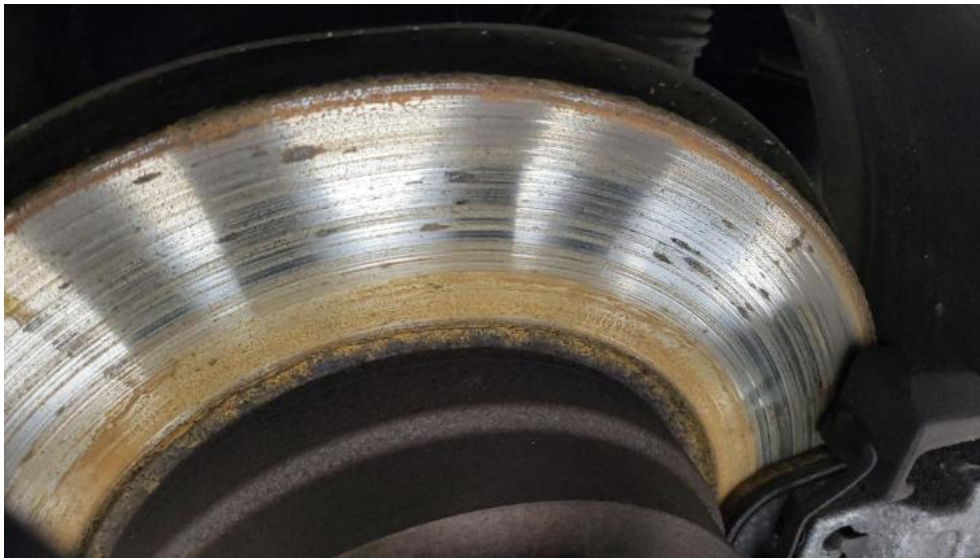
**Photo 17.**

Tarcza hamulcowa tylna lewa

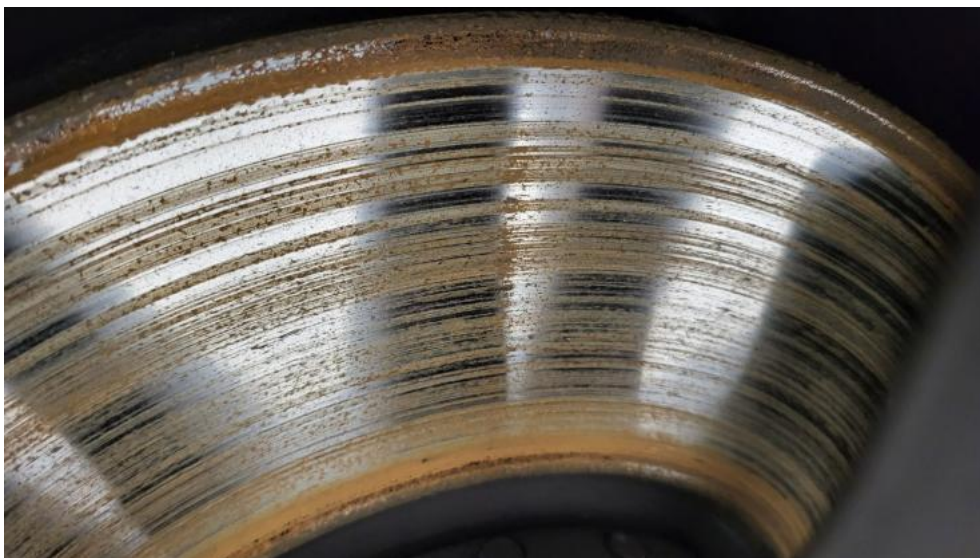
**Photo 18.**

Tarcza hamulcowa przednia lewa

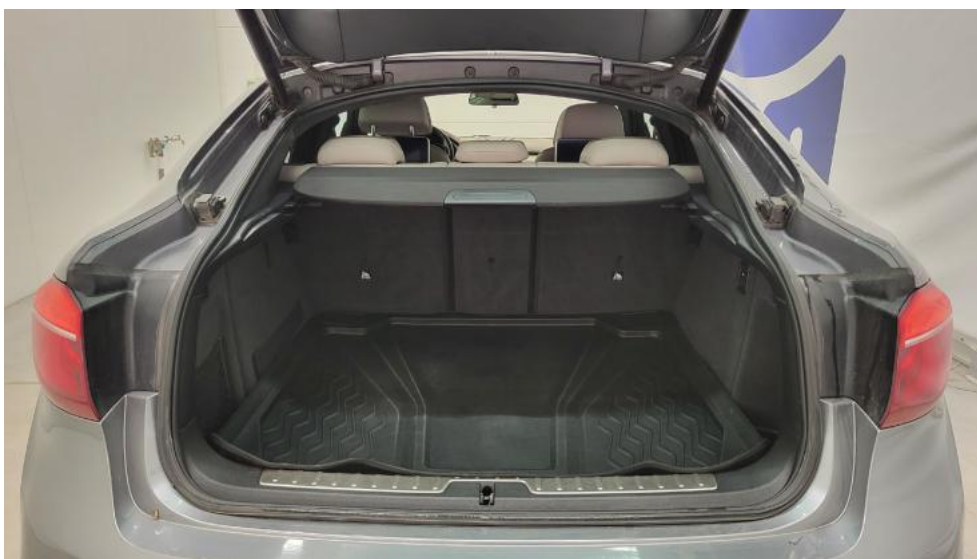
**Photo 19.**  
Bagażnik

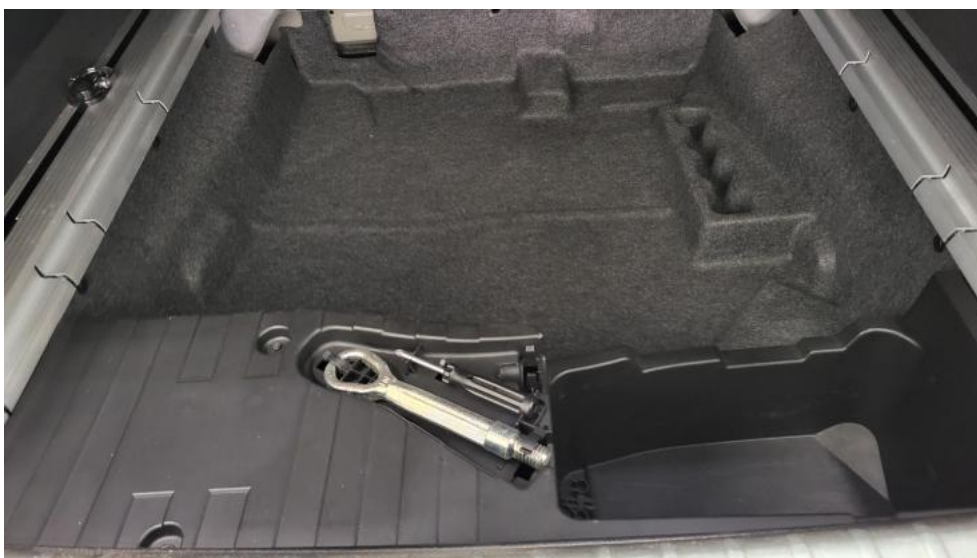
**Photo 20.**  
Koło zapasowe

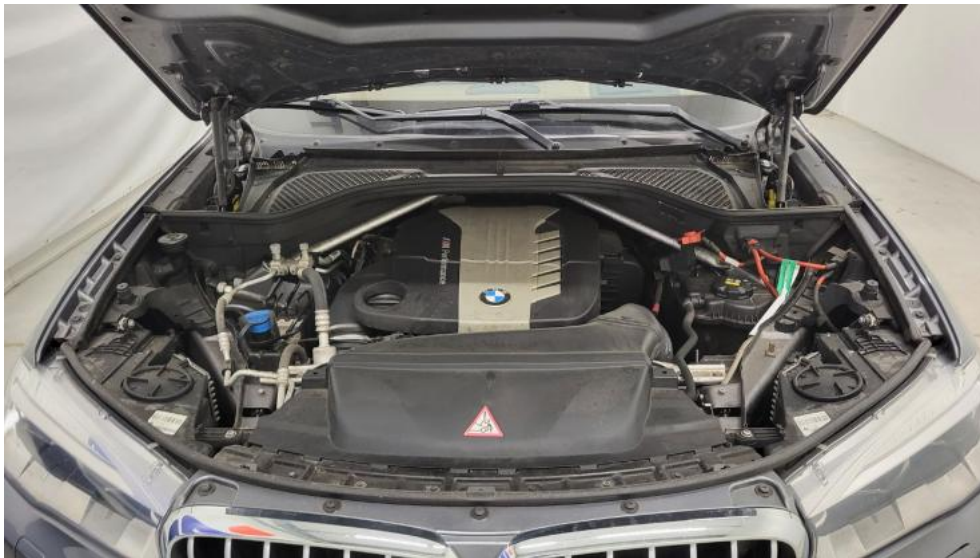
**Photo 21.**  
Komora silnika

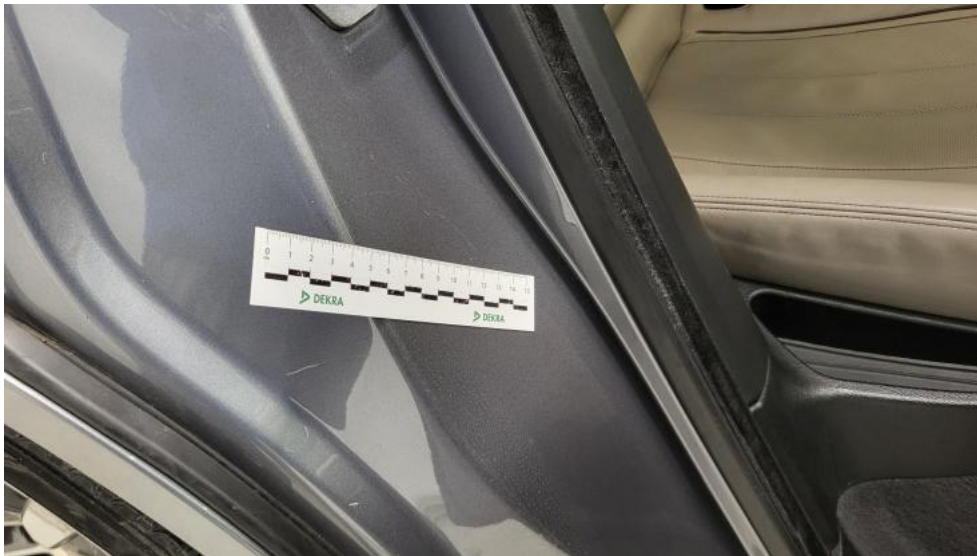
**Photo 55.**

Błotnik tylny P / Ściana boczna P - Rysa/odprysk 1

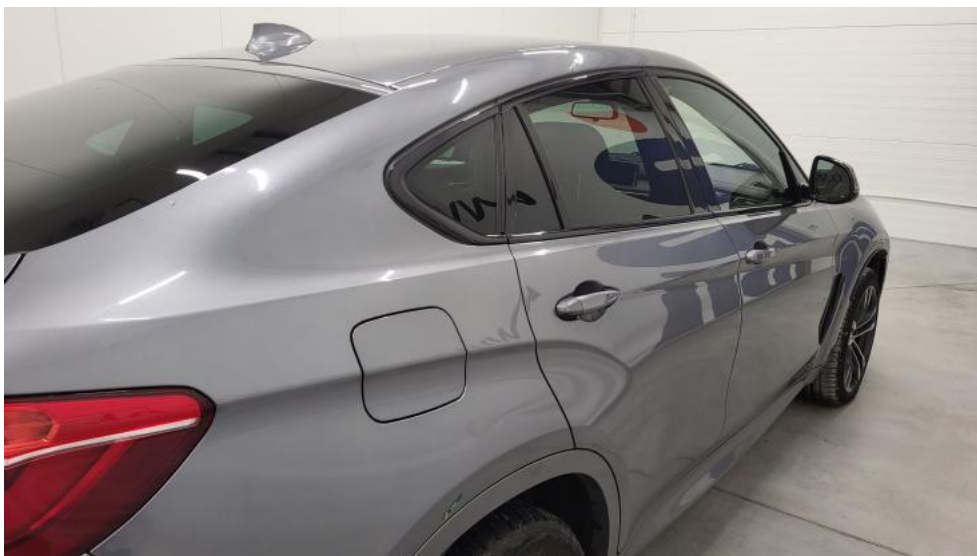
**Photo 56.**

Błotnik tylny P / Ściana boczna P - Wgniecenie/odkształcenie 1

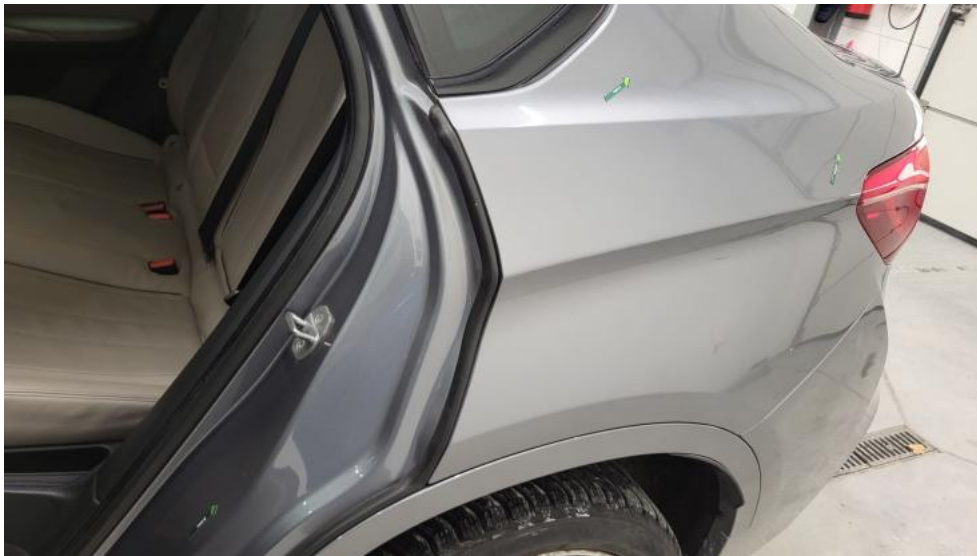
**Photo 65.**

Ścianka tylna L / Ścianka boczna L - Wgniecenie/odkształcenie 1

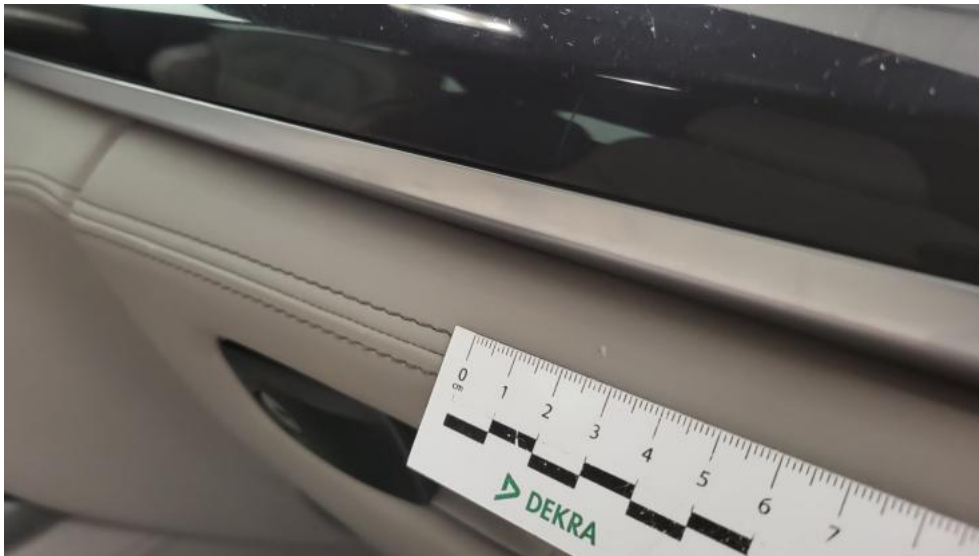
**Photo 77.**

Pokrywa schowka deski rozdzielczej - Rysa/odprysk 1

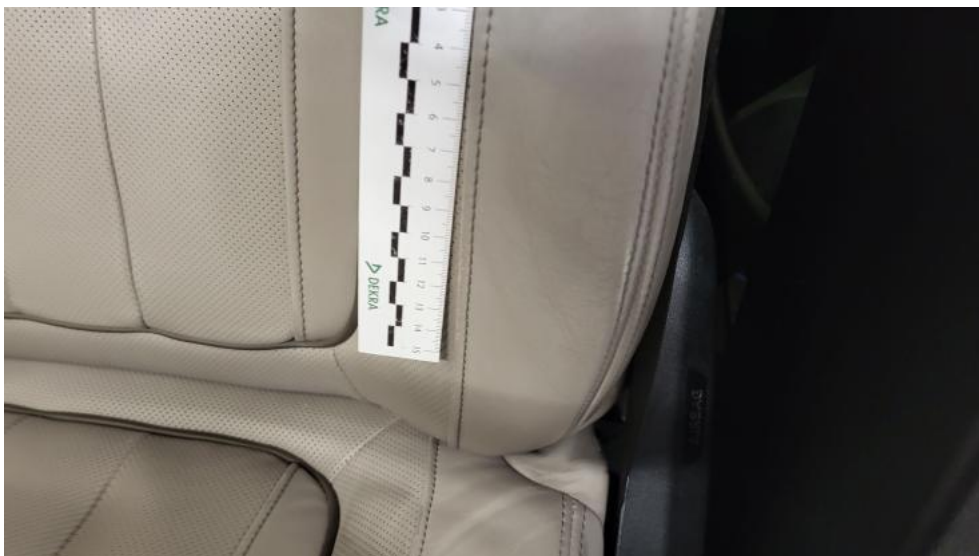
**Photo 78.**

Fotel prz. lewy - Inne 1

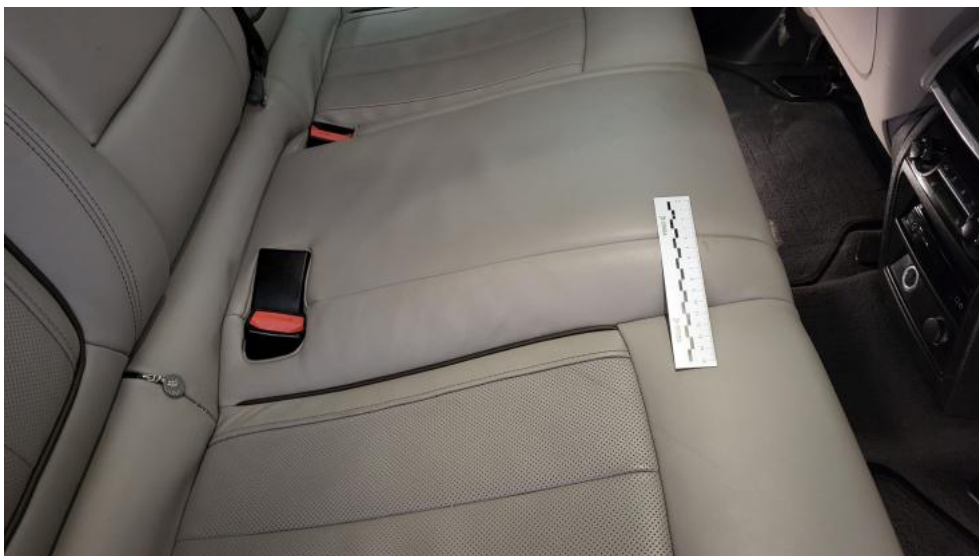
**Photo 80.**

Kanapa tyl. - Inne 1

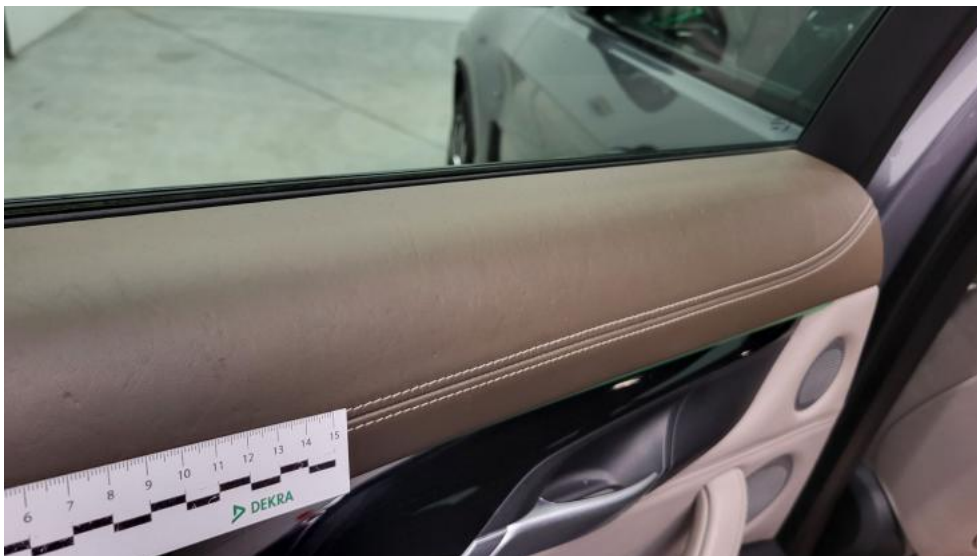
**Photo 81.**

Tapicerka drzwi tylnych L - Wgniecenie/odkształcenie 1

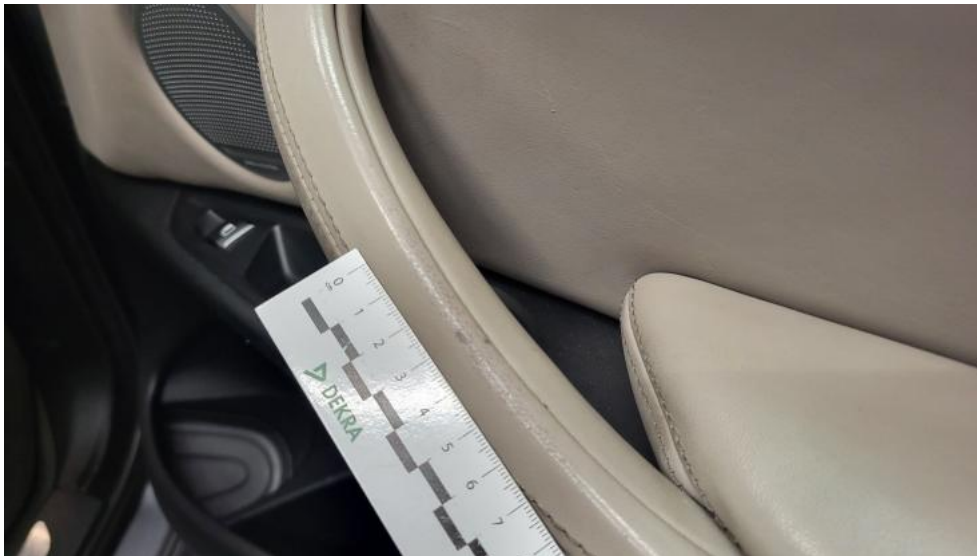
**Photo 83.**

Uchwyt drzwi prze P - Rysa/odprysk 1
