DEKRA's commission No. : PKOL(W)/LODZ/76711/26/08/17  
commission/ damage No. : 25/009788  
Date of commission: 17-08-2026

| Manufacturer | MAZDA |
| Type / version | CX-5 2.5 Skypassion AWD aut |
| Registration /record No. | SK7F425 |

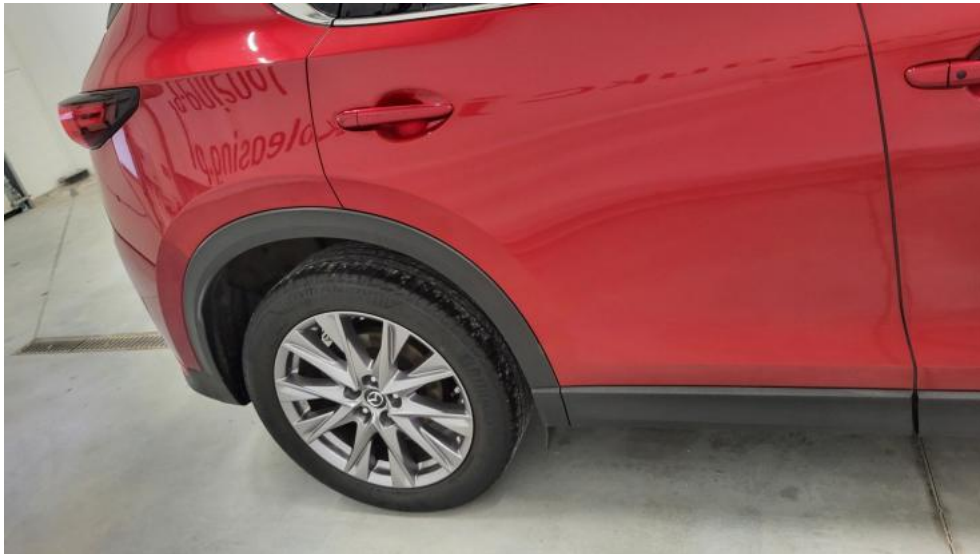
**Photo 5.**  
Bok prawy z tyłu

Drzwi tylne P - Rysa/odprysk 2

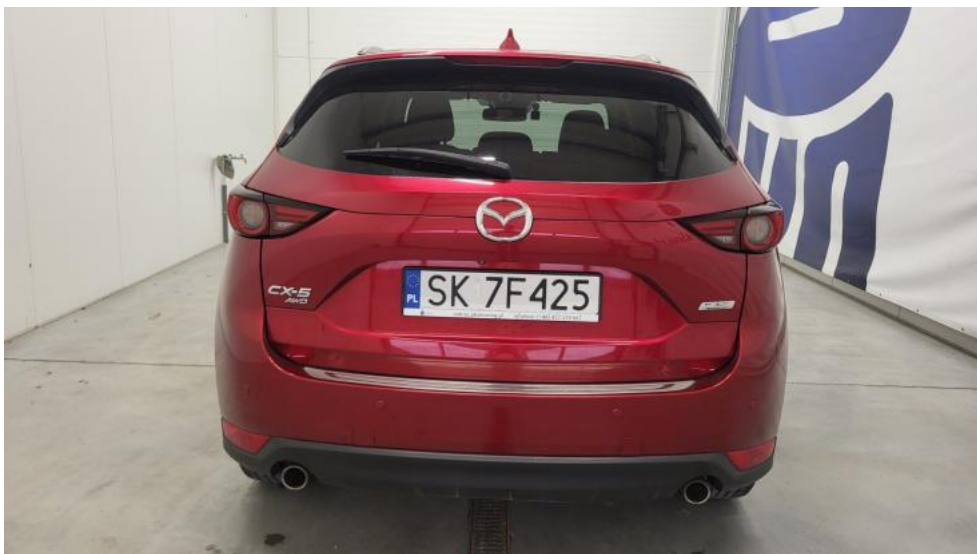
**Photo 7.**

Zderzak tylny - Rysa/odprysk 2

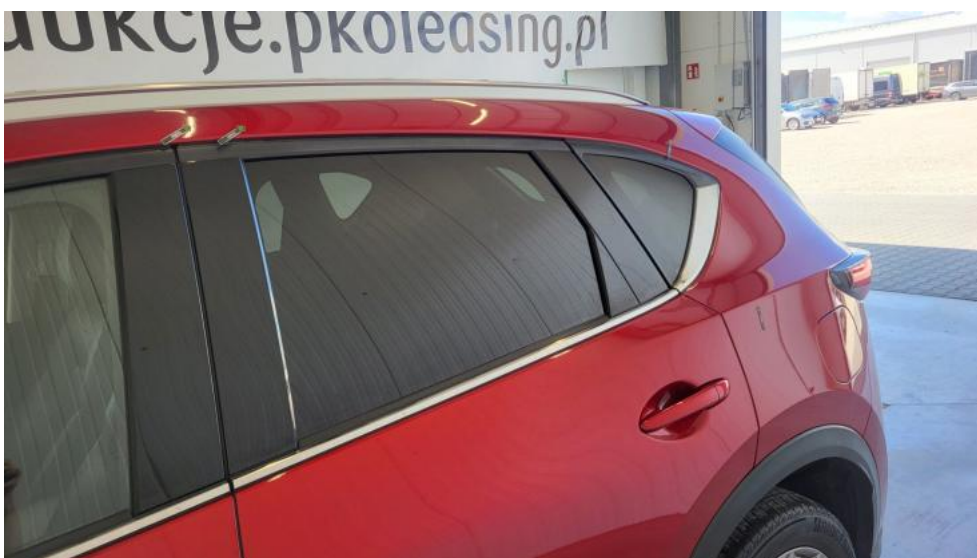
**Photo 54.**

Łotnik tylny L / Ściana boczna L - zdjęcie pogładowe 1

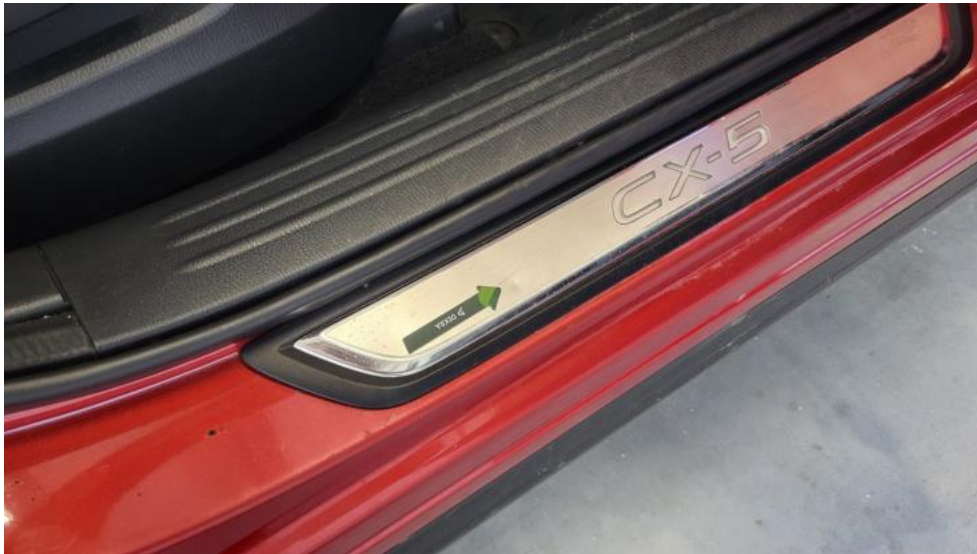
**Photo 69.**

Listwy progowe praw. - Wgniecenie/odkształcenie 1

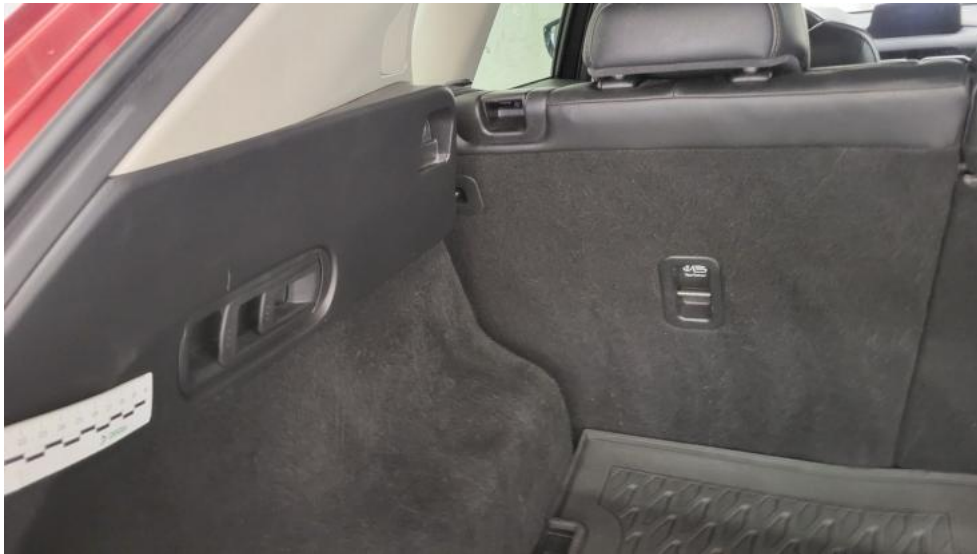
**Photo 71.**

Półka/roleta tylna - Inne 1
