DEKRA's commission No. : PKOL(W)/LODZ/83840/24/10/29
commission/ damage No. : 22/016986
Date of commission: 29-10-2024

Vehicle data

Group of objects (Eurotax)	cars
EC code (Eurotax)	0123825
Manufacturer	BMW
Model	Seria 5 [G30/F90] 16-20
Type / version	520d xDrive M Sport sport-aut
Body type	sedan
Number of doors / seats	4/5
Curb weight [kg]	1620
Gross vehicle weight [kg]	2325
Wheelbase 1/2	2975
Engine type	Automatic ignition
Supercompression	turbocompressor with intercooler
Pollution reduction system	DPF
Emission standard	EURO 6
Engine capacity [ccm]	1995
Engine Power [hp/kW]	190/140
Gearbox	automatic 8- gear
Registration /record No.	SK271XN
VIN / serial number	WBAJC51030WB86900
Date of first registration	15-02-2018
Date of next. tech. test	23-02-2025
Readout [km]	252 425 (read)
Body color / type of coating	black/METALIK

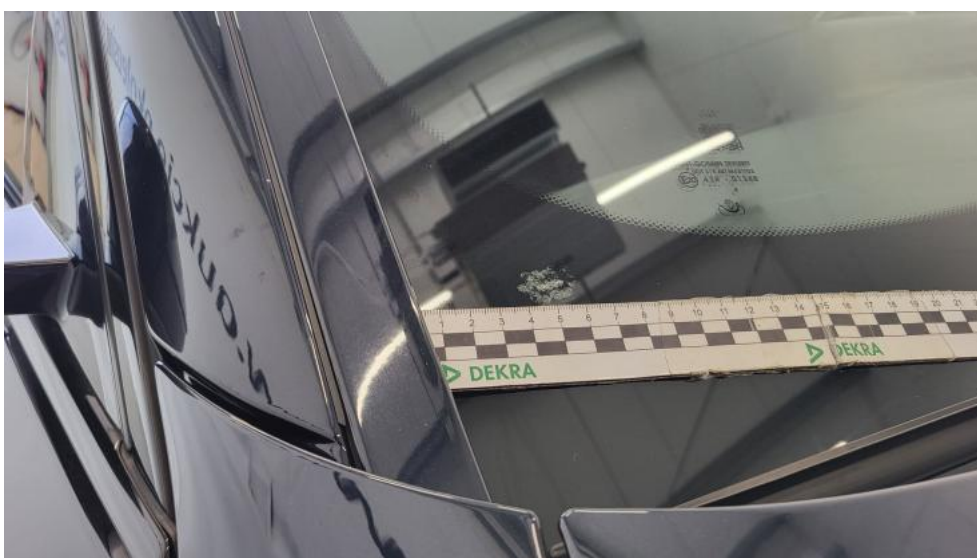
Photo 52.
Szyba czołowa - zdjęcie poglądowe 1

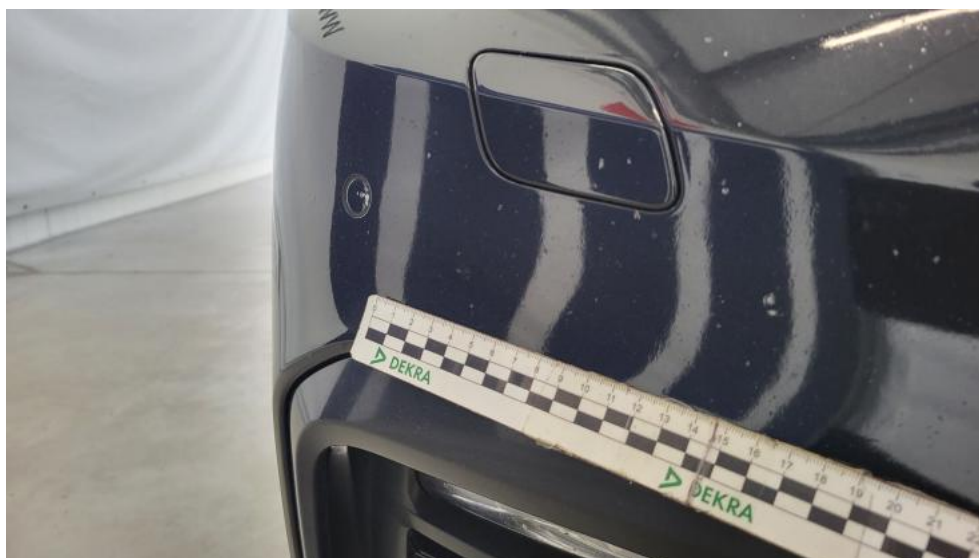
Photo 56.
Zderzak - zdjęcie poglądowe 1

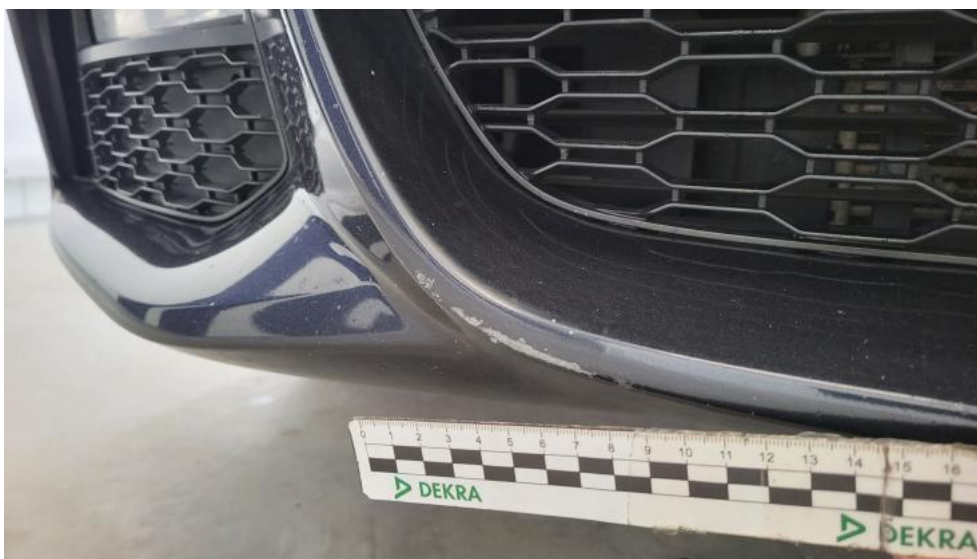
Photo 57.

Zderzak - zdjęcie poglądowe 2

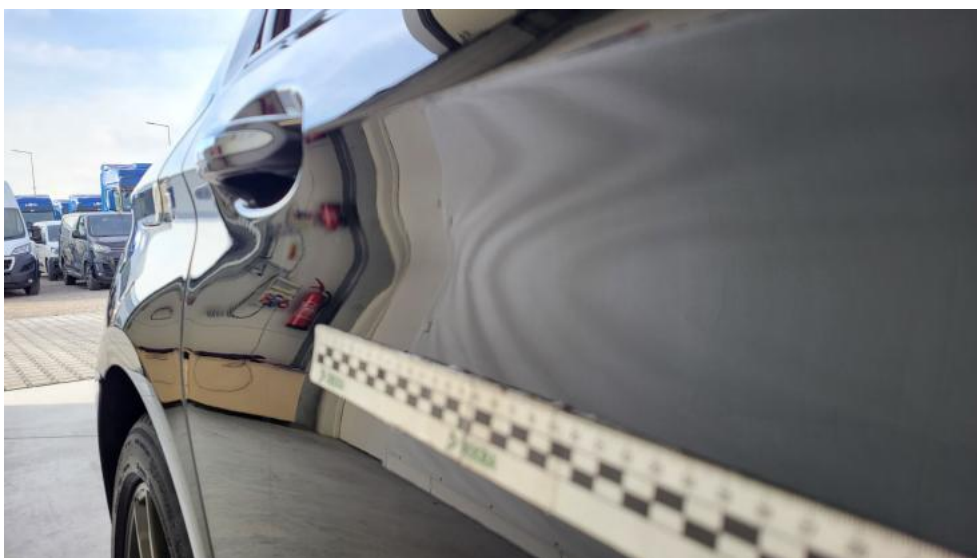
Photo 66.

Drzwi tylne P - Wgniecenie/odkształcenie 1

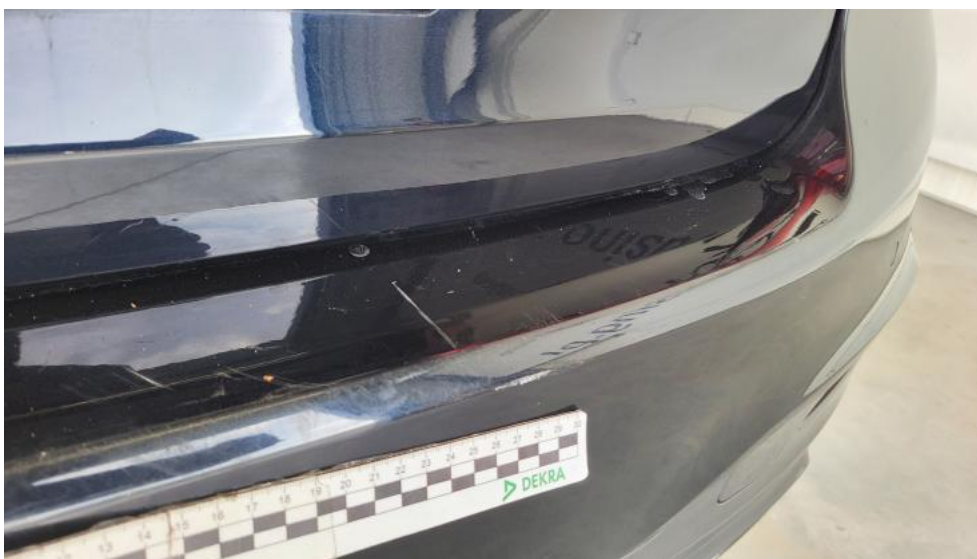
Photo 71.
Zderzak tylny - zdjęcie poglądowe 1

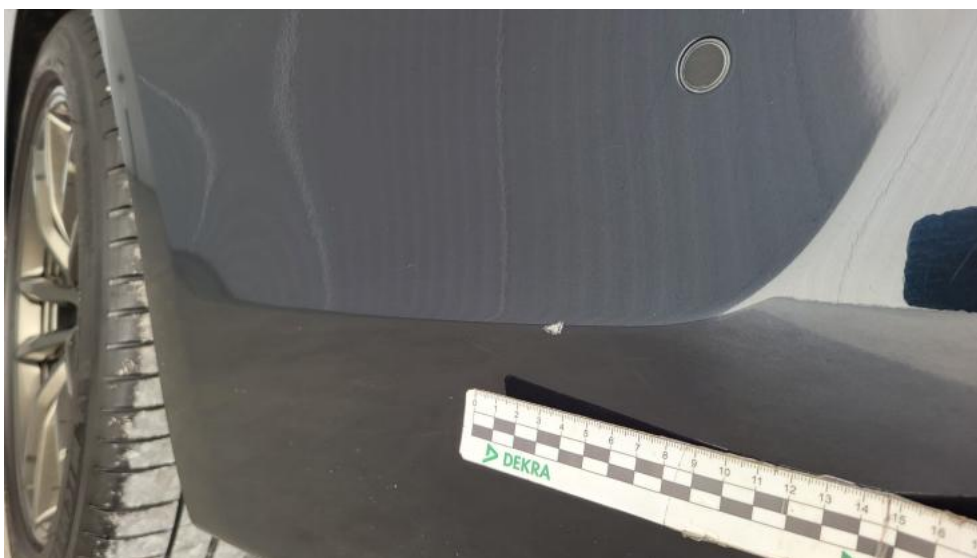
Photo 72.
Zderzak tylny - zdjęcie poglądowe 2

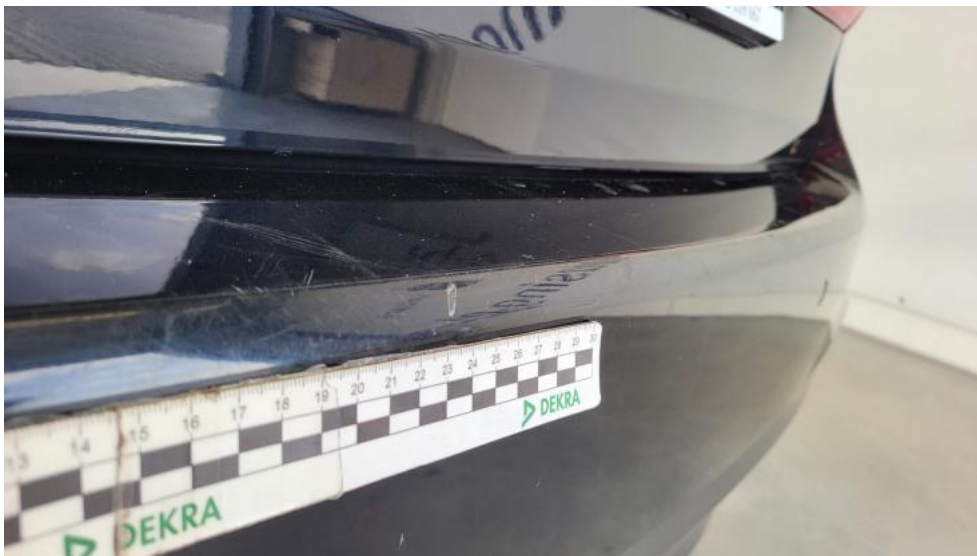
Photo 75.
Zderzak tylny() - Rysa/odprysk 3

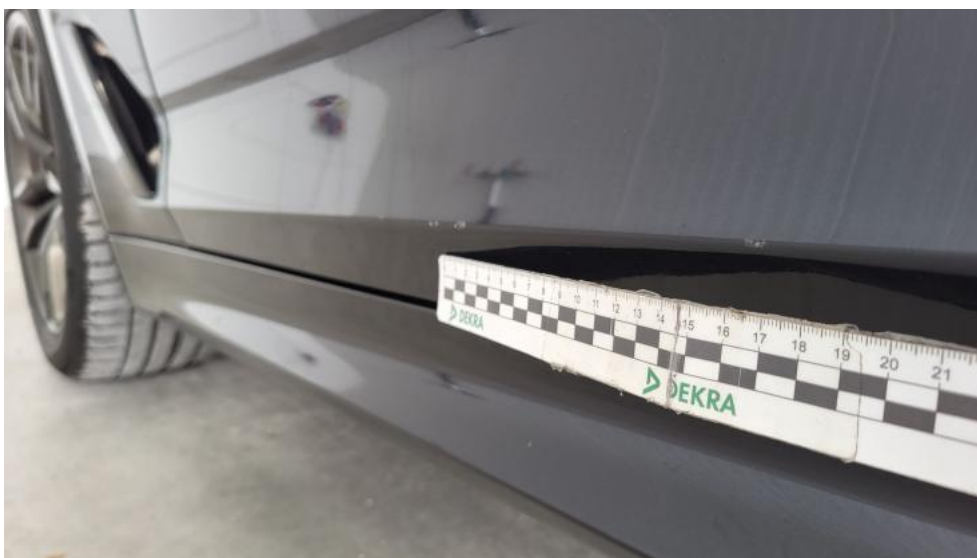
Photo 84.

Drzwi przed L() - Rysa/odprysk 3

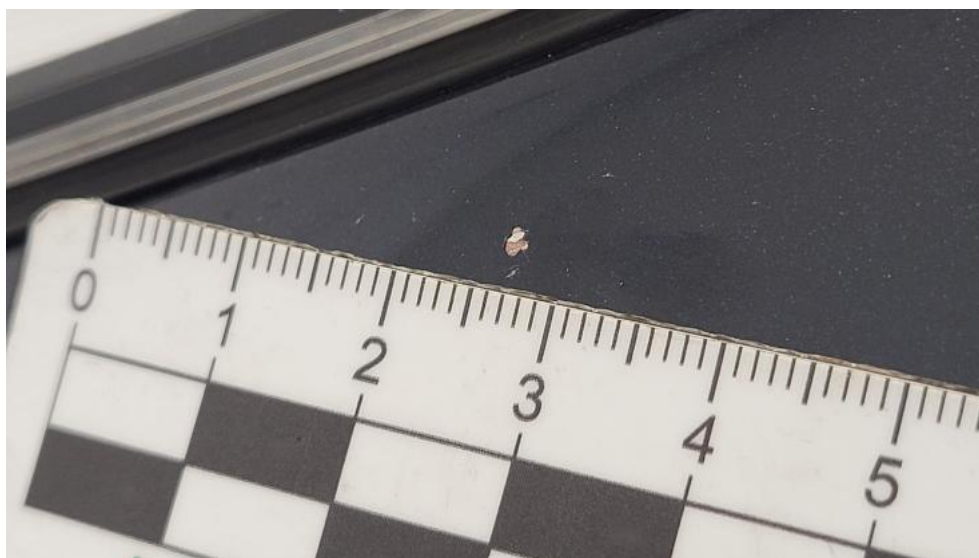
Photo 90.
Błotnik przedni L - zdjęcie pogładowe 1

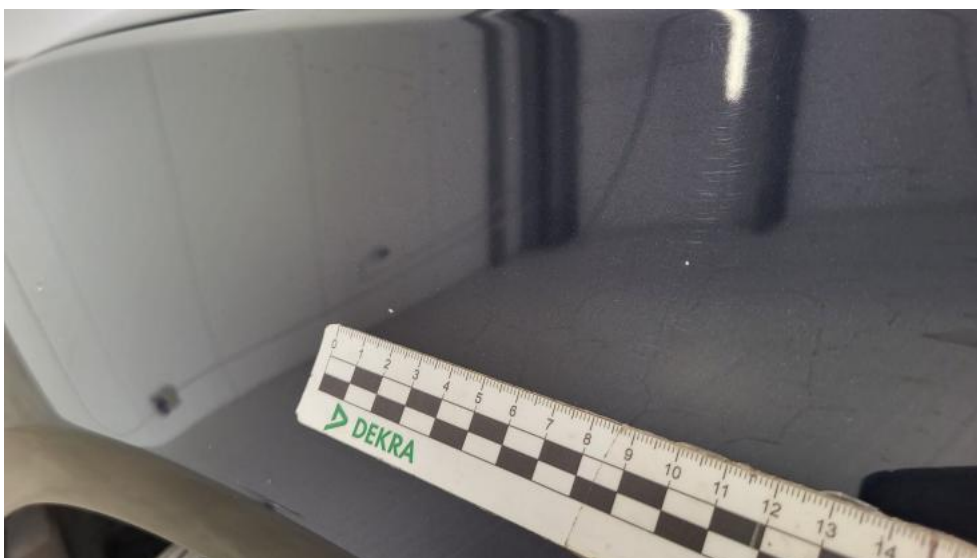
Photo 92.
Błotnik przedni L - Rysa/odprysk 2
