DEKRA's commission No. : PKOL(W)/LODZ/87484/26/09/17  
commission/ damage No. : 23/007880  
Date of commission: 17-09-2026

**DEKRA Poland - Headquarters**  
02-673 Warszawa, ul. Konstruktorska 12A

| Manufacturer | BMW |
| Model | Seria 8 Gran Coupe [G16] 19-22 |

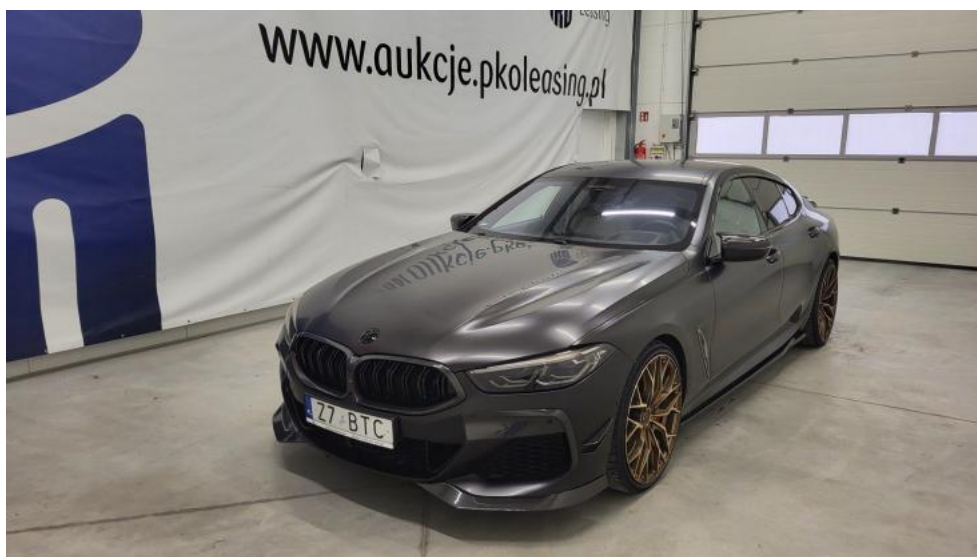
**Photo 1.**  
Przekątna przednia lewa

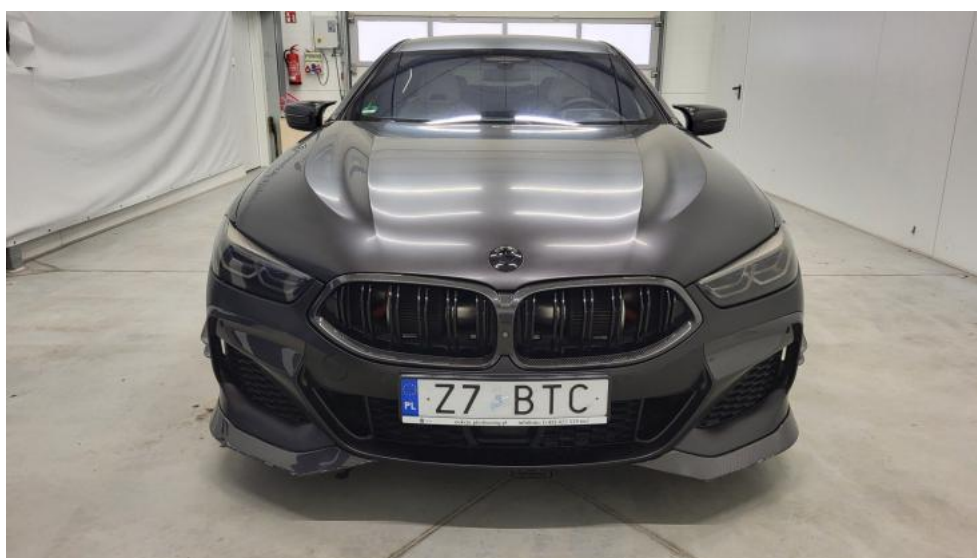
**Photo 2.**  
Przód

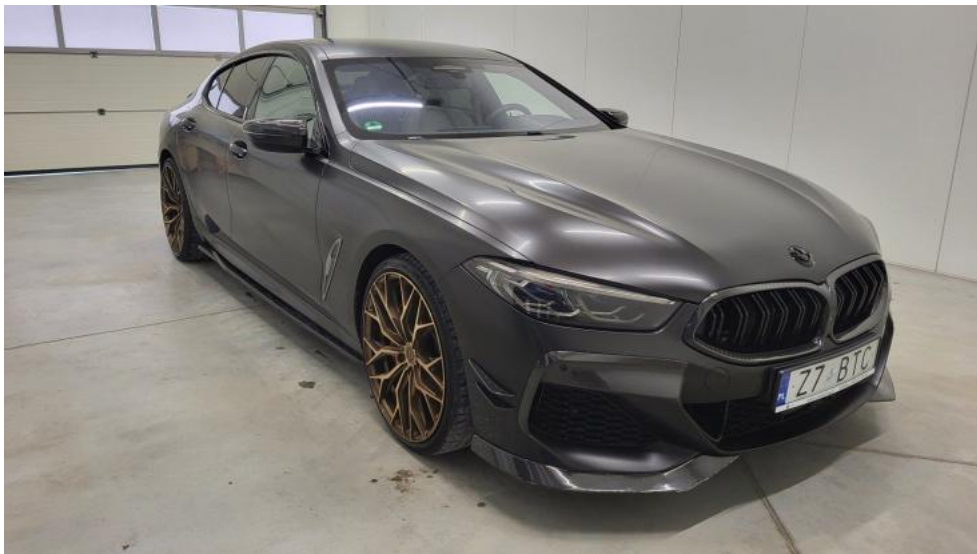
**Photo 3.**

Przekątna przednia prawa

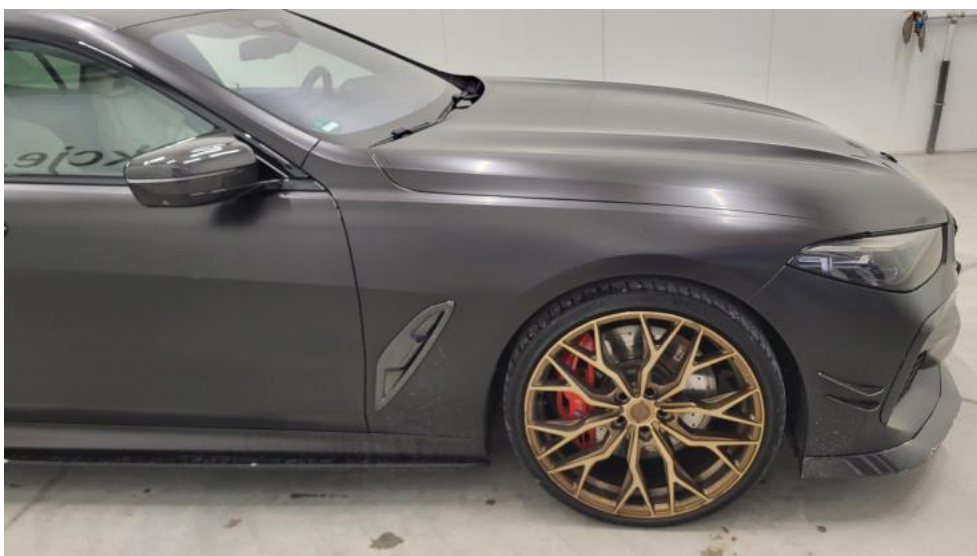
**Photo 4.**

Bok prawy z przodu

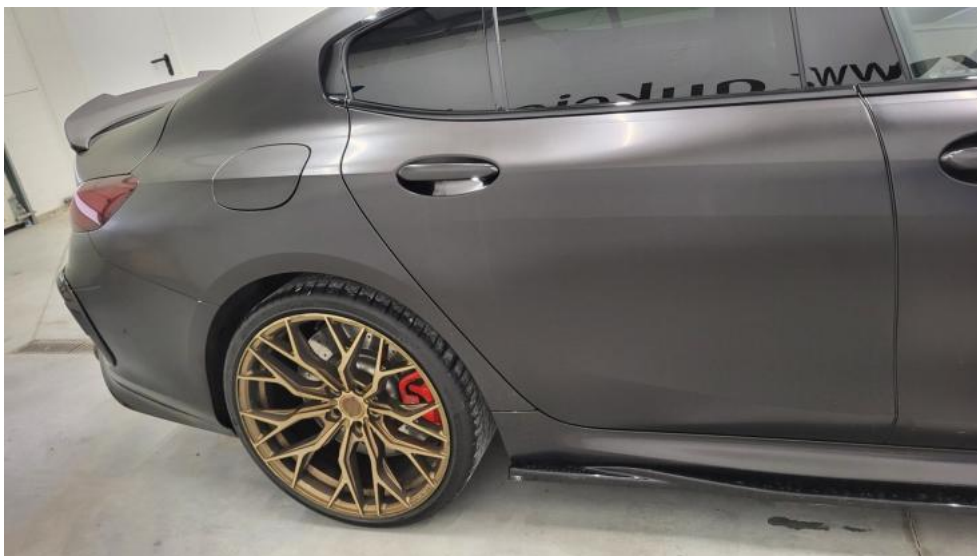
**Photo 5.**  
Bok prawy z tyłu

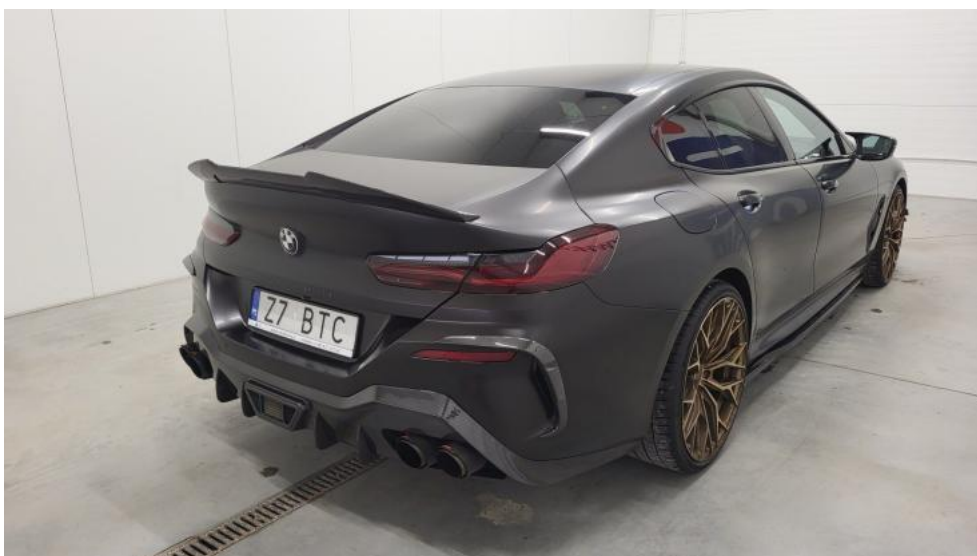
**Photo 6.**  
Przekątna tylna prawa

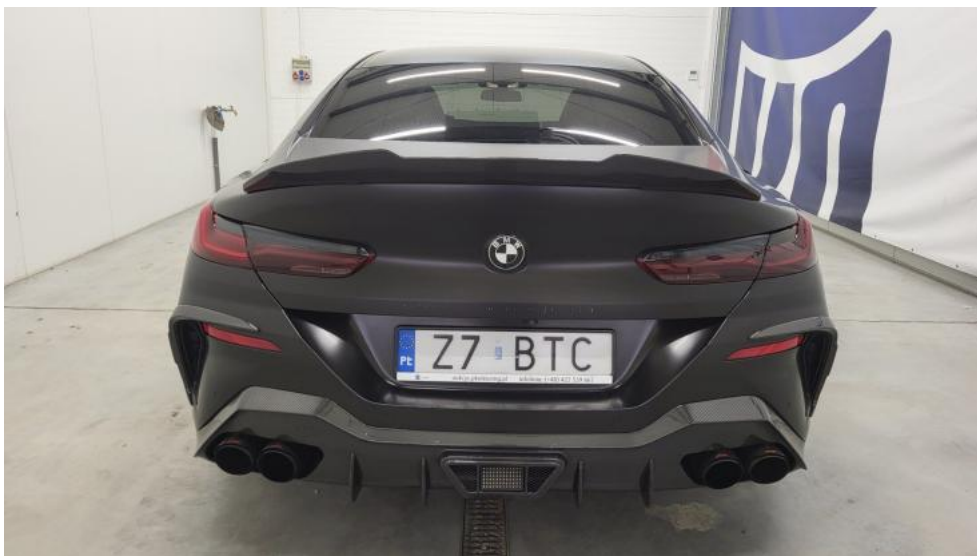
**Photo 7.**

Tył

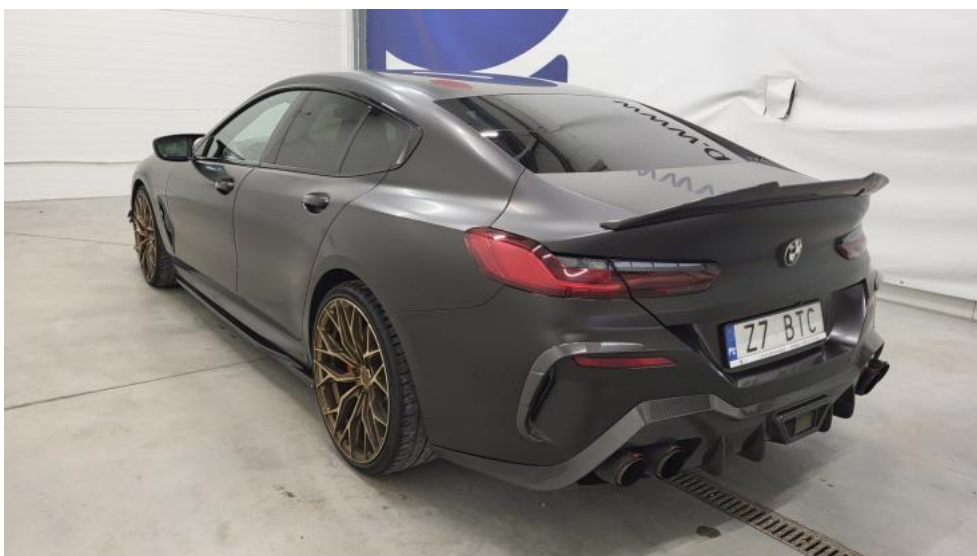
**Photo 8.**

Przekątna tylna lewa

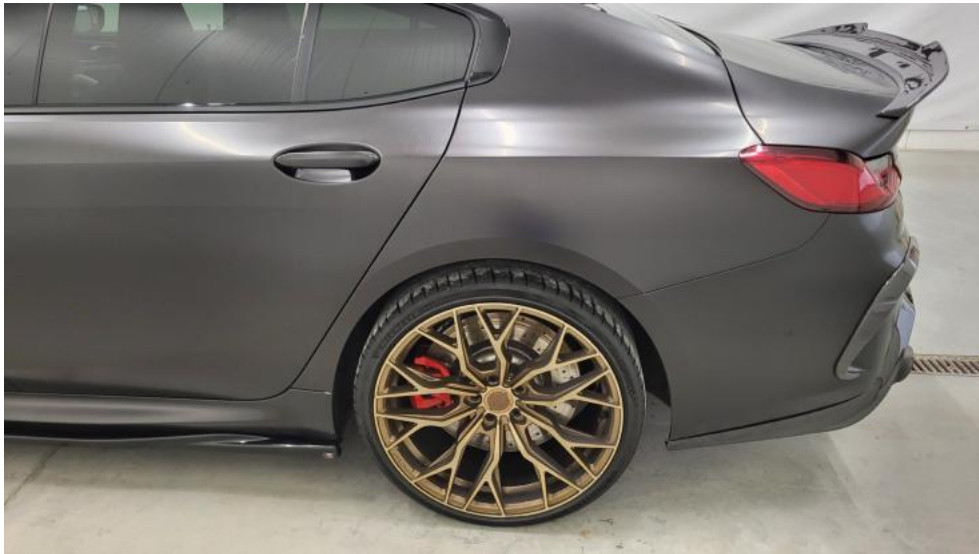
**Photo 9.**

Bok lewy z tyłu

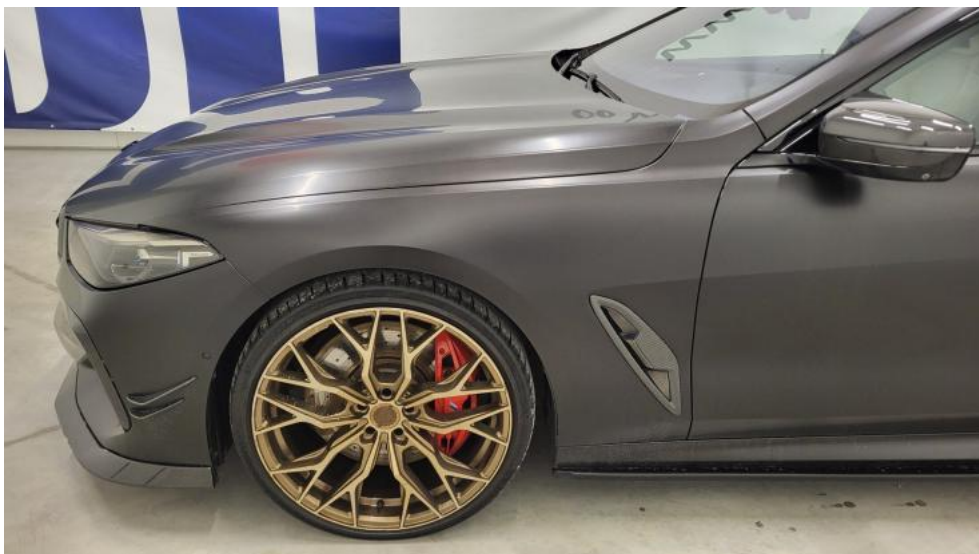
**Photo 10.**

Bok lewy z przodu

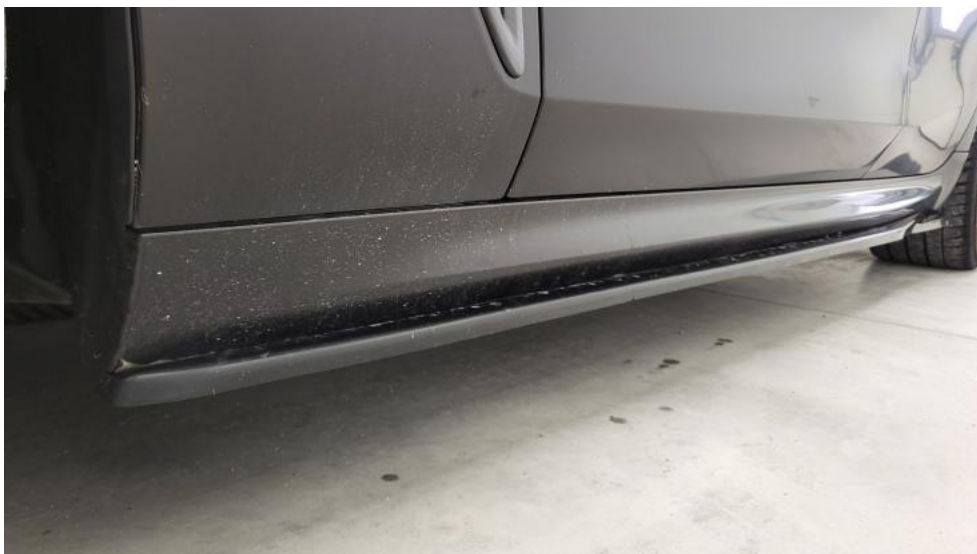
**Photo 11.**  
Próg lewy (widok od przodu)

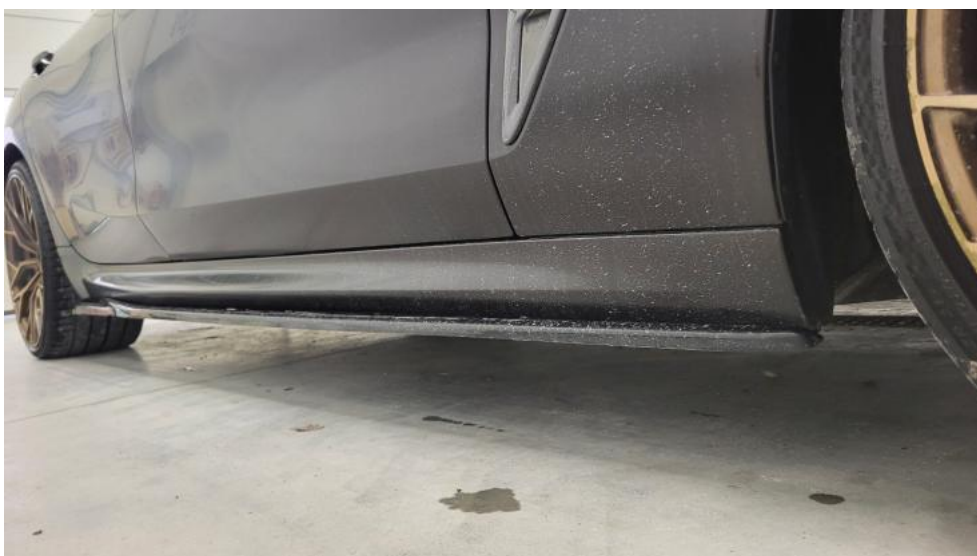
**Photo 12.**  
Próg prawy (widok od przodu)

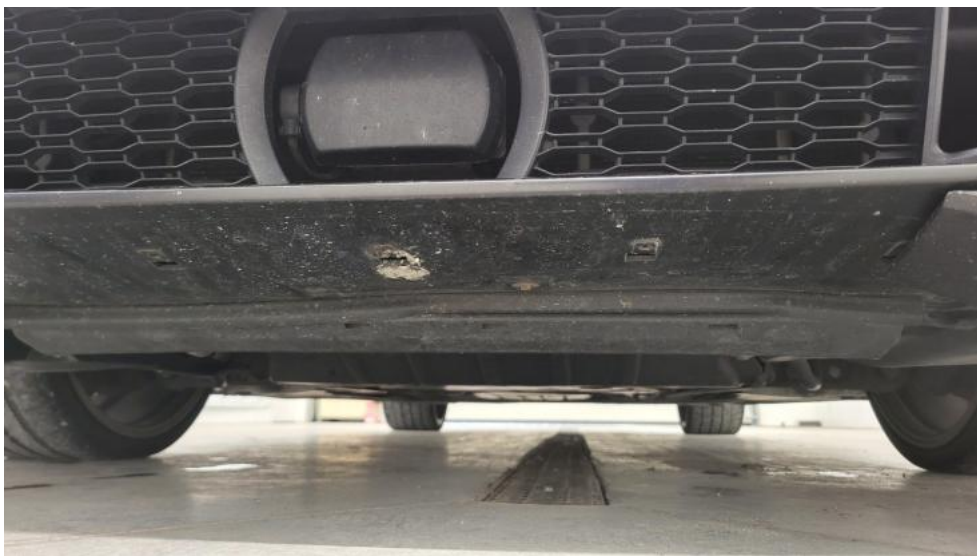
**Photo 13.**  
Spód pojazdu przód

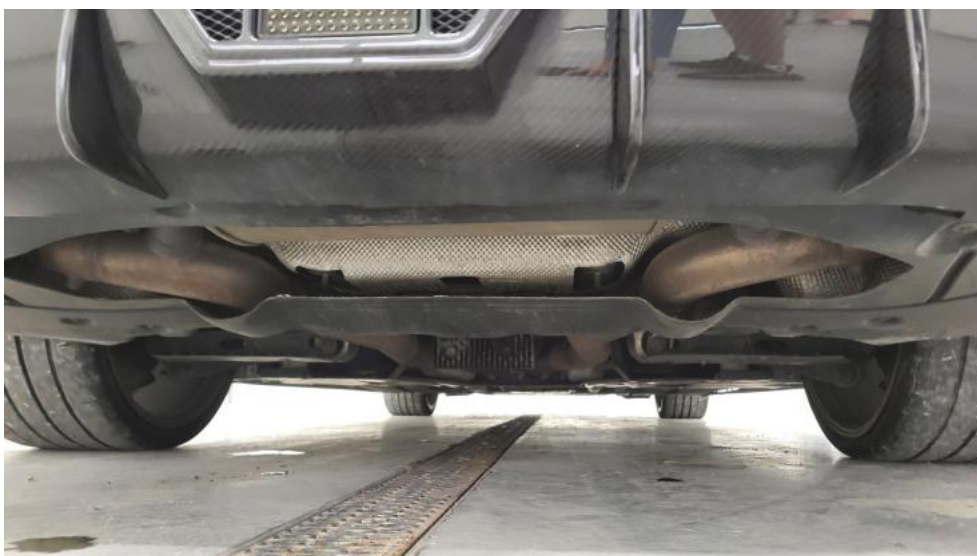
**Photo 14.**  
Spód pojazdu tył

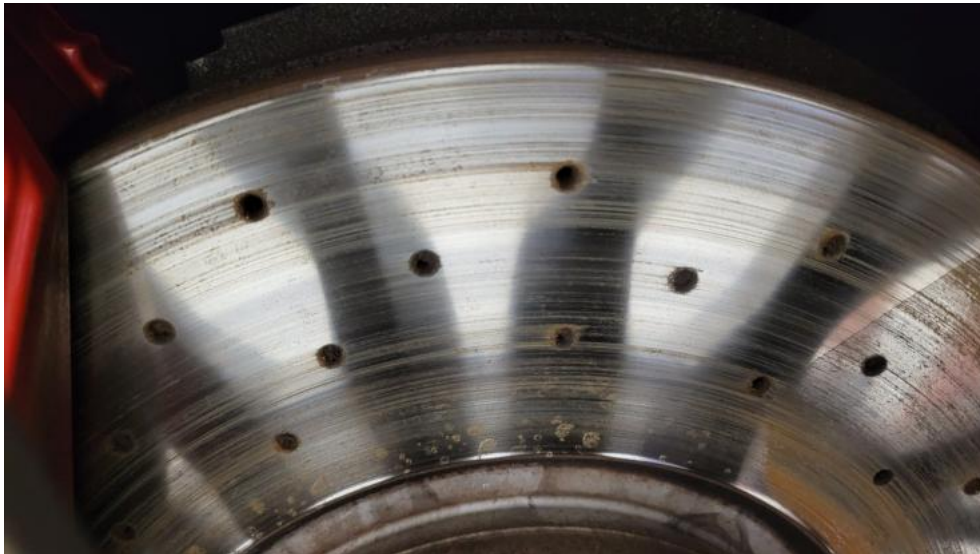
**Photo 15.**

Tarcza hamulcowa przednia prawa

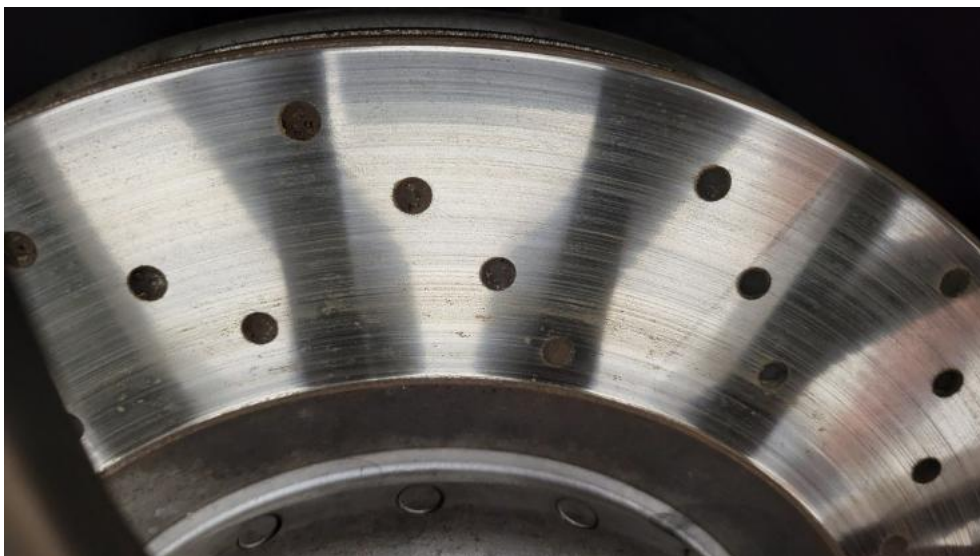
**Photo 16.**

Tarcza hamulcowa tylna prawa

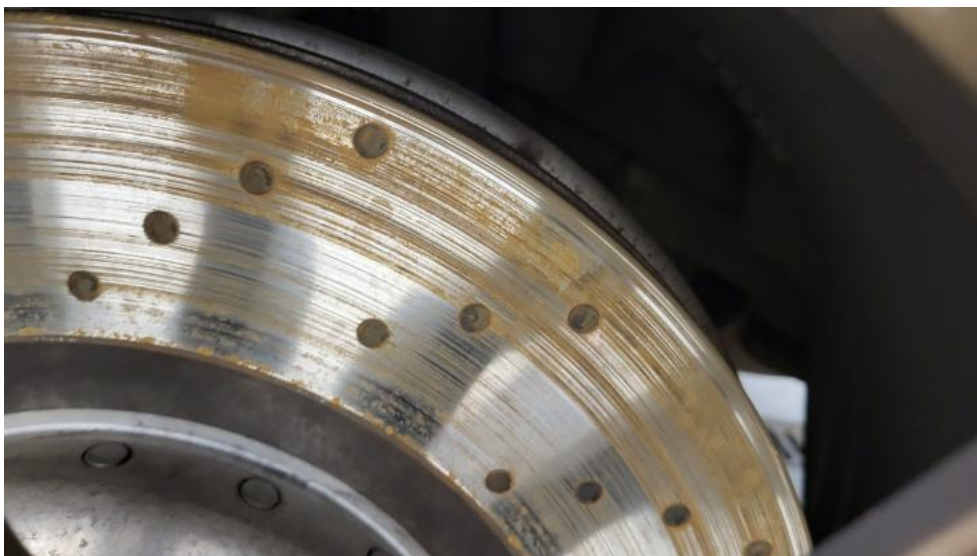
Tarcza hamulcowa tylna lewa

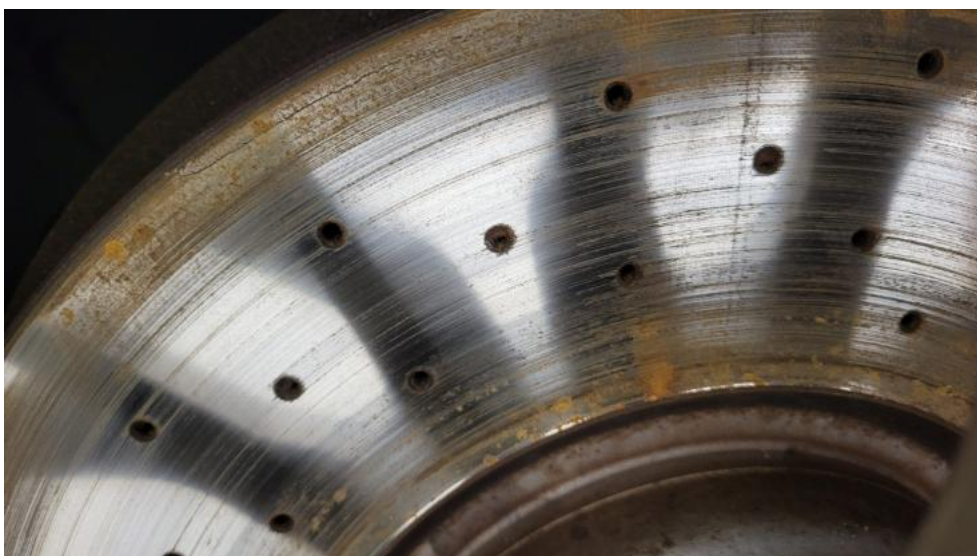
**Photo 18.**

Tarcza hamulcowa przednia lewa

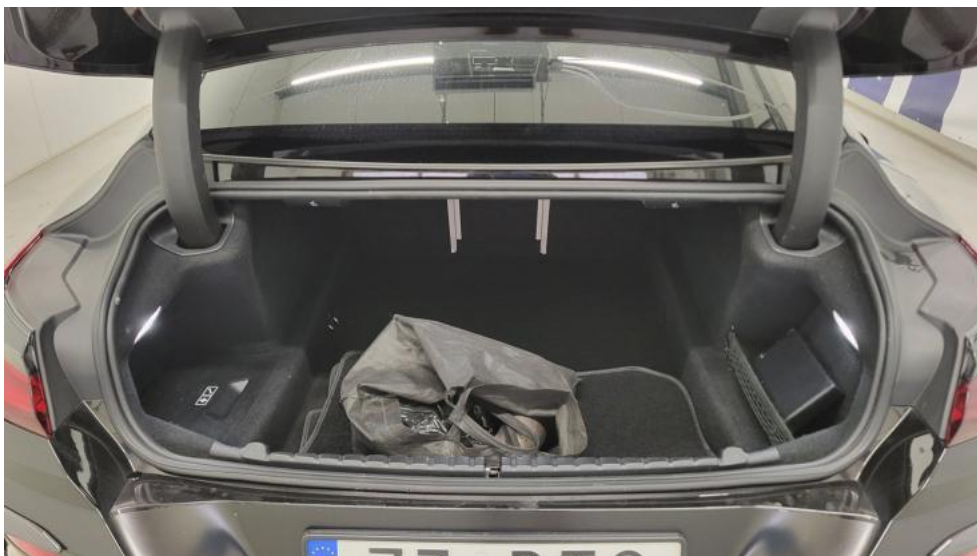
**Photo 19.**  
Bagażnik

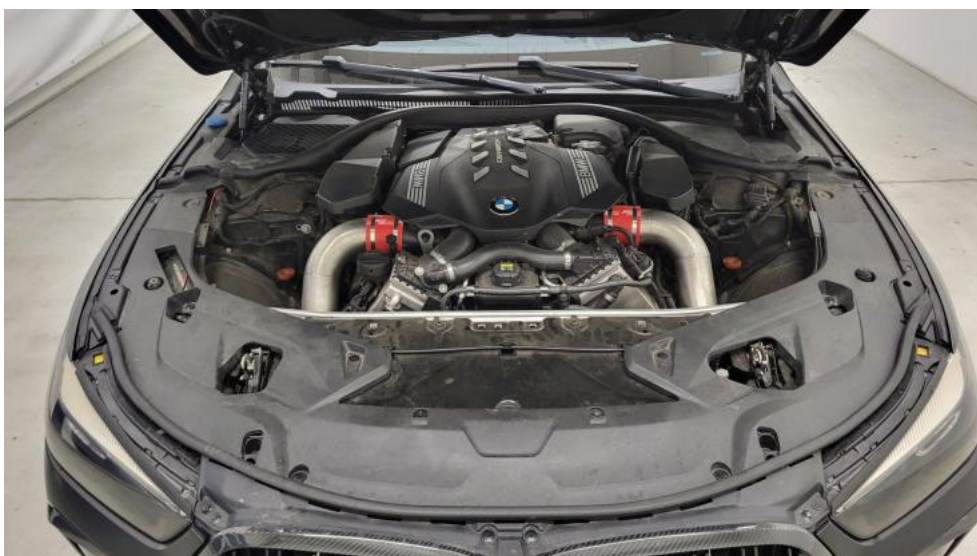
**Photo 20.**  
Komora silnika

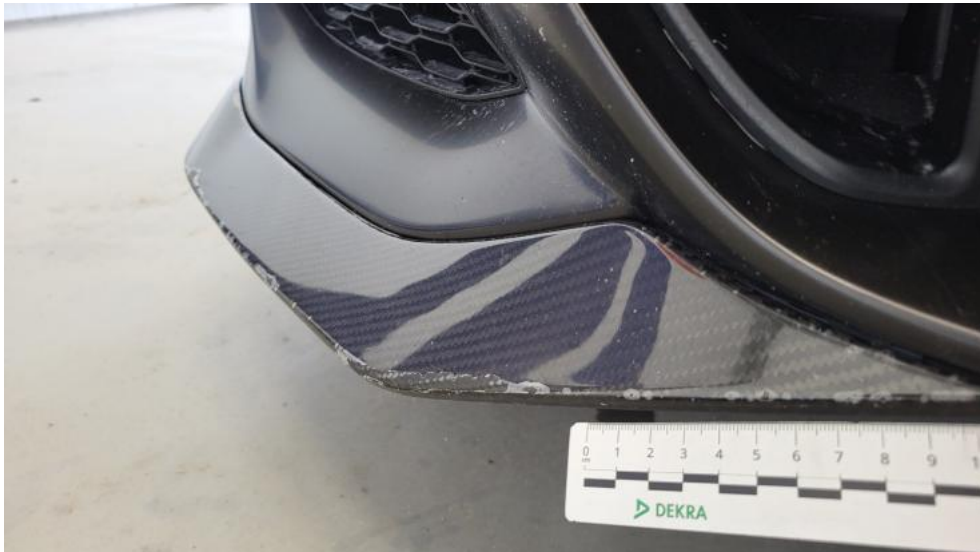
**Photo 57.**

Spoiler zderzaka przedniego - Inne 2

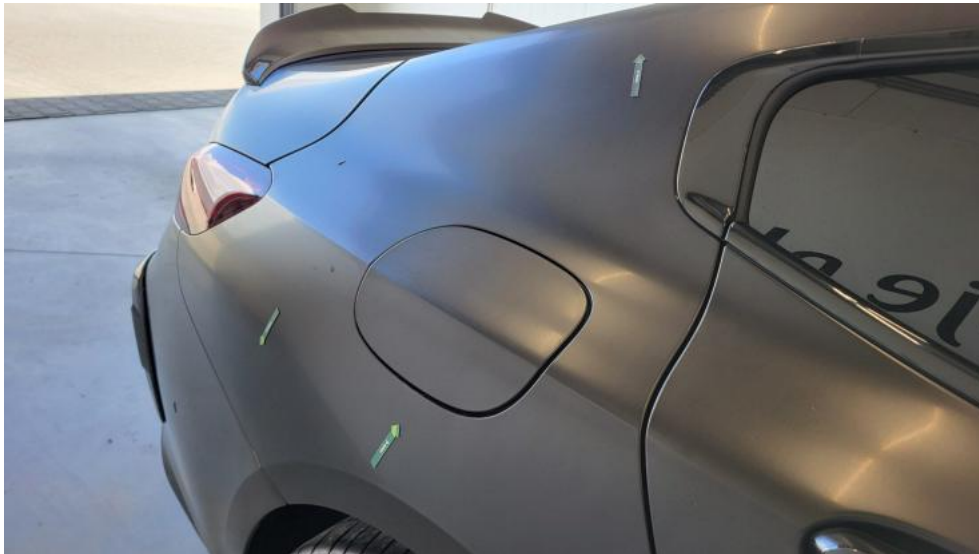
**Photo 61.**

Błotnik tylny P / Ściana boczna P - zdjęcie pogładowe 1

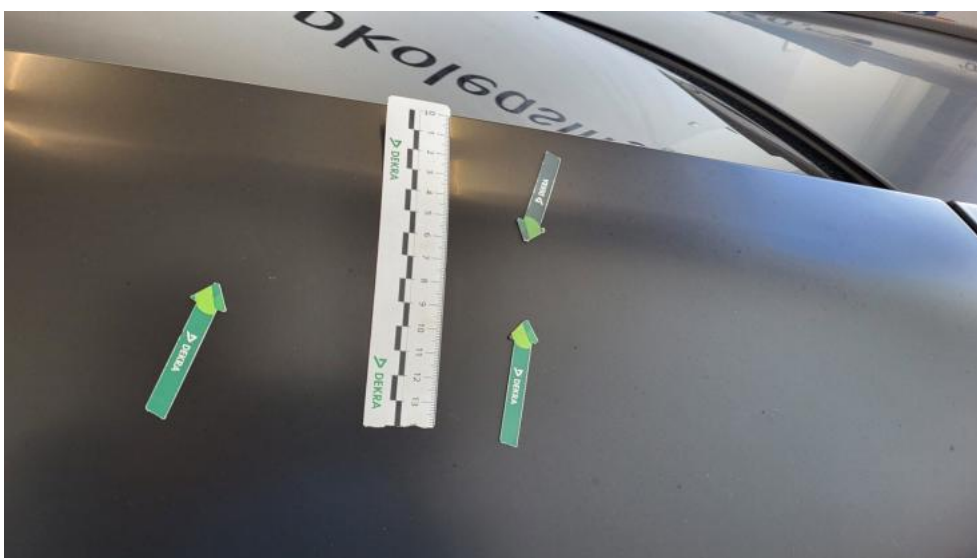
**Photo 66.**

Łotnik tylny L / Ściana boczna L - zdjęcie pogładowe 1

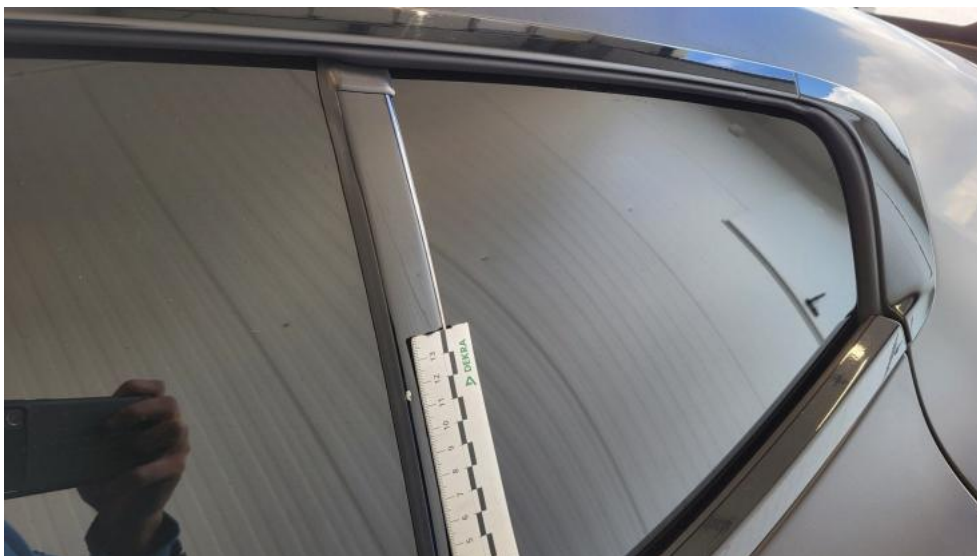
**Photo 71.**

Listwa drzwi tylnych L - zdjęcie poglądowe 1

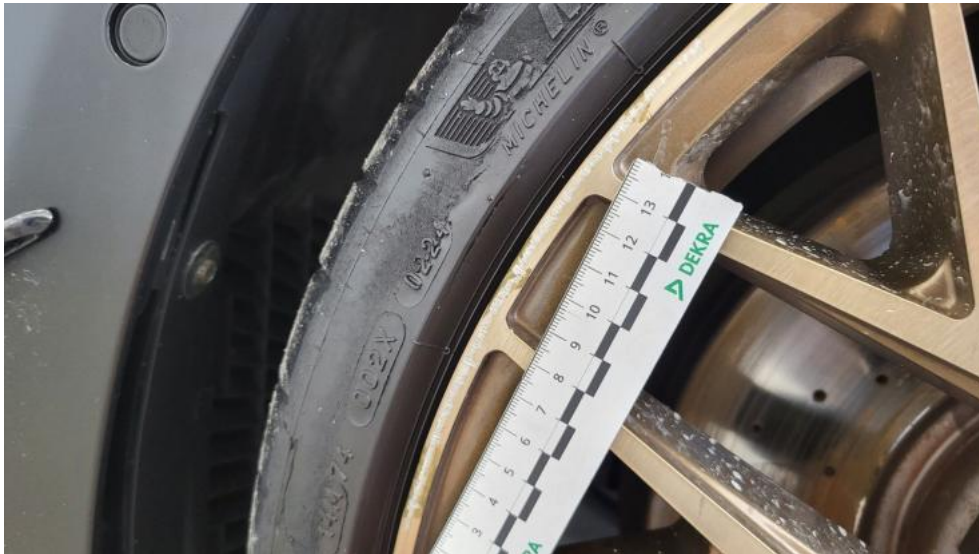
**Photo 73.**

Felga Aluminiowa przednia L - Rysa/odprysk 1
