DEKRA's commission No. : PKOL(W)/LODZ/32114/25/05/05  
commission/ damage No. : 22/024624  
Date of commission: 05-05-2025

| Manufacturer | BMW |
| Type / version | 530d mHEV M Sport sport-aut |
| Registration /record No. | TK955CC |

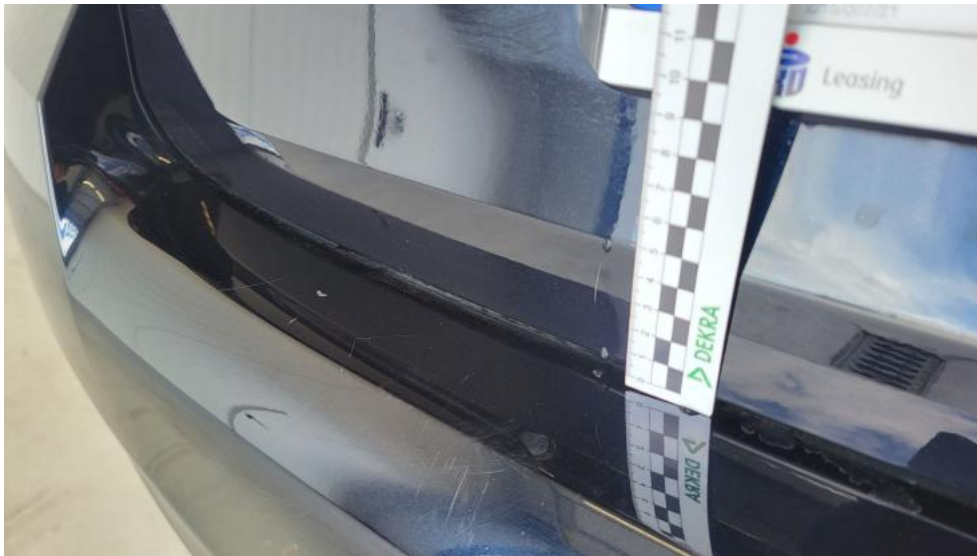
**Photo 57.**

Pokrywy bagażnika() - Rysa/odprysk 3

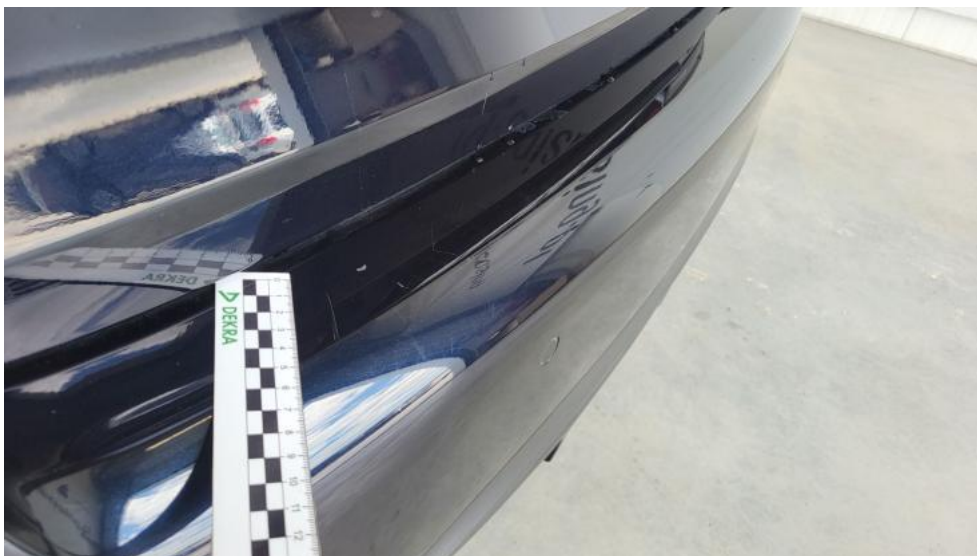
**Photo 58.**

Zderzak tylny - Rysa/odprysk 1
