DEKRA's commission No. : PKOL(W)/LODZ/37030/25/05/22  
commission/ damage No. : 23/014456  
Date of commission: 22-05-2025

**Vehicle data**

| Model | Range Rover 21- |
| Type / version | Range Rover 3.0 P510e PHEV SV |

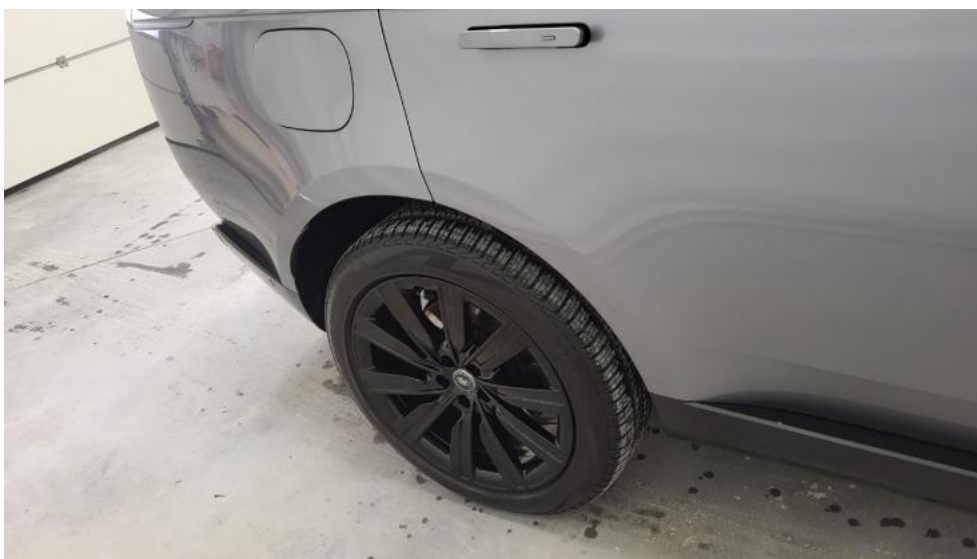
**Photo 5.**  
Bok prawy z tyłu

Błotnik tylny P / Ściana boczna P - Rysa/odprysk 2

Błotnik tylny P / Ściana boczna P() - Rysa/odprysk 3

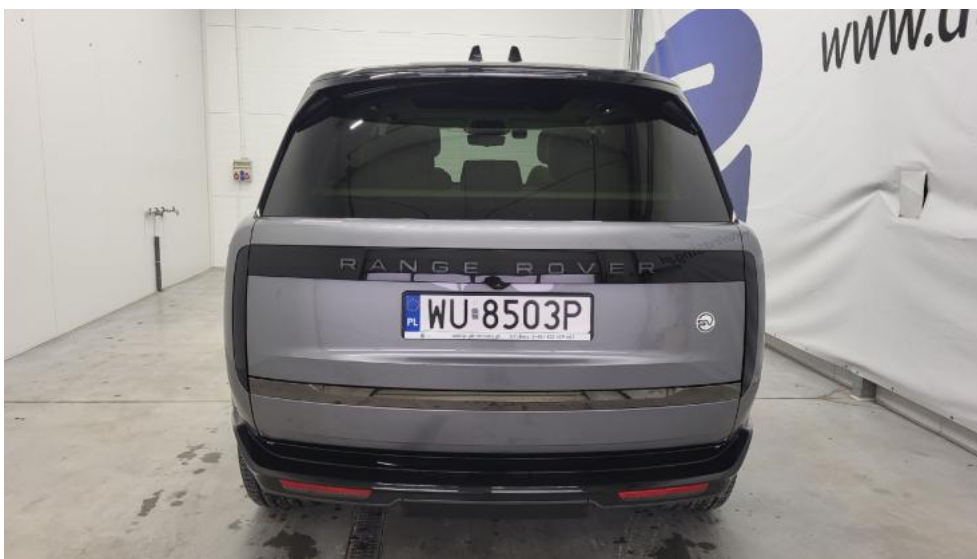
**Photo 7.**

Pokrywy bagażnika - Rysa/odprysk 2

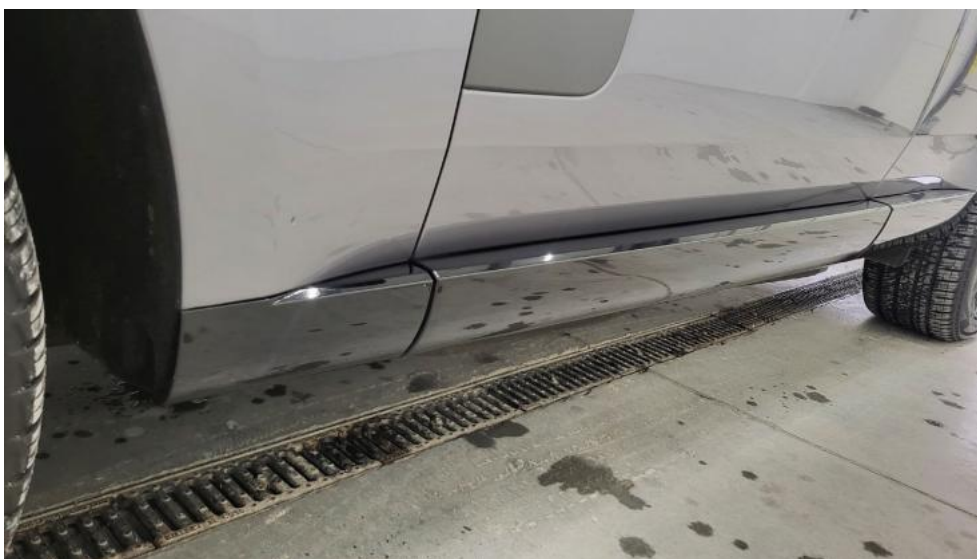
**Photo 11.**

Próg lewy (widok od przodu)

Listwy progowe lew. - Pęknięcie/rozerwanie 1

Listwy progowe lew. - Pęknięcie/rozerwanie 2

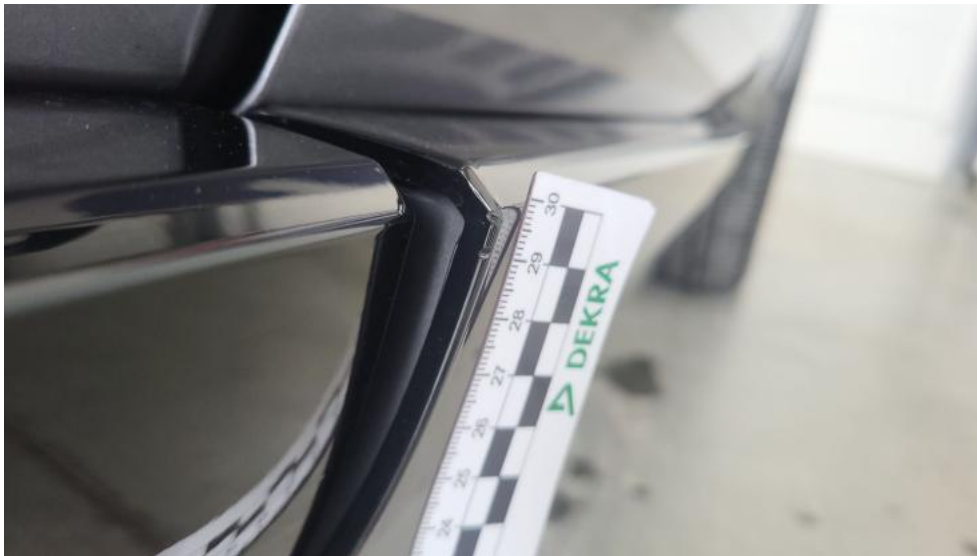
**Photo 65.**

Listwa drzwi przednich P - Rysa/odprysk 1

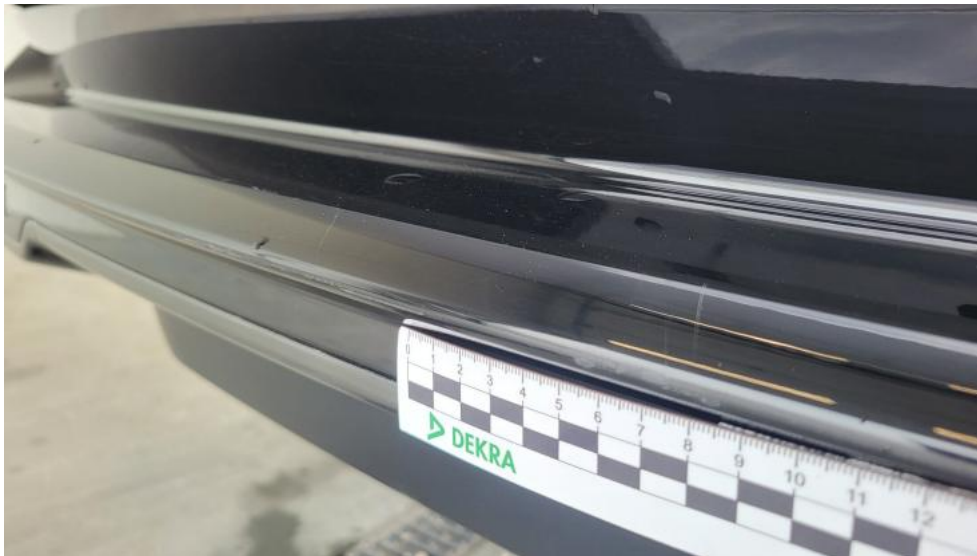
**Photo 71.**

Zderzak tylny - Rysa/odprysk 1

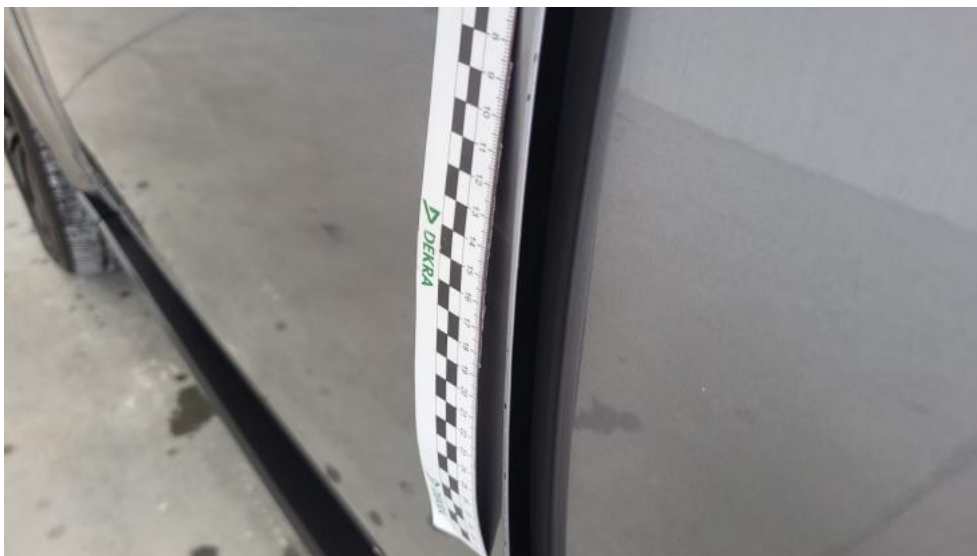
**Photo 72.**

Drzwi przed L - Rysa/odprysk 1

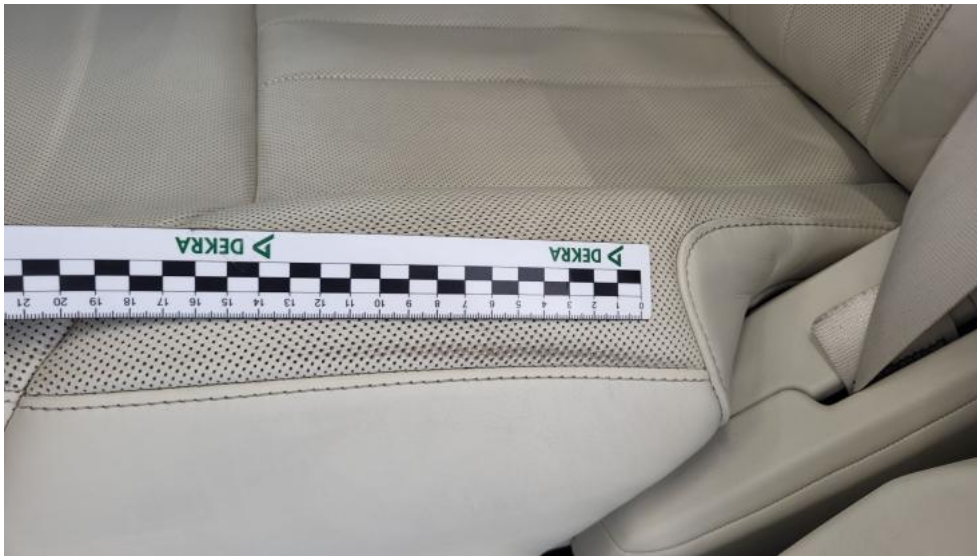
**Photo 77.**

Fotel prz. lew. - Inne 1
