DEKRA's commission No. : PKOL(W)/LODZ/90125/26/09/25  
commission/ damage No. : 23/038830  
Date of commission: 25-09-2026

**DEKRA Poland - Headquarters**  
02-673 Warszawa, ul. Konstruktorska 12A

| Manufacturer | CITROEN |
| Type / version | SpaceTourer 2.0 BlueHDi XL Business Lounge Aut. |

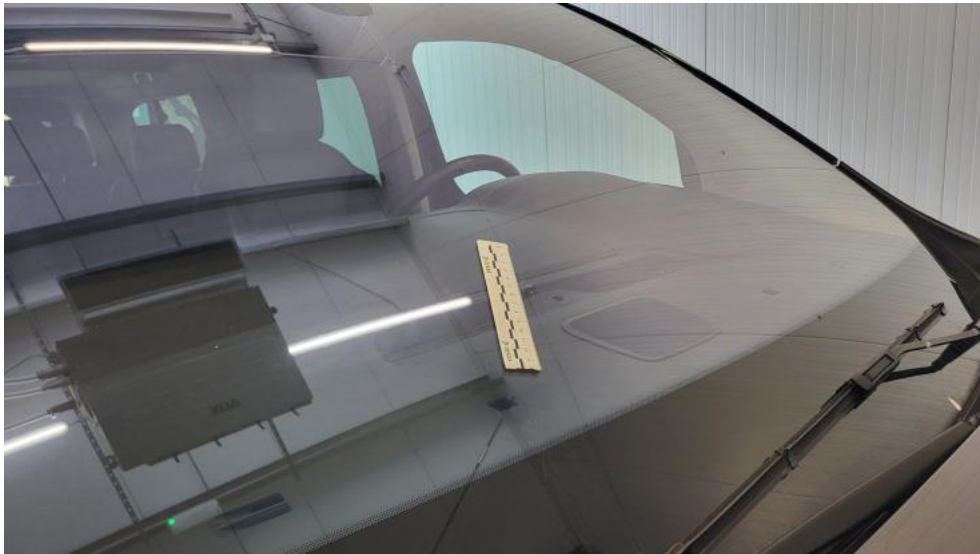
**Photo 43.**

Szyba czołowa - zdjęcie poglądowe 1

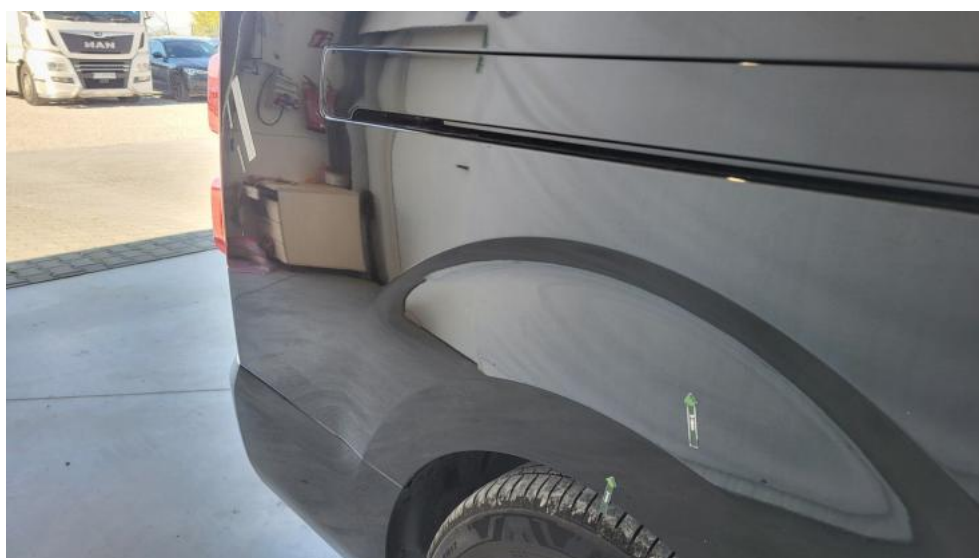
**Photo 60.**

Ścianka tylna P / Ścianka boczna P - zdjęcie poglądowe 1

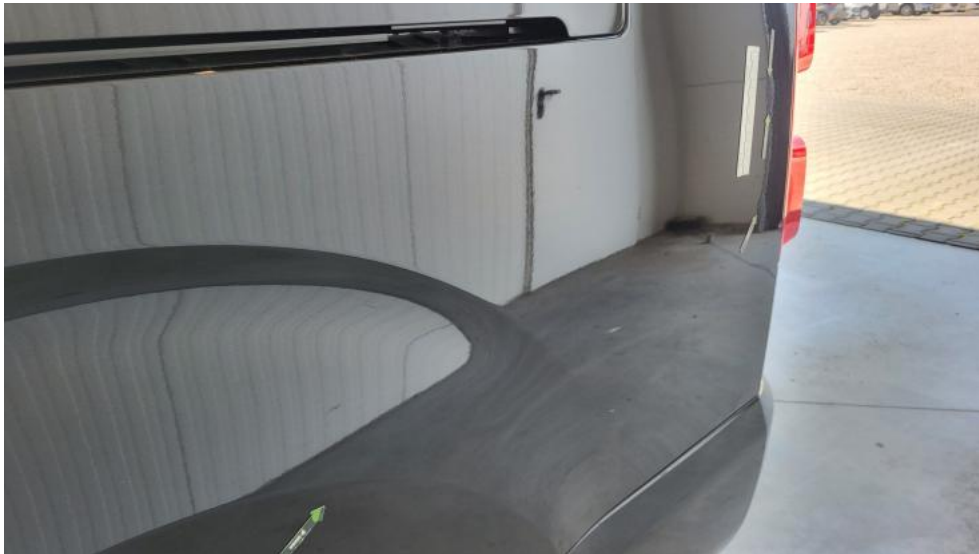
**Photo 67.**

Błotnik tylny L / Ściana boczna L - Wgniecenie/odkształcenie 1

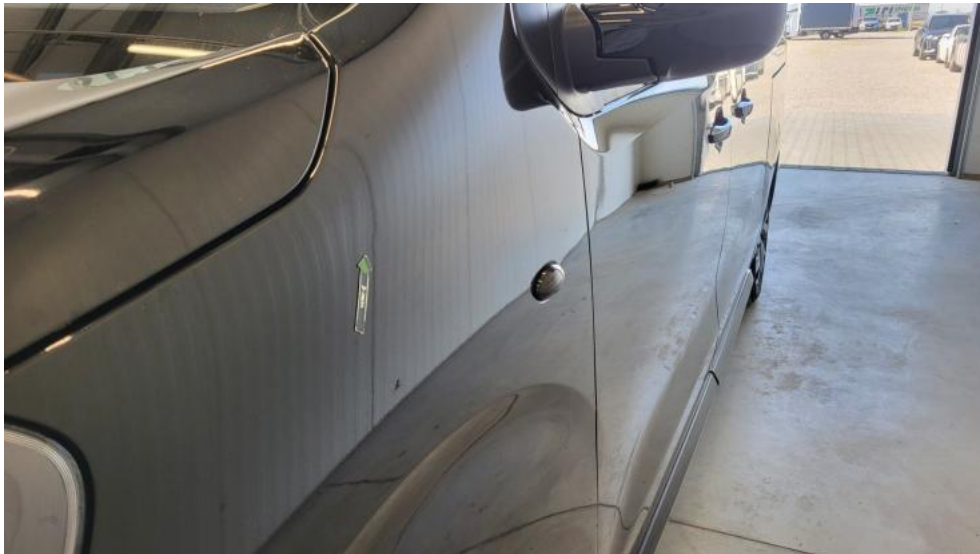
**Photo 77.**

Błotnik przedni L - Wgniecenie/odkształcenie 1

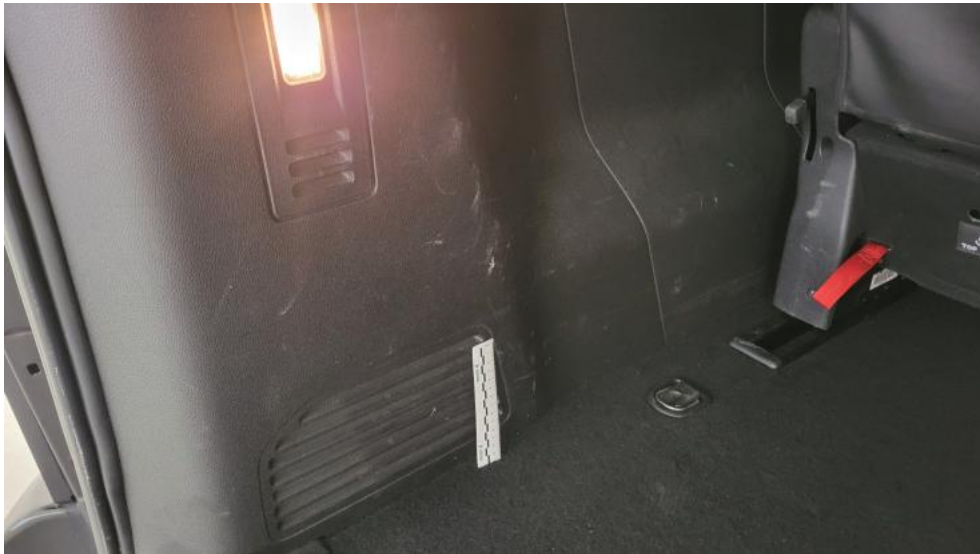
**Photo 81.**

Wykładzina przestrzeni bagażowej - Rysa/odprysk 1
